## 1 - Building 1 \_ South Elevation (Elevation 10) \_ Works to Existing

## Trinity One LLP 16,047 Trinity One, Huddersfield Building 1 - North and South Elevations The Old Brewery High Court Checked by Contractor must verify all dimensions on site before commencing any work or shop drawings. If this drawing exceeds the quantities taken in any way Scale: the Architects are to be informed before the work is initiated. Only figured dimensions to be taken from this drawing. Do not scale off this drawing. Drawings based on Ordnance Survey and / or existing record drawings - design and drawing content subject to Site Survey, Structural Survey, Site 1:100@A1 Jul 18 LS2 7ES A Buildings 2 & 3 included as retained Investigations, Planning and Statutory Requirements and Approvals. Authorised reproduction from Ordnance Survey Map with permission of the Controller of Her Majesty's Stationery Office. Crown Copyright reserved. Enjoy Design Ltd. Tel: 0113 242 3622 Drawn By: Revision: Drawing No: By Date

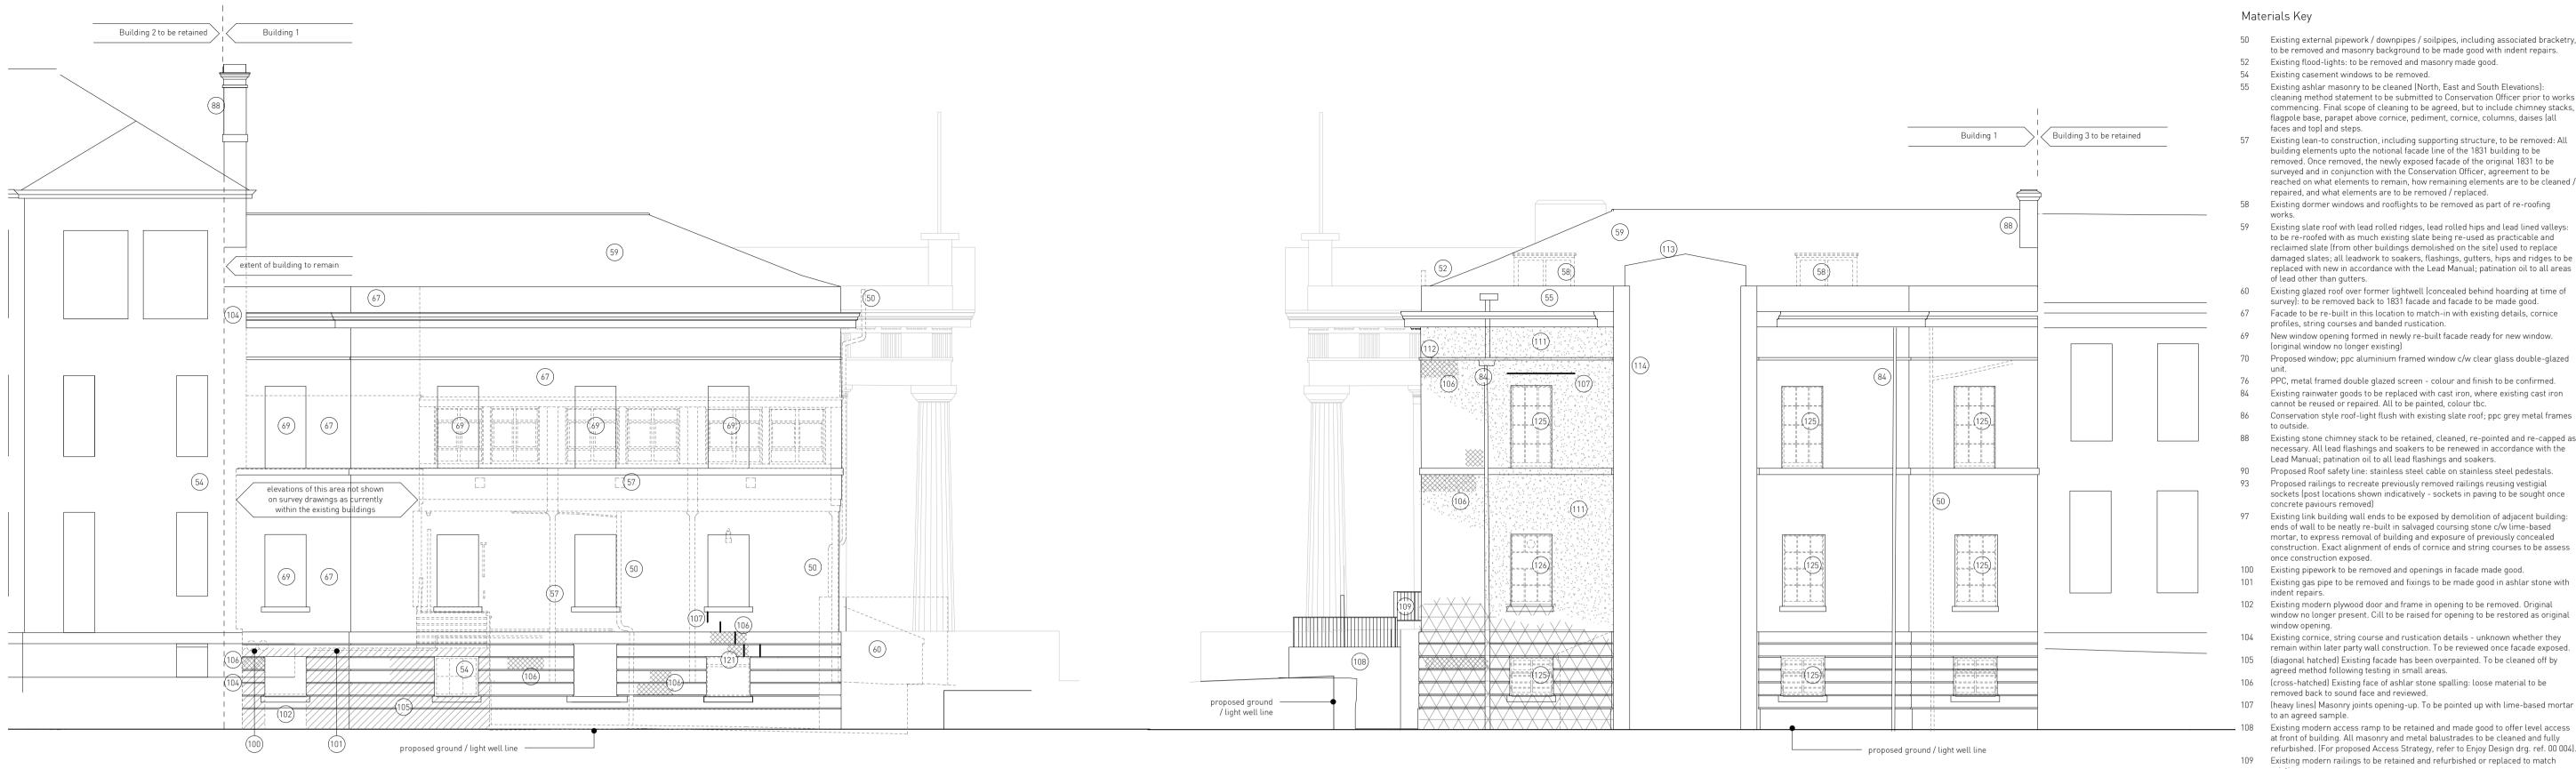
For survey of Building 1 as existing, refer to Met Surveys drg P17-00727-MET-EXT-ELE-M2-B-001
