1 - Building 1 _ North Wing South Elevation (Elevation 3) _ Works to Existing

4 - Building 1 _ North Wing South Elevation (Elevation 3) _ As Proposed

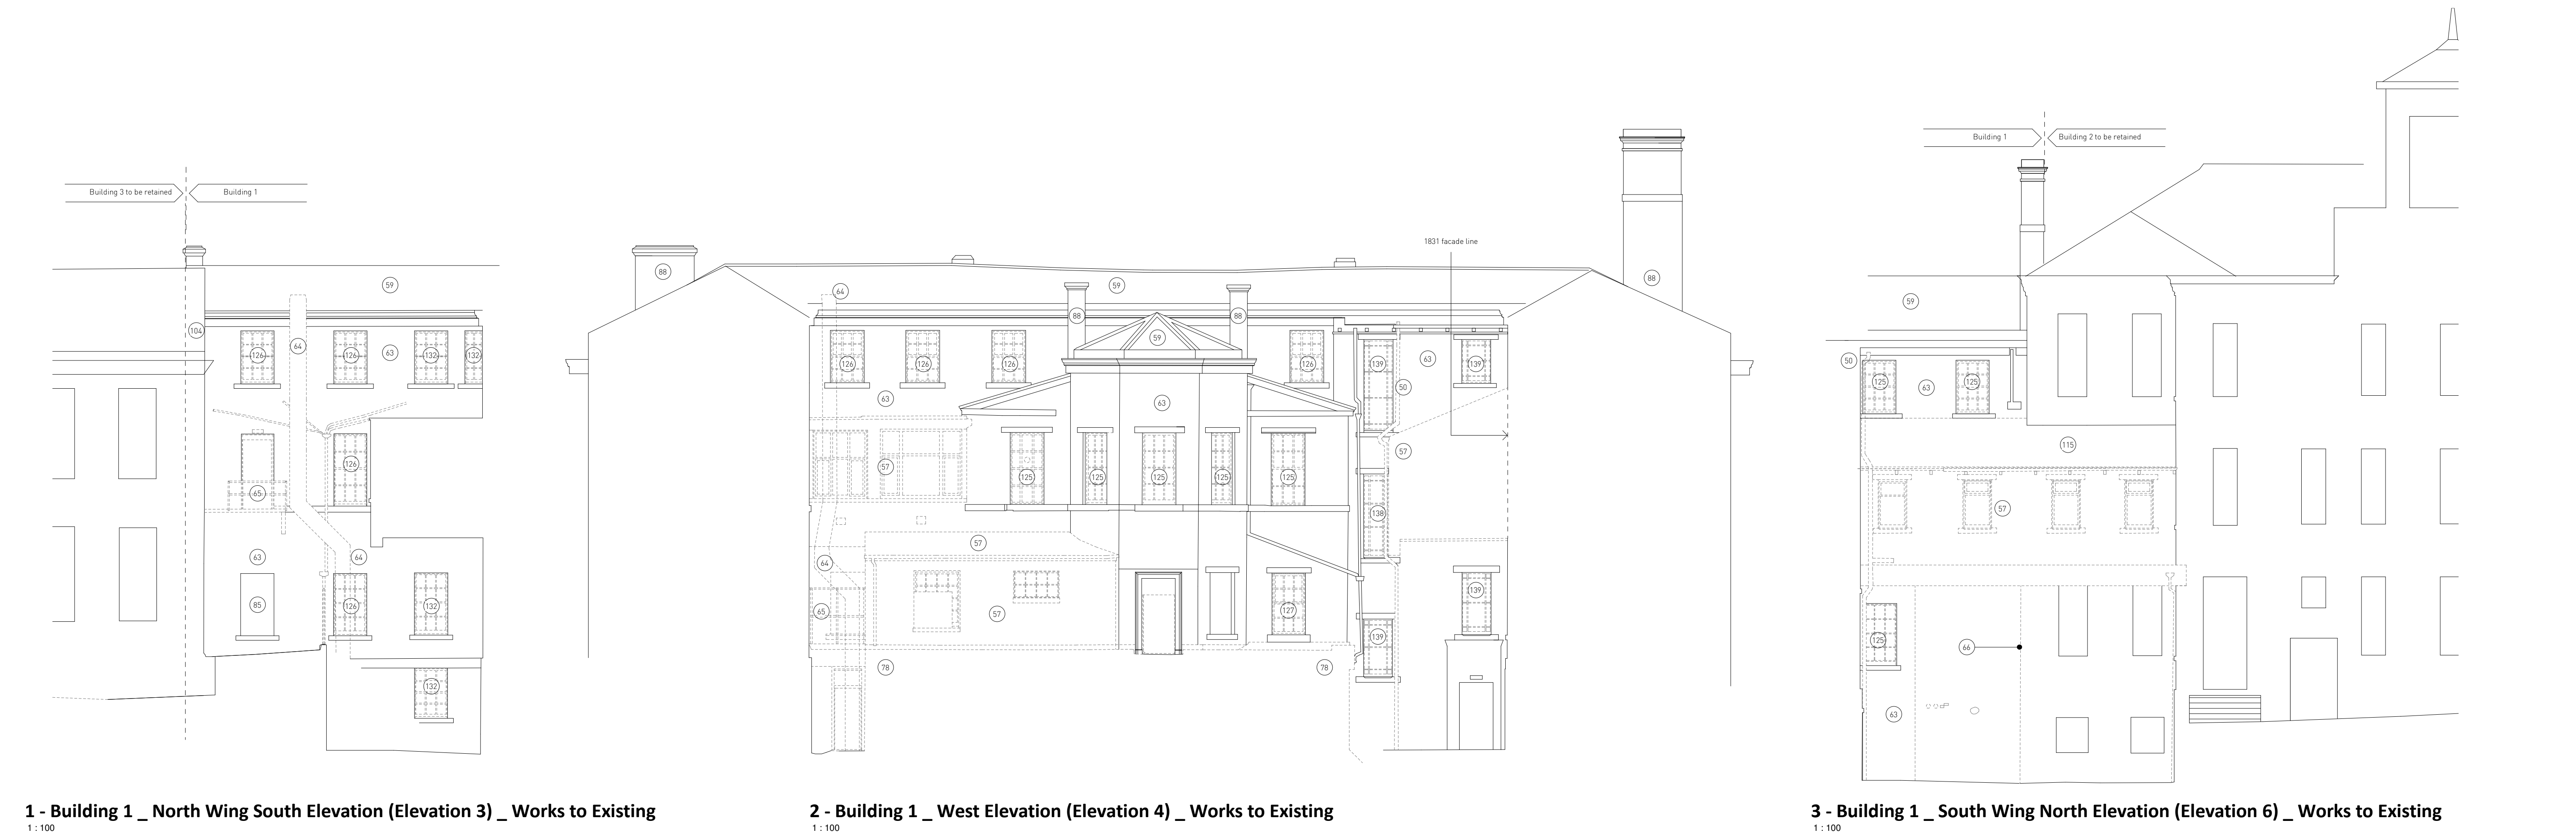
2 - Building 1 _ West Elevation (Elevation 4) _ Works to Existing

3 - Building 1 _ South Wing North Elevation (Elevation 6) _ Works to Existing

For survey of Building 1 as existing, refer to Met Surveys drg P17-00727-MET-EXT-ELE-M2-B-001

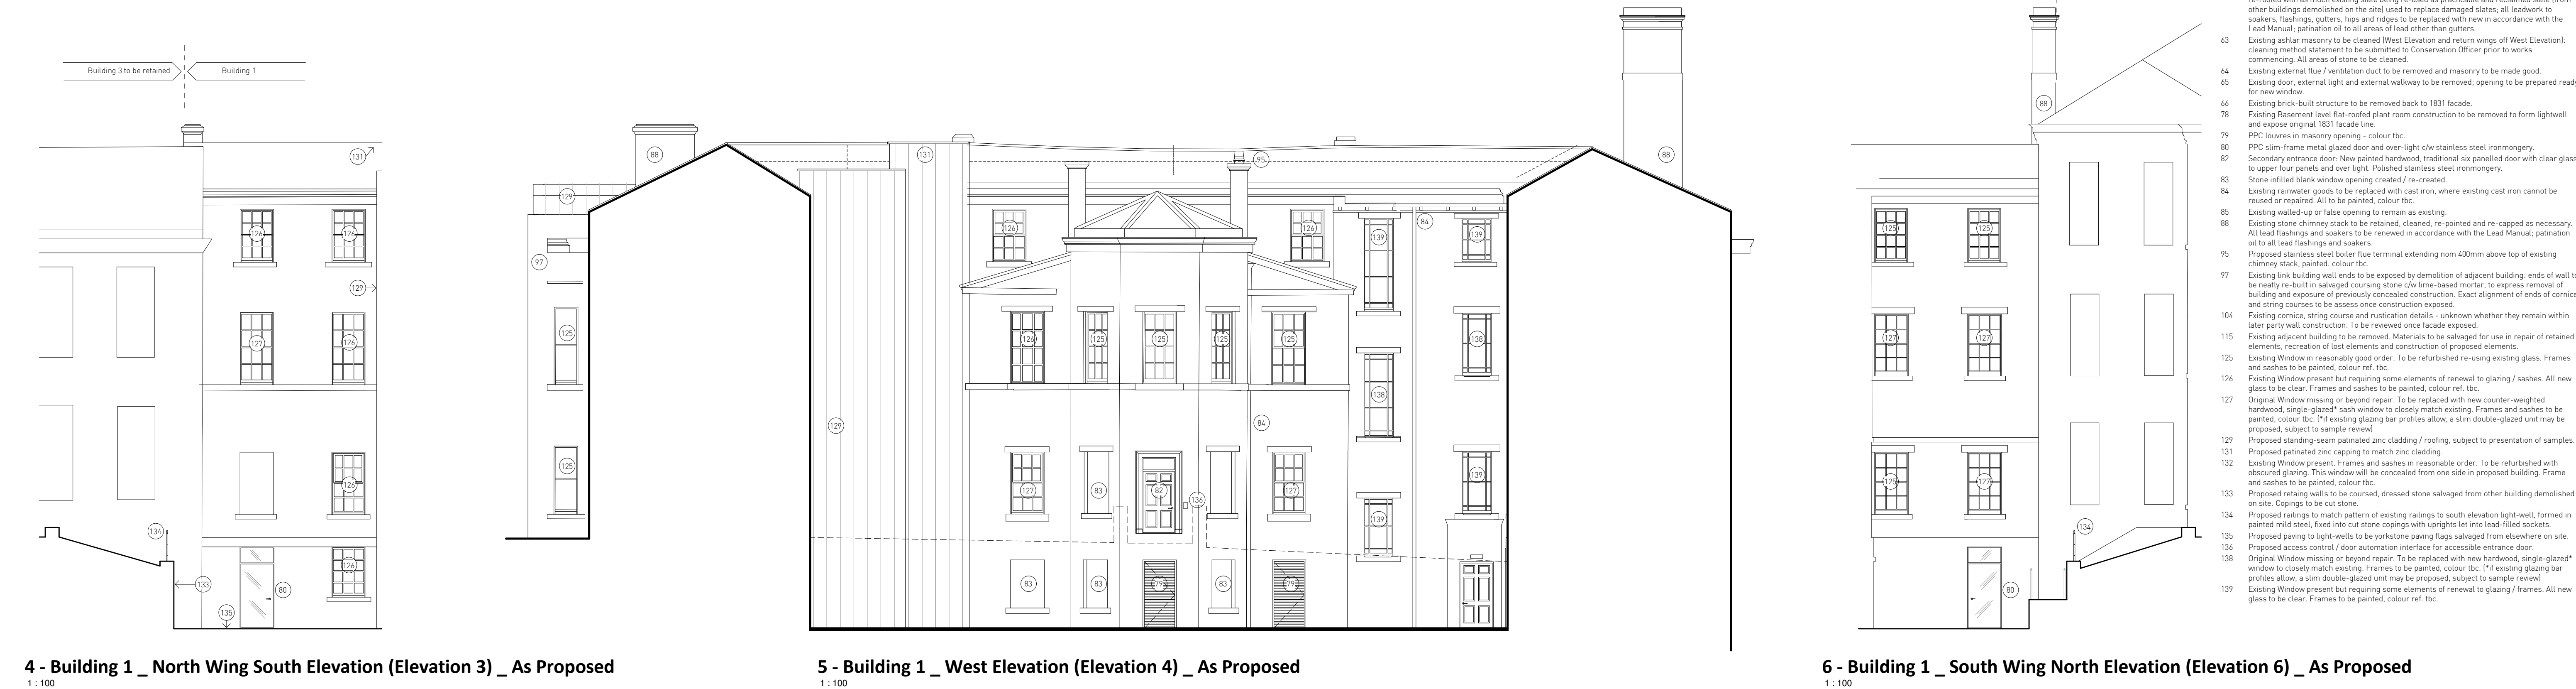
5 - Building 1 _ West Elevation (Elevation 4) _ As Proposed

6 - Building 1 _ South Wing North Elevation (Elevation 6) _ As Proposed
