## Phase 1 GeoEnvironmental Desk Study

Busker Lane

Scissett

December 2016

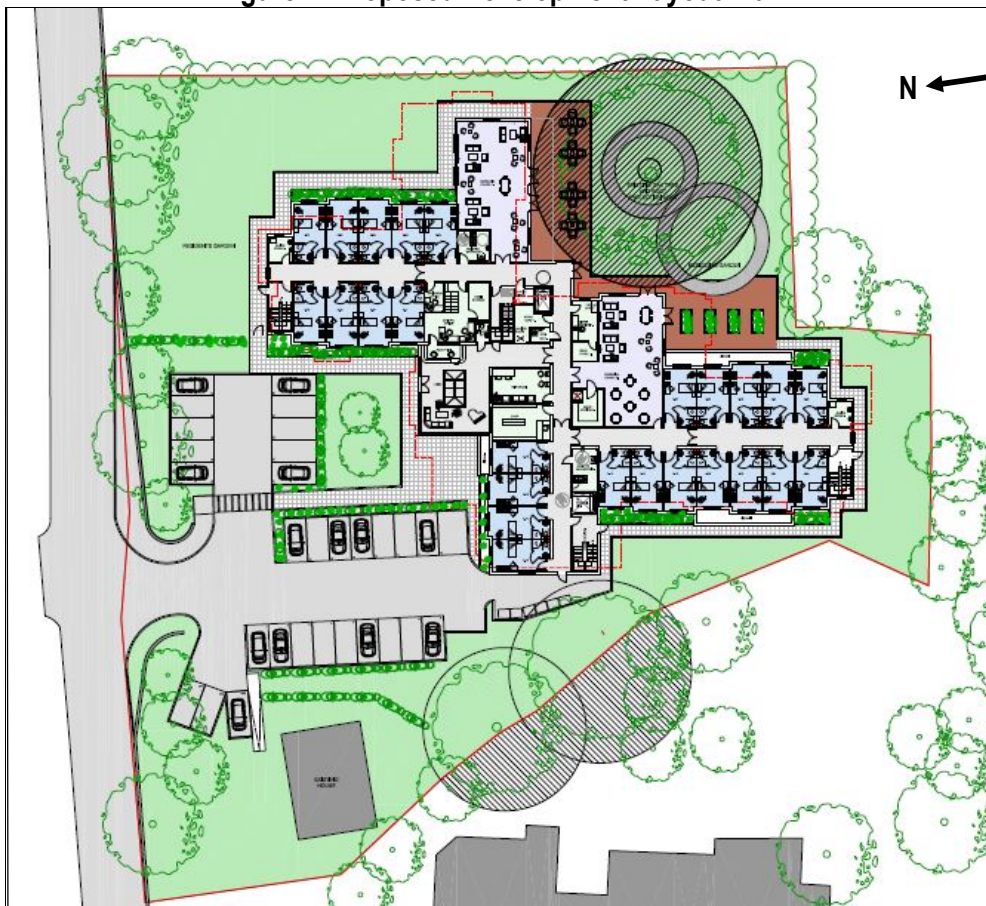
**Figure 2: Proposed Development Layout Plan**

2.7 The proposed development consists of a care home scheme with private garden areas and parking.
