# TECHNICAL REPORT ON A SUBSIDENCE CLAIM

**Crawford Reference: SU1900467**

## **SUBSIDENCE CLAIM**

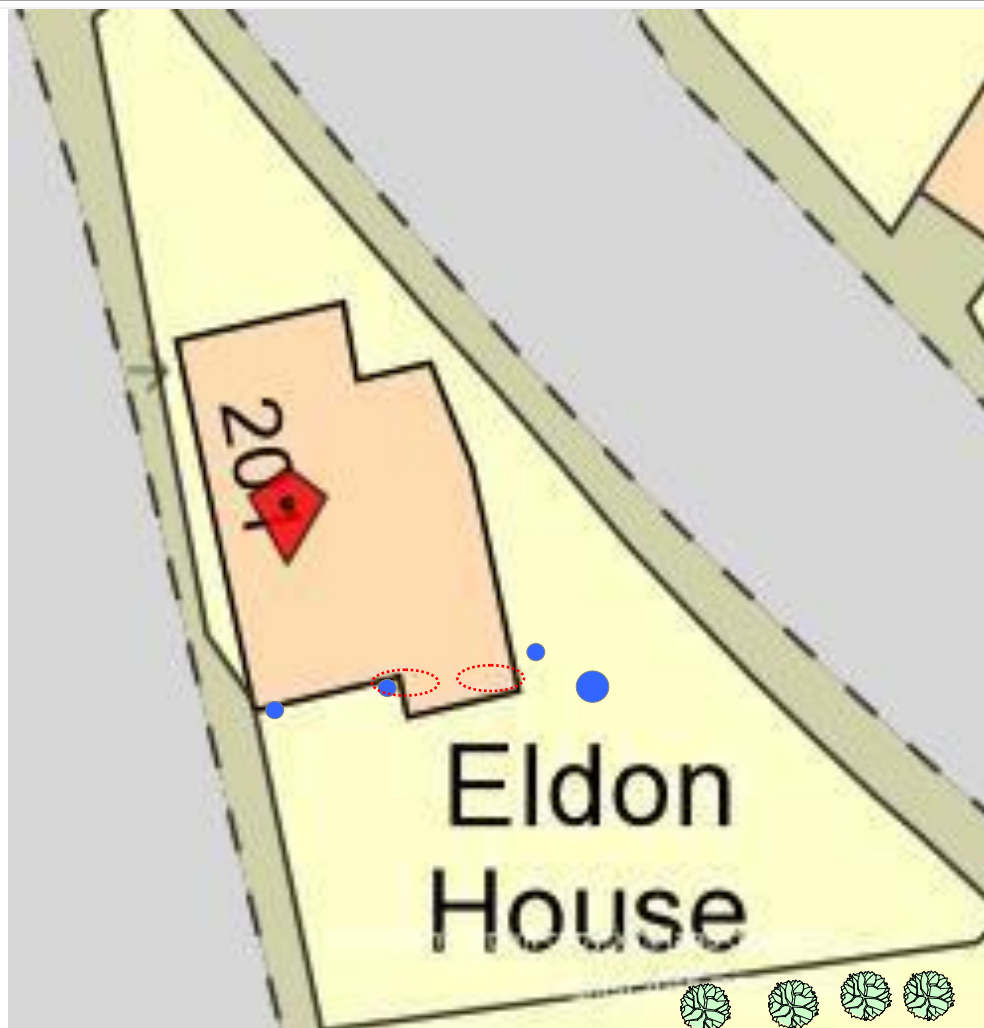
**Site Plan****This plan is Not to Scale**

This is an Aerial Photograph of the property and the immediate surrounding area. The positions of utilities etc are only indicative and contractors must satisfy themselves regarding actual location before commencing works.

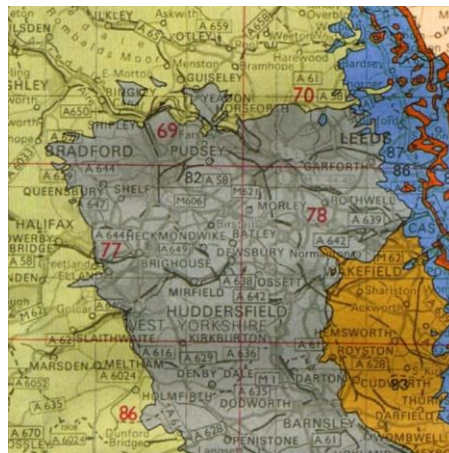
Geology. Reproduced with consent of The British Geological Survey at Keyworth.  
Licence IPR/34-7C CSL British Geological Survey. ©NERC. All rights Reserved.

Reference to the 1:625,000 scale British Geological Survey Map (solid edition) OS Tile number SESW suggests the underlying geology to be Sandstone.

The superficial deposits are thought to be Silts.

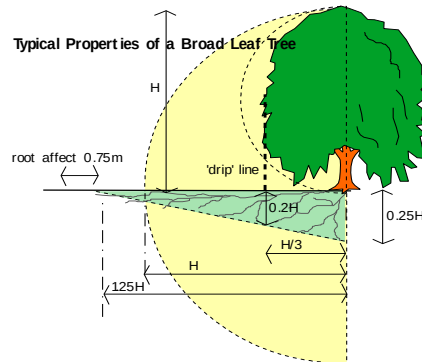
Typical proportions of a broadleaf tree. Note the potential root zone. It must be noted that every tree is different, and the root zone will vary with soil type, health of the tree and climatic conditions.

See sketch. Tree roots can be troublesome in cohesive (clay) soils because they can induce volumetric change. They are rarely troublesome in non-cohesive soils (sands and gravels etc.) other than when they enter drains, in which case blockages can ensue.
