# Coal Mining Risk Assessment

Oxford Road, Dewsbury, Kirklees, WF13 4EH

Residential development

Assessment Summary

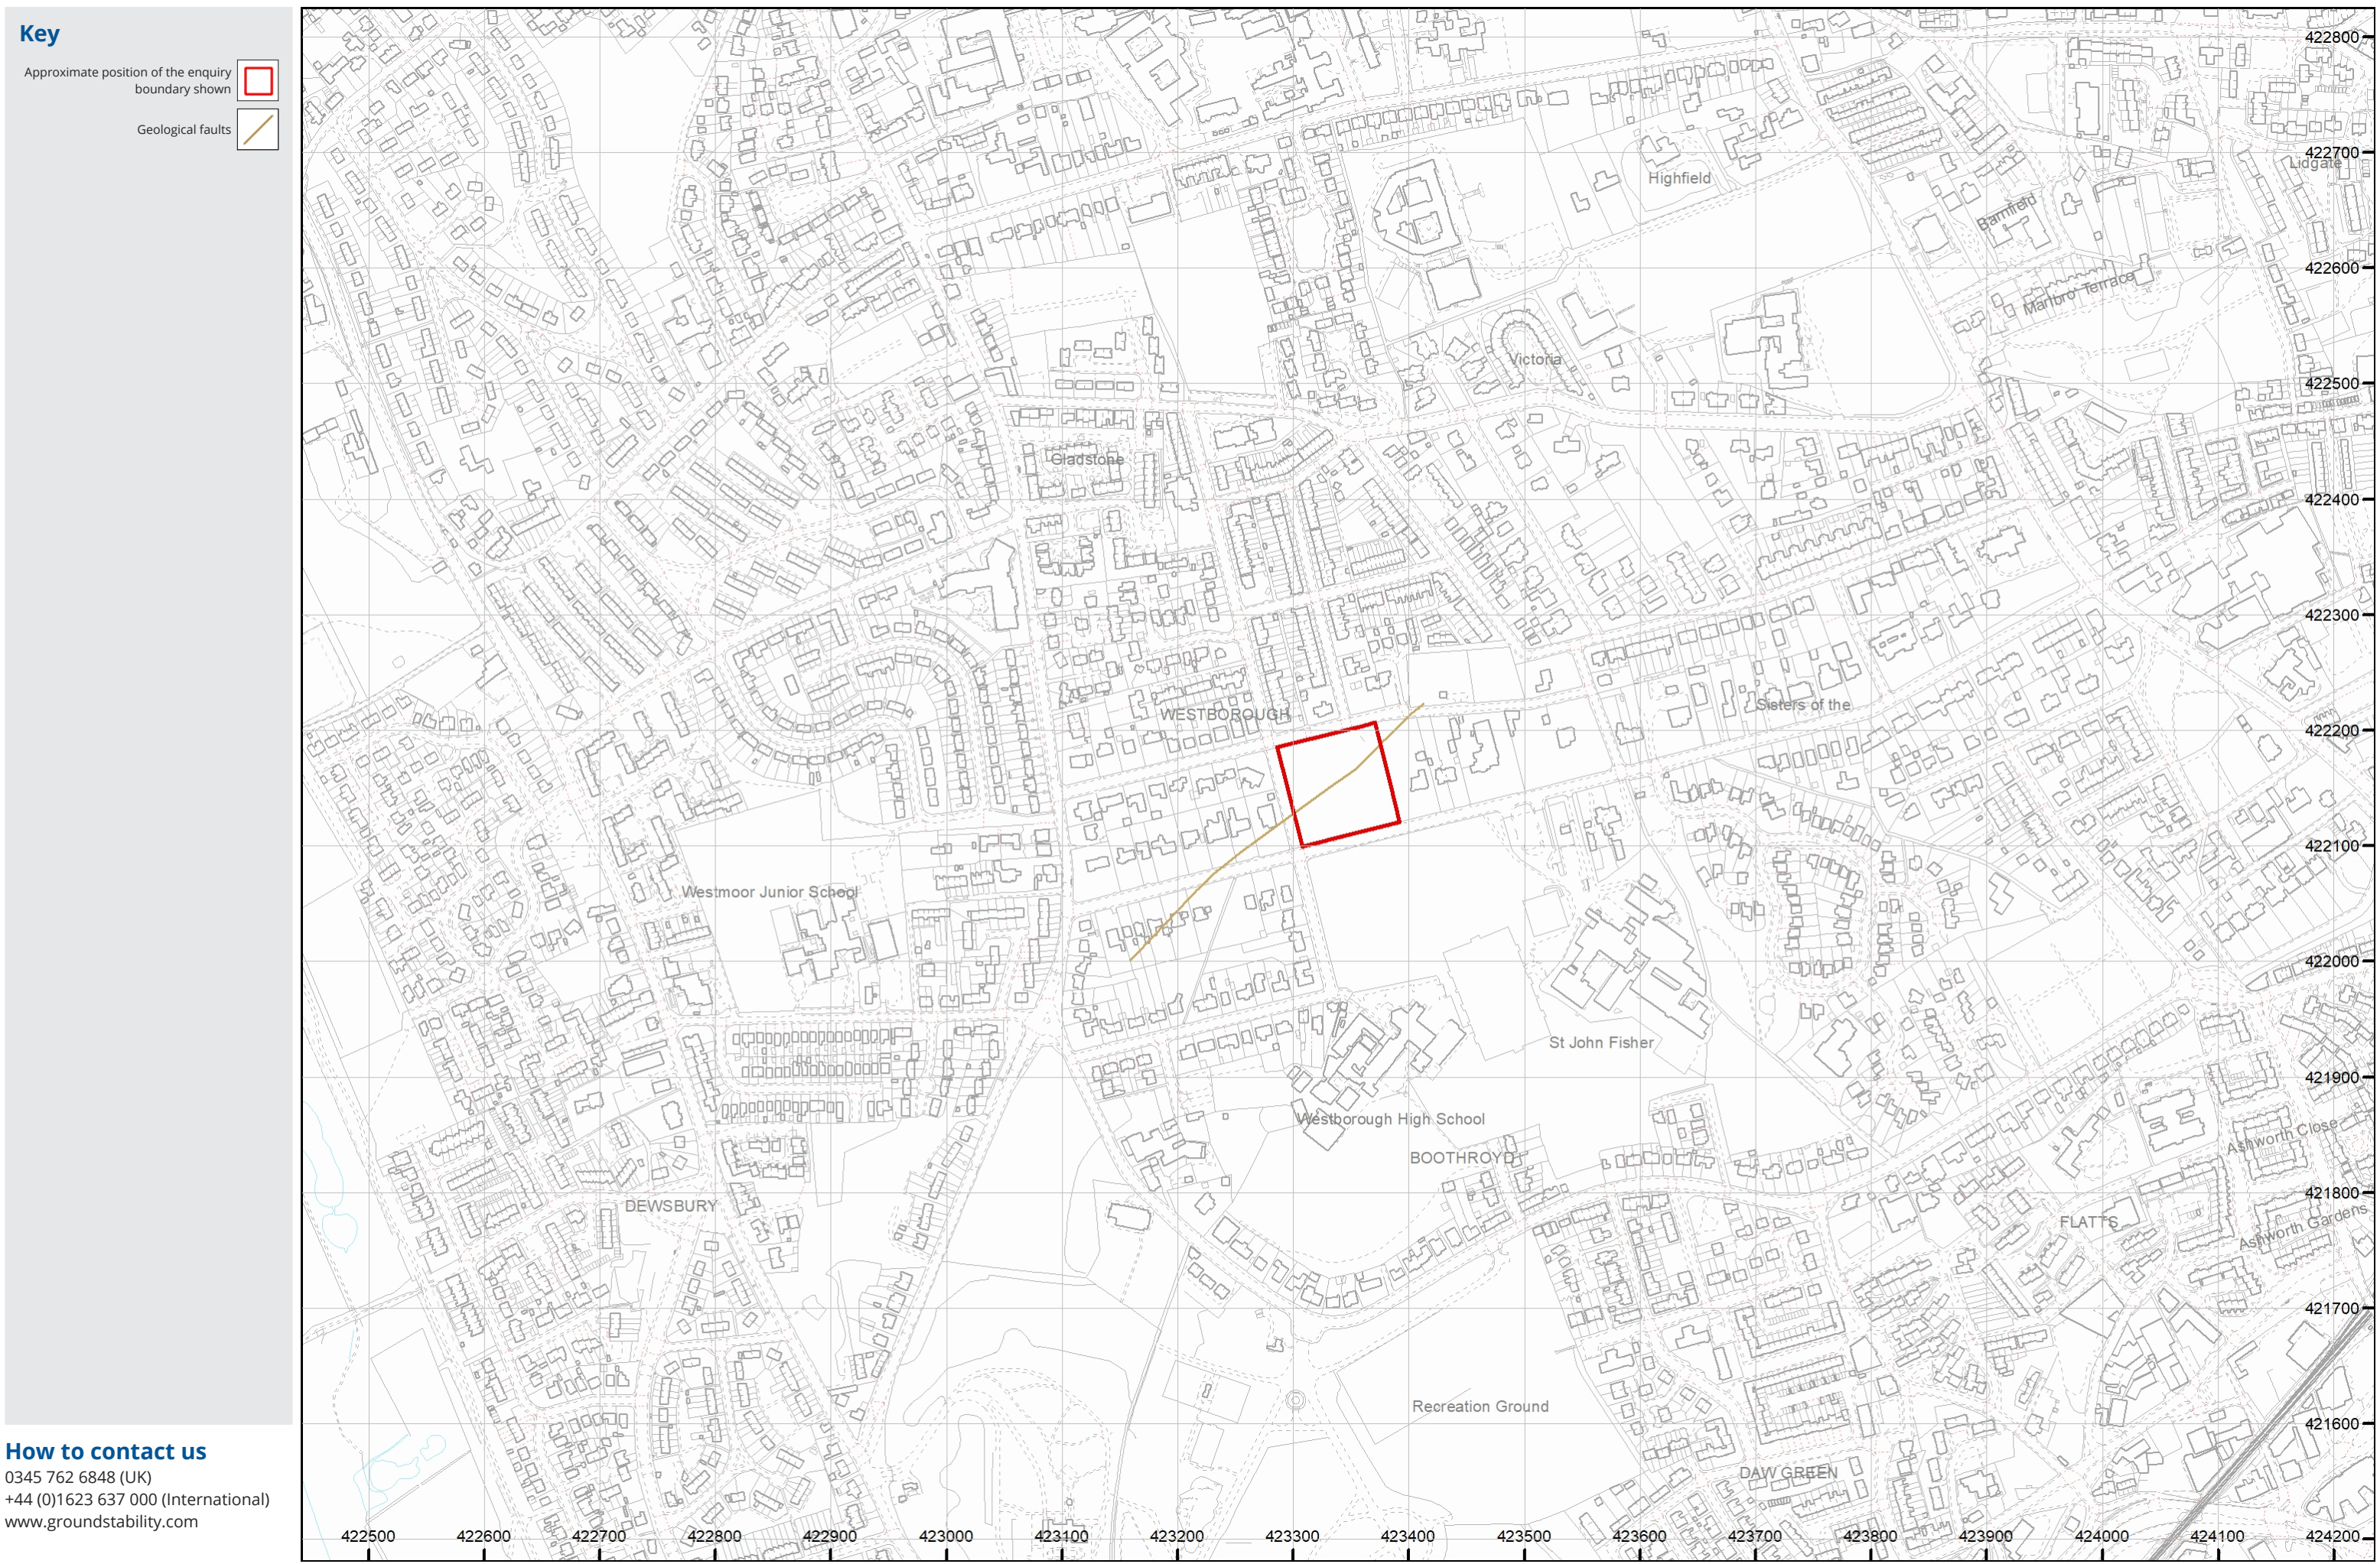
The map highlights any specific surface or subsurface features within or near to the boundary of the site.
