The Merchants House, Carlinghow, Batley

Heritage Statement in Support of a Listed Building Consent Application for Repairs and Restorations

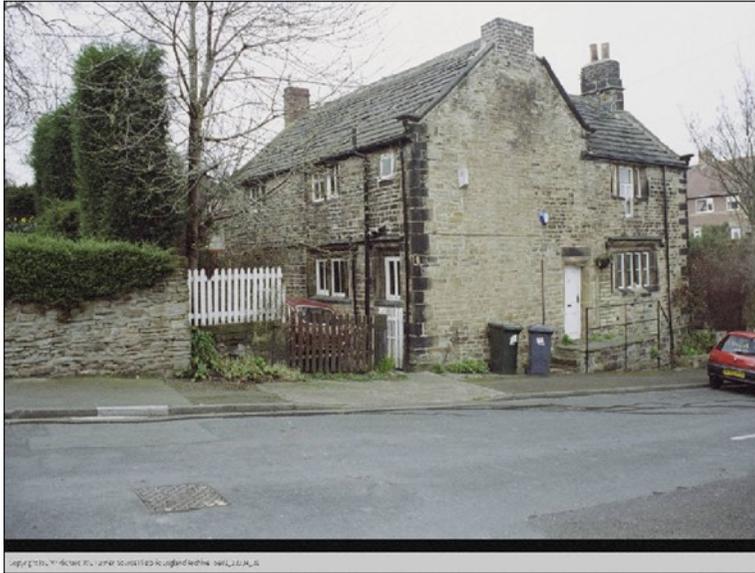
Plate 1. The Merchants House 2005, looking north-west

storey rear wing extends off to the north at the east end of the building (refer to Figure 1). Although listed as early 18th century, the building presents the characteristics of a late medieval/early modern yeoman aisled house (Plate 1).

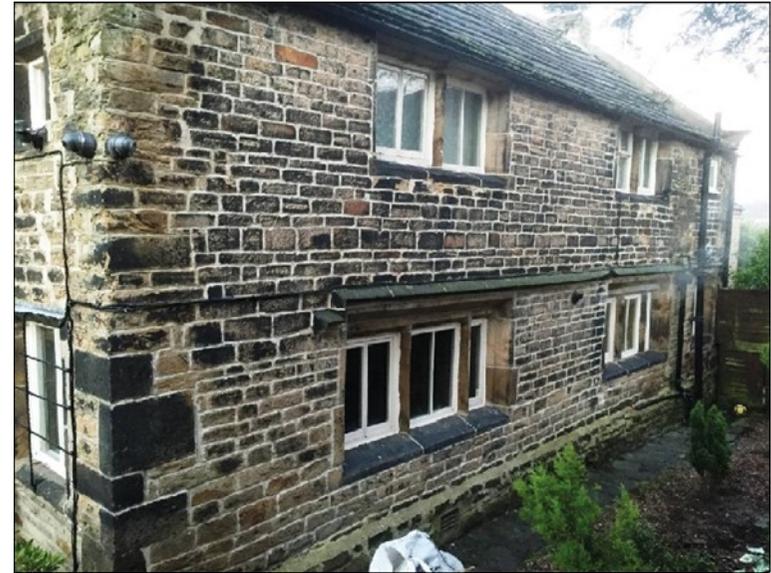
Plate 2. South elevation, Looking north-east

The main front of the building is to the south. Here there are splayed mullioned windows (Plate 2) lighting a parlour, hall and fire-area, with a continuous drip mould over them.

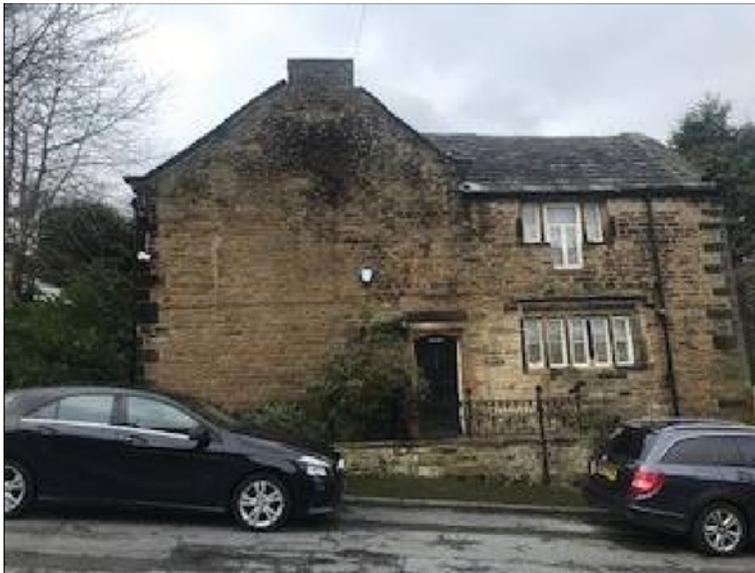
Plate 3. East elevation, looking west

The main original door of the house is in the east gable (Plate 3): it has a broad-chamfered surround and a shallow arched Tudor head.

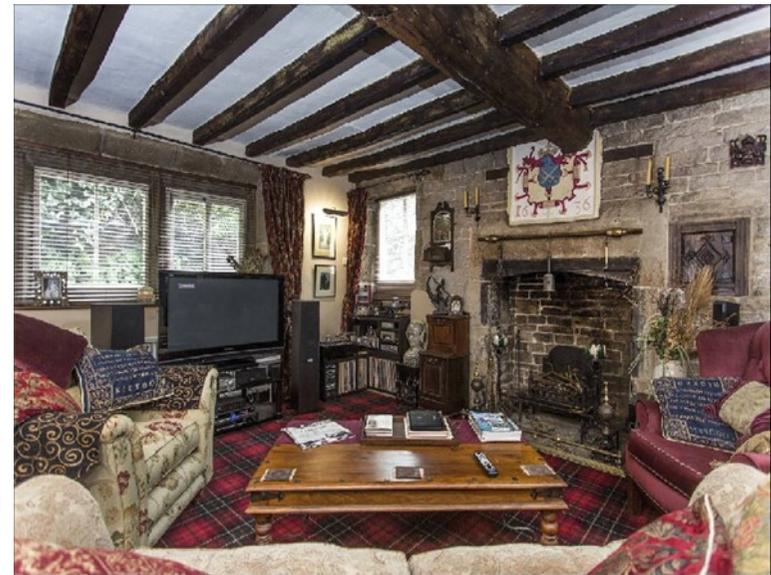
Plate 4. General view of the fire place in the parlour

The parlour (today a living room) lies to the west of the hall, it has stopped chamfered beams and joists and it is heated by a stack on the gable wall (Plate 4).

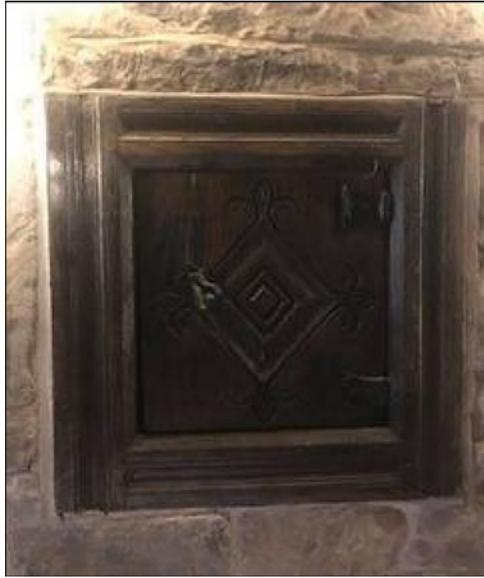
Plate 5. Salt-cellar

To the right of the fireplace, there is an original salt/spice-cellar (Plate 5).

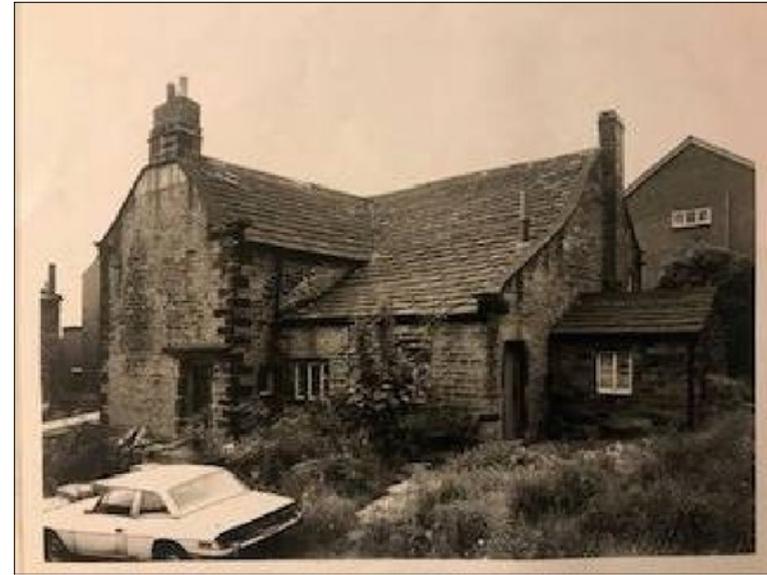
Plate 6. North elevation, 1963, looking south-east

The rear wing, at the east end of the house (Plate 6), was very likely entered from the hall by means of a door near the main gable opening. The wing has a single room with probably a service function originally. This room also had a firehood as demonstrated by the break of the spine beam some 6’ from the end wall and the

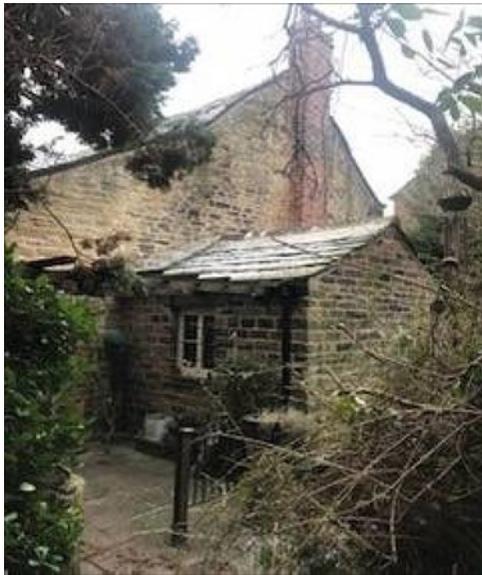
Plate 7. West elevation and outshut, looking south-

The outshut, built in a later phase in the west elevation (Plate 7), has the characteristics of an additional service room which was possibly a shop chamber typical of yeomen/clothiers'.⁴

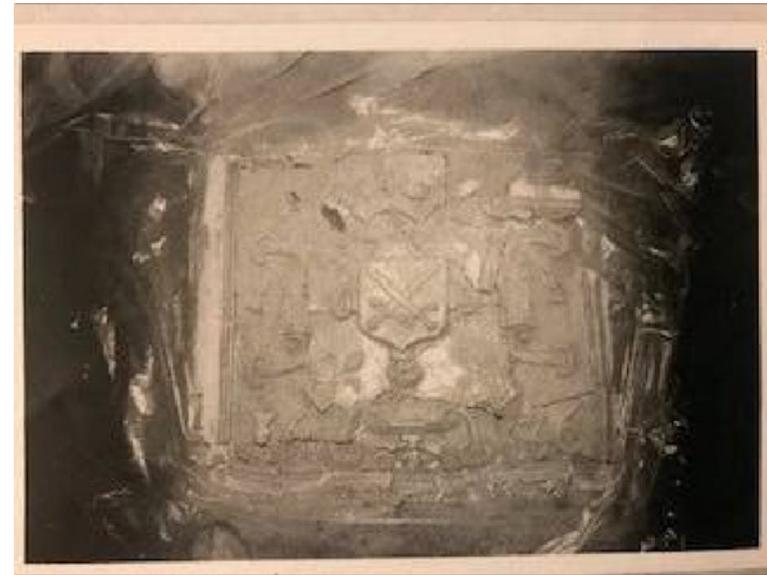
Plate 8. Coat of arm

During restorations in the 1970s, a plaster panel was found over the fireplace of the parlour (Plate 8). The panel shows a coat of arms with a decorative surround and the date 1636. The arms have crossed swords on a plane field. The panel was painted (Plate 9) after 1979 but before 2005. It is not certain whether the panel belongs in the parlour and the arms have not been traced yet, but the suggested date is quite acceptable for the typology of the house.
