NORTHORPE LANE, MIRFIELD

HIGHWAY CONDITION SURVEY

JUNE 2023

Newett Homes

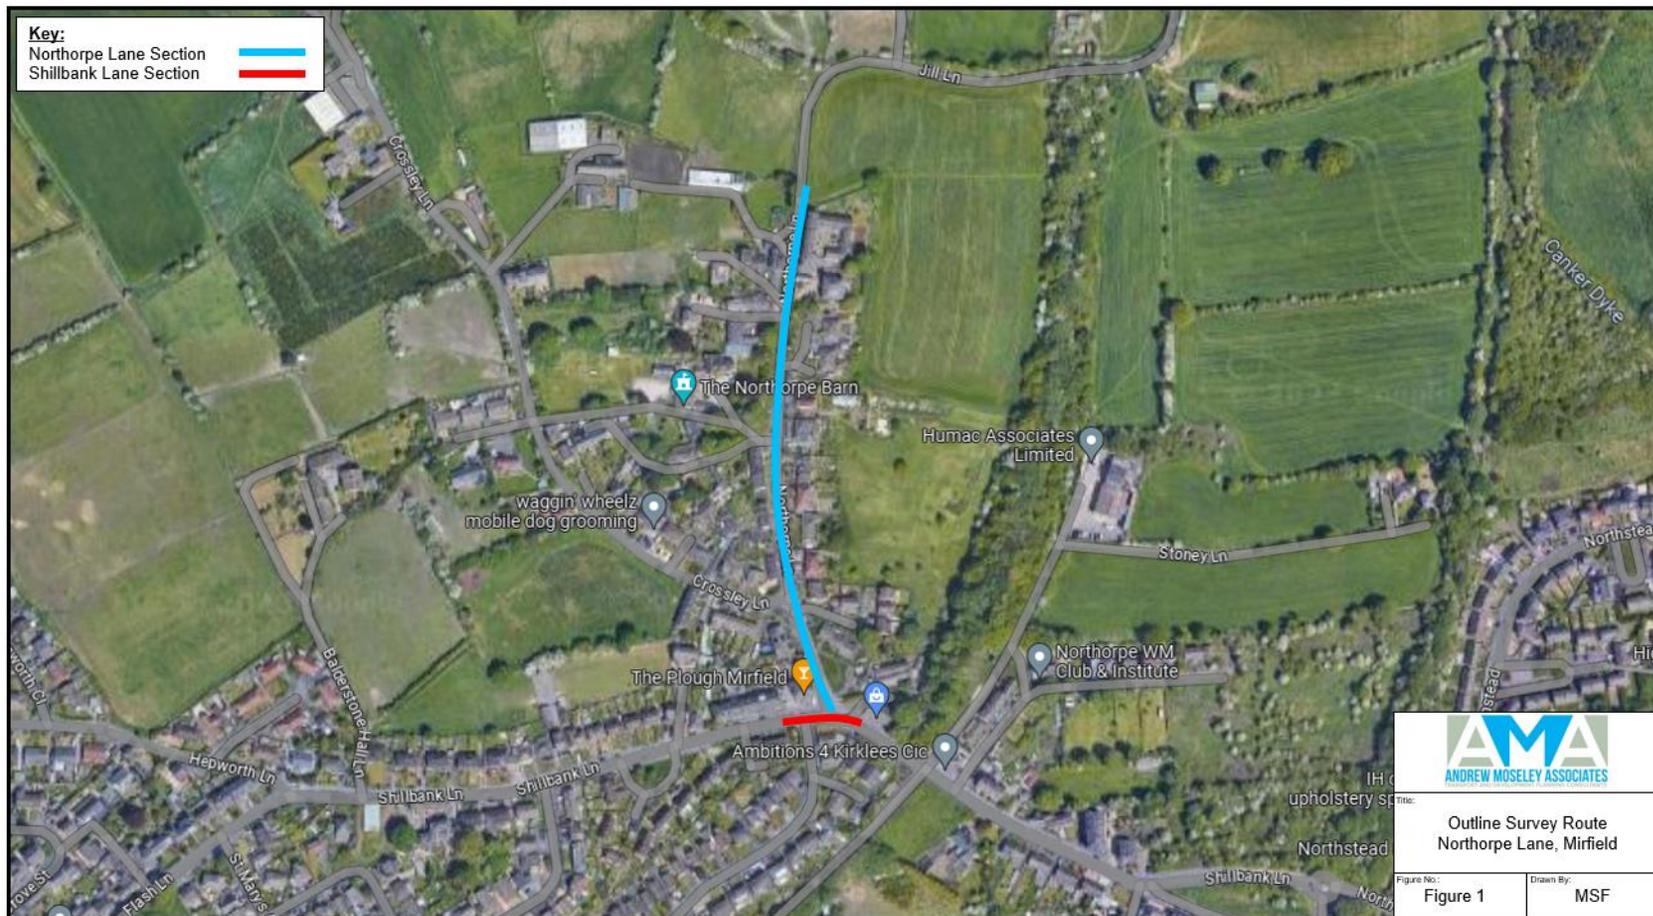
Appendix A

OUTLINE PLAN ROUTE

1.1.2 The survey was carried out to understand the condition of the existing carriageway, footway, kerbing, manholes as well as other existing features along the route highlighted in blue / red, in accordance with Condition 14 of planning application reference: 2021/91914.

1.1.4 An outline plan of the route covered by the highway condition survey is shown in **Appendix A**.

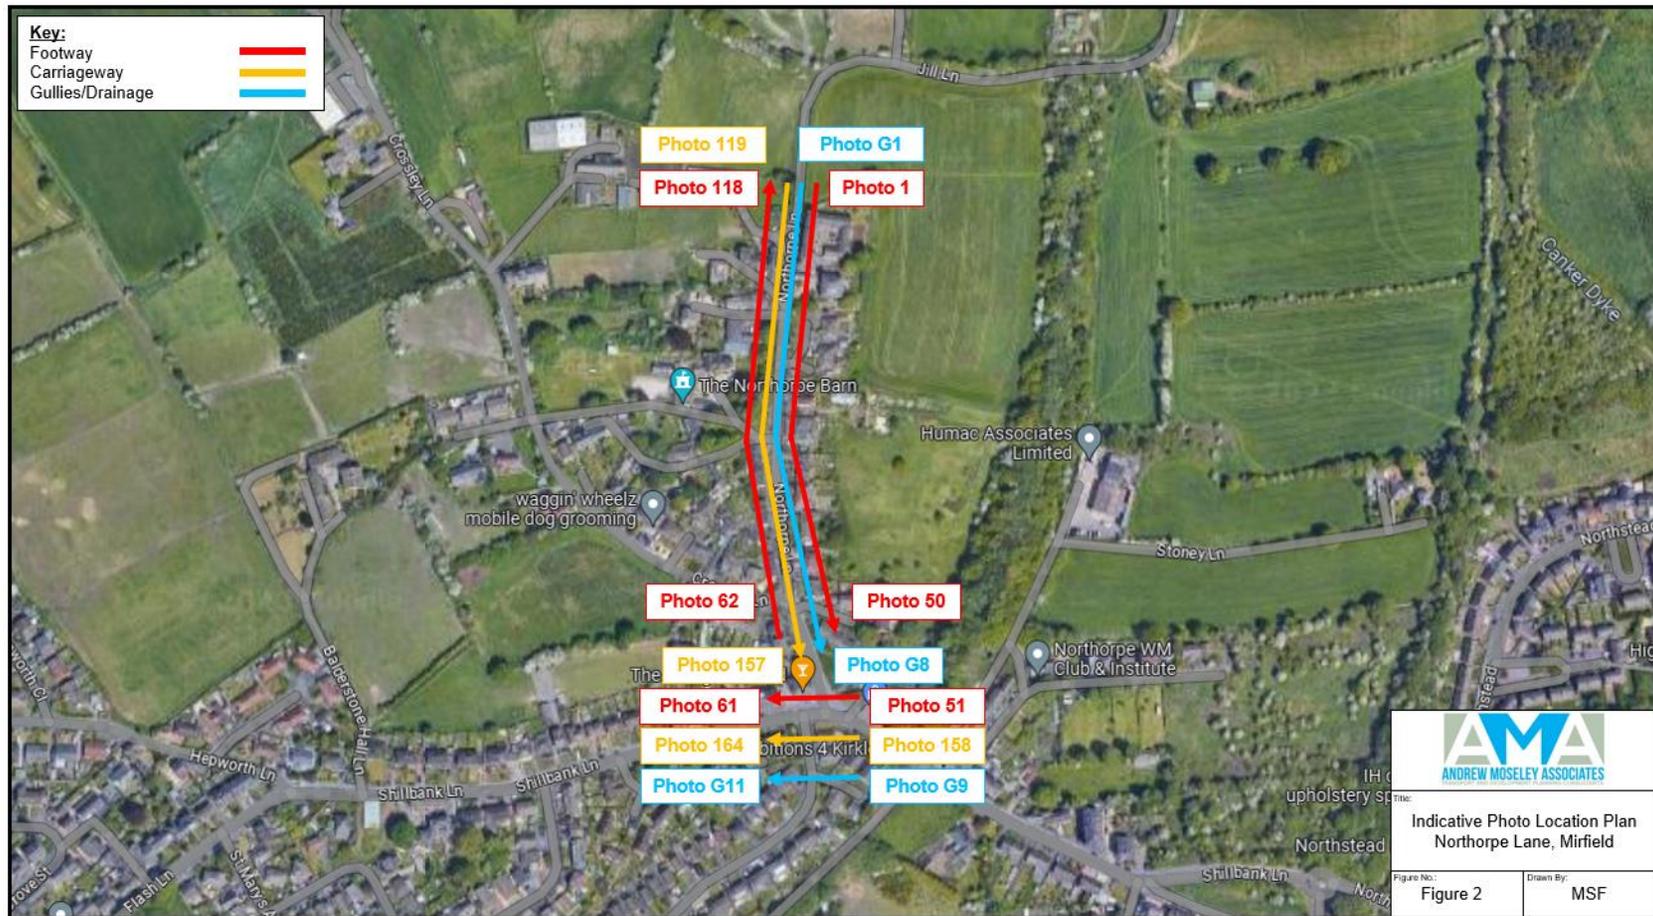
Appendix B

INDICATIVE SITE PHOTOGRAPH LOCATIONS

1.1.5 The location plan for photographs can be seen in **Appendix B**.
