**Coal Mining Risk Assessment**  
**at**  
**Abbey Place Nursing Home, 90 Abbey Road,**  
**Fartown Huddersfield HD2 1BB**  
**For**  
**Wood Care Group**

<b>Proposal</b>	A single storey infill extension.
<b>Current land use</b>	Existing nursing home complex and associated land lying between approximately 77.0m AOD and 73.0m AOD, falling gently to the east.
<b>Mining related site history</b>	<p>No historic mining features recorded on the site.</p> <p>Several former collieries are present locally.</p> <p>A former clay pit is recorded approximately 550m west.</p> <p>The site lies within an area significantly affected by historic mining activities.</p>
<b>Geology</b>	Directly underlain by the undifferentiated strata of the Lower Coal Measures. The Hard Bed coal seam underlies the site at shallow depth.
<b>Mining history and context</b>	<p>There is a single seam of worked coal, Hard Bed coal seam, recorded beneath the site at shallow depth, last worked in 1902.</p> <p>The ganister and fireclay associated with this seam may also have been exploited.</p> <p>No former mine entries are recorded on or within the vicinity of the site.</p> <p>The site lies within an area of recorded past sha

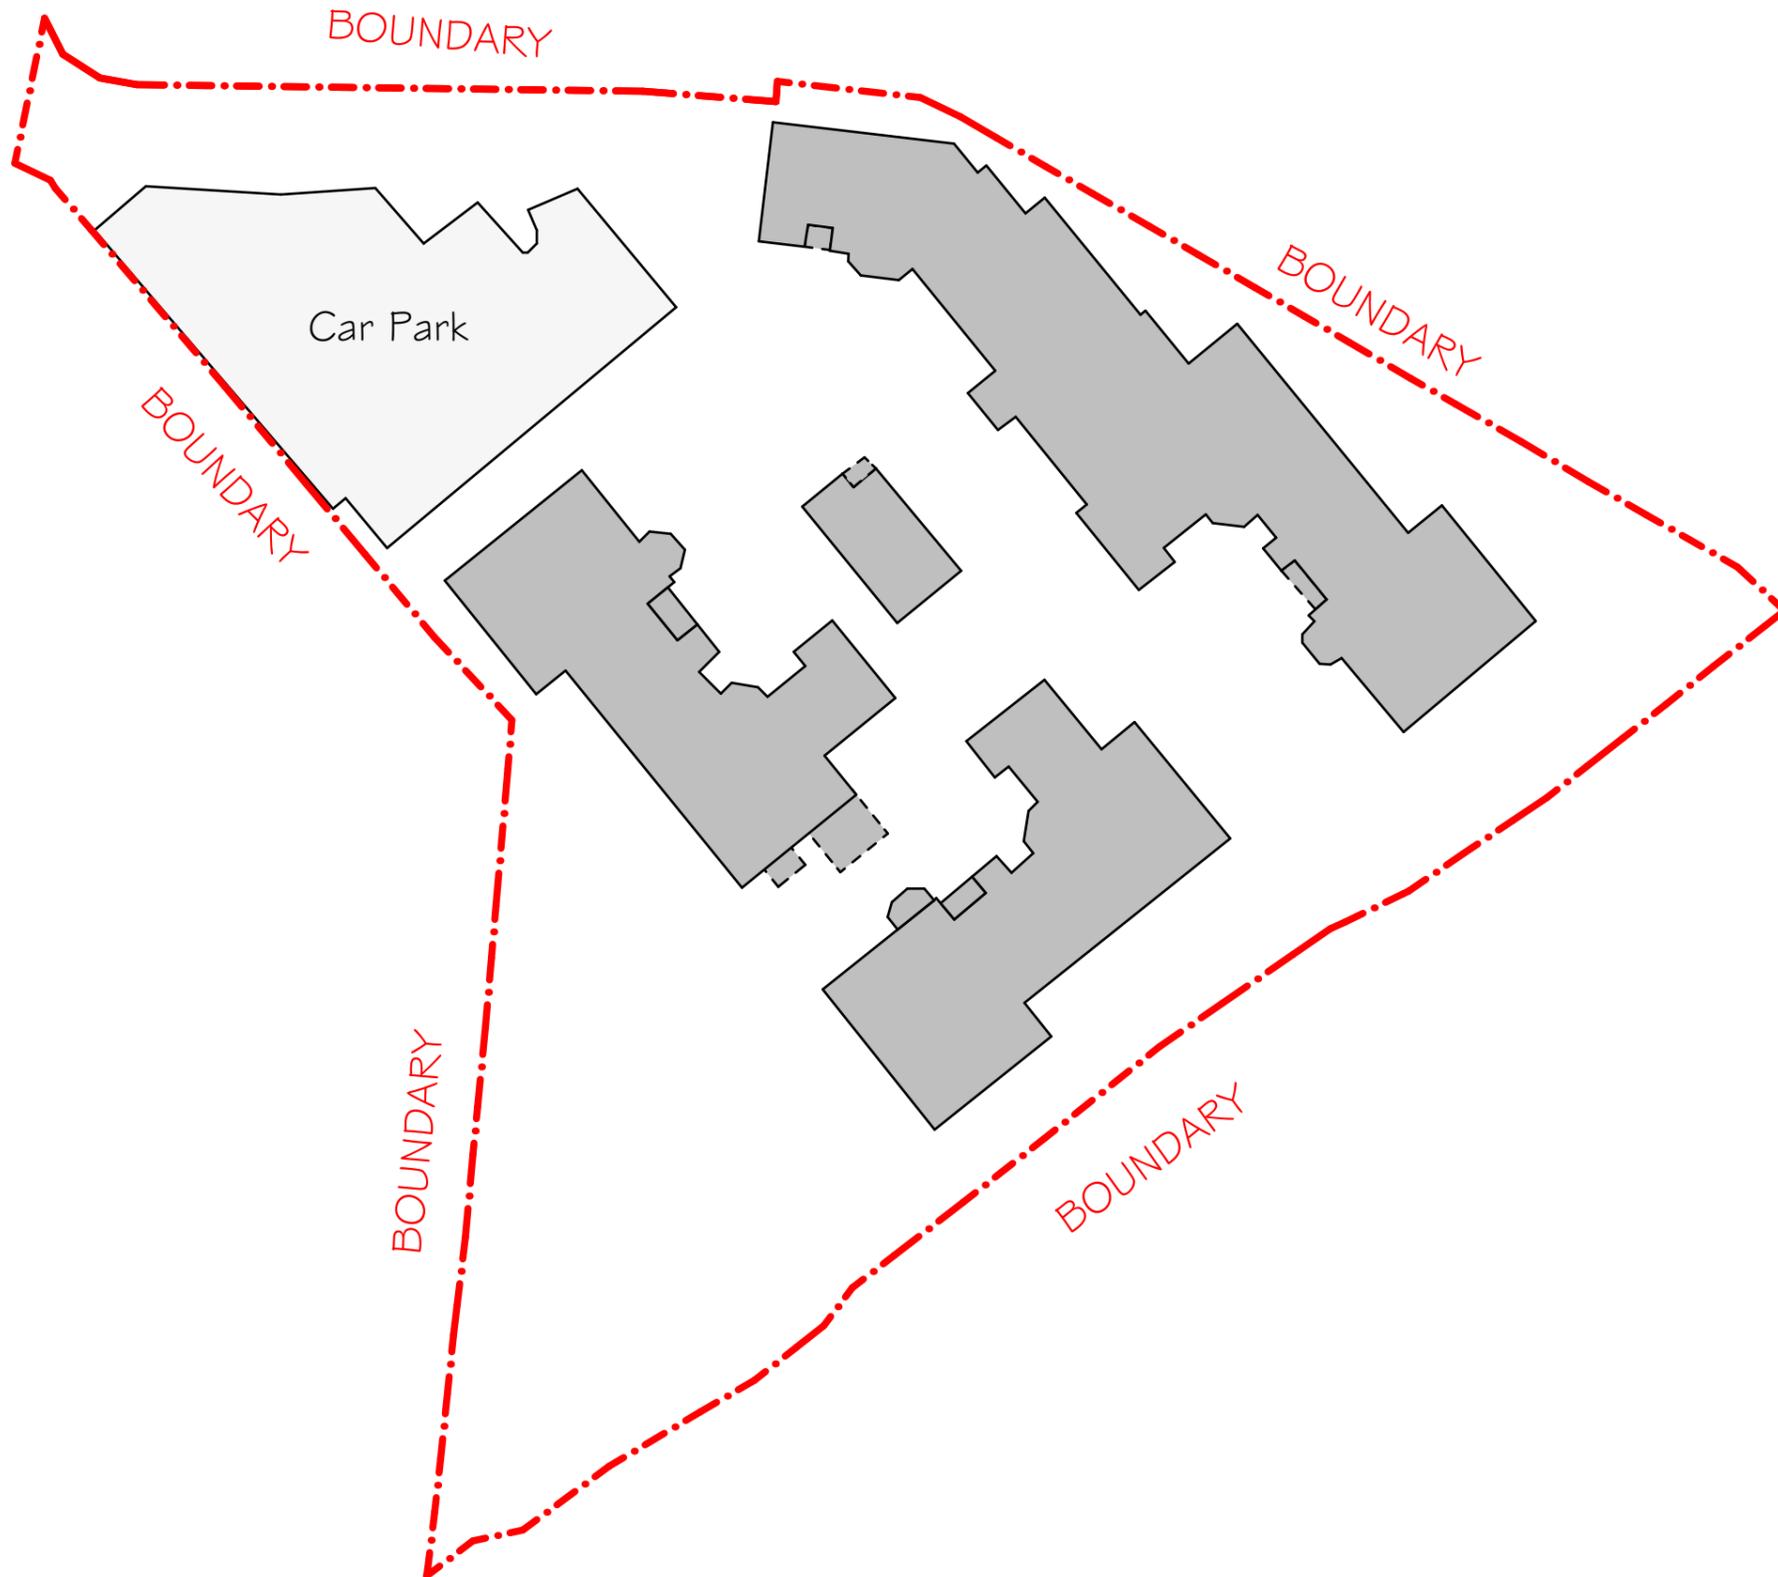
EXISTING SITE PLAN  
1:500@A3

Title - EXISTING SITE & LOCATION PLAN
Project - SINGLE STOREY EXTENSION INFILL
Client - 90 ABBEY ROAD, FARTOWN, HUDDERSFIELD, HD2 1BB, ABBEY CARE HOME

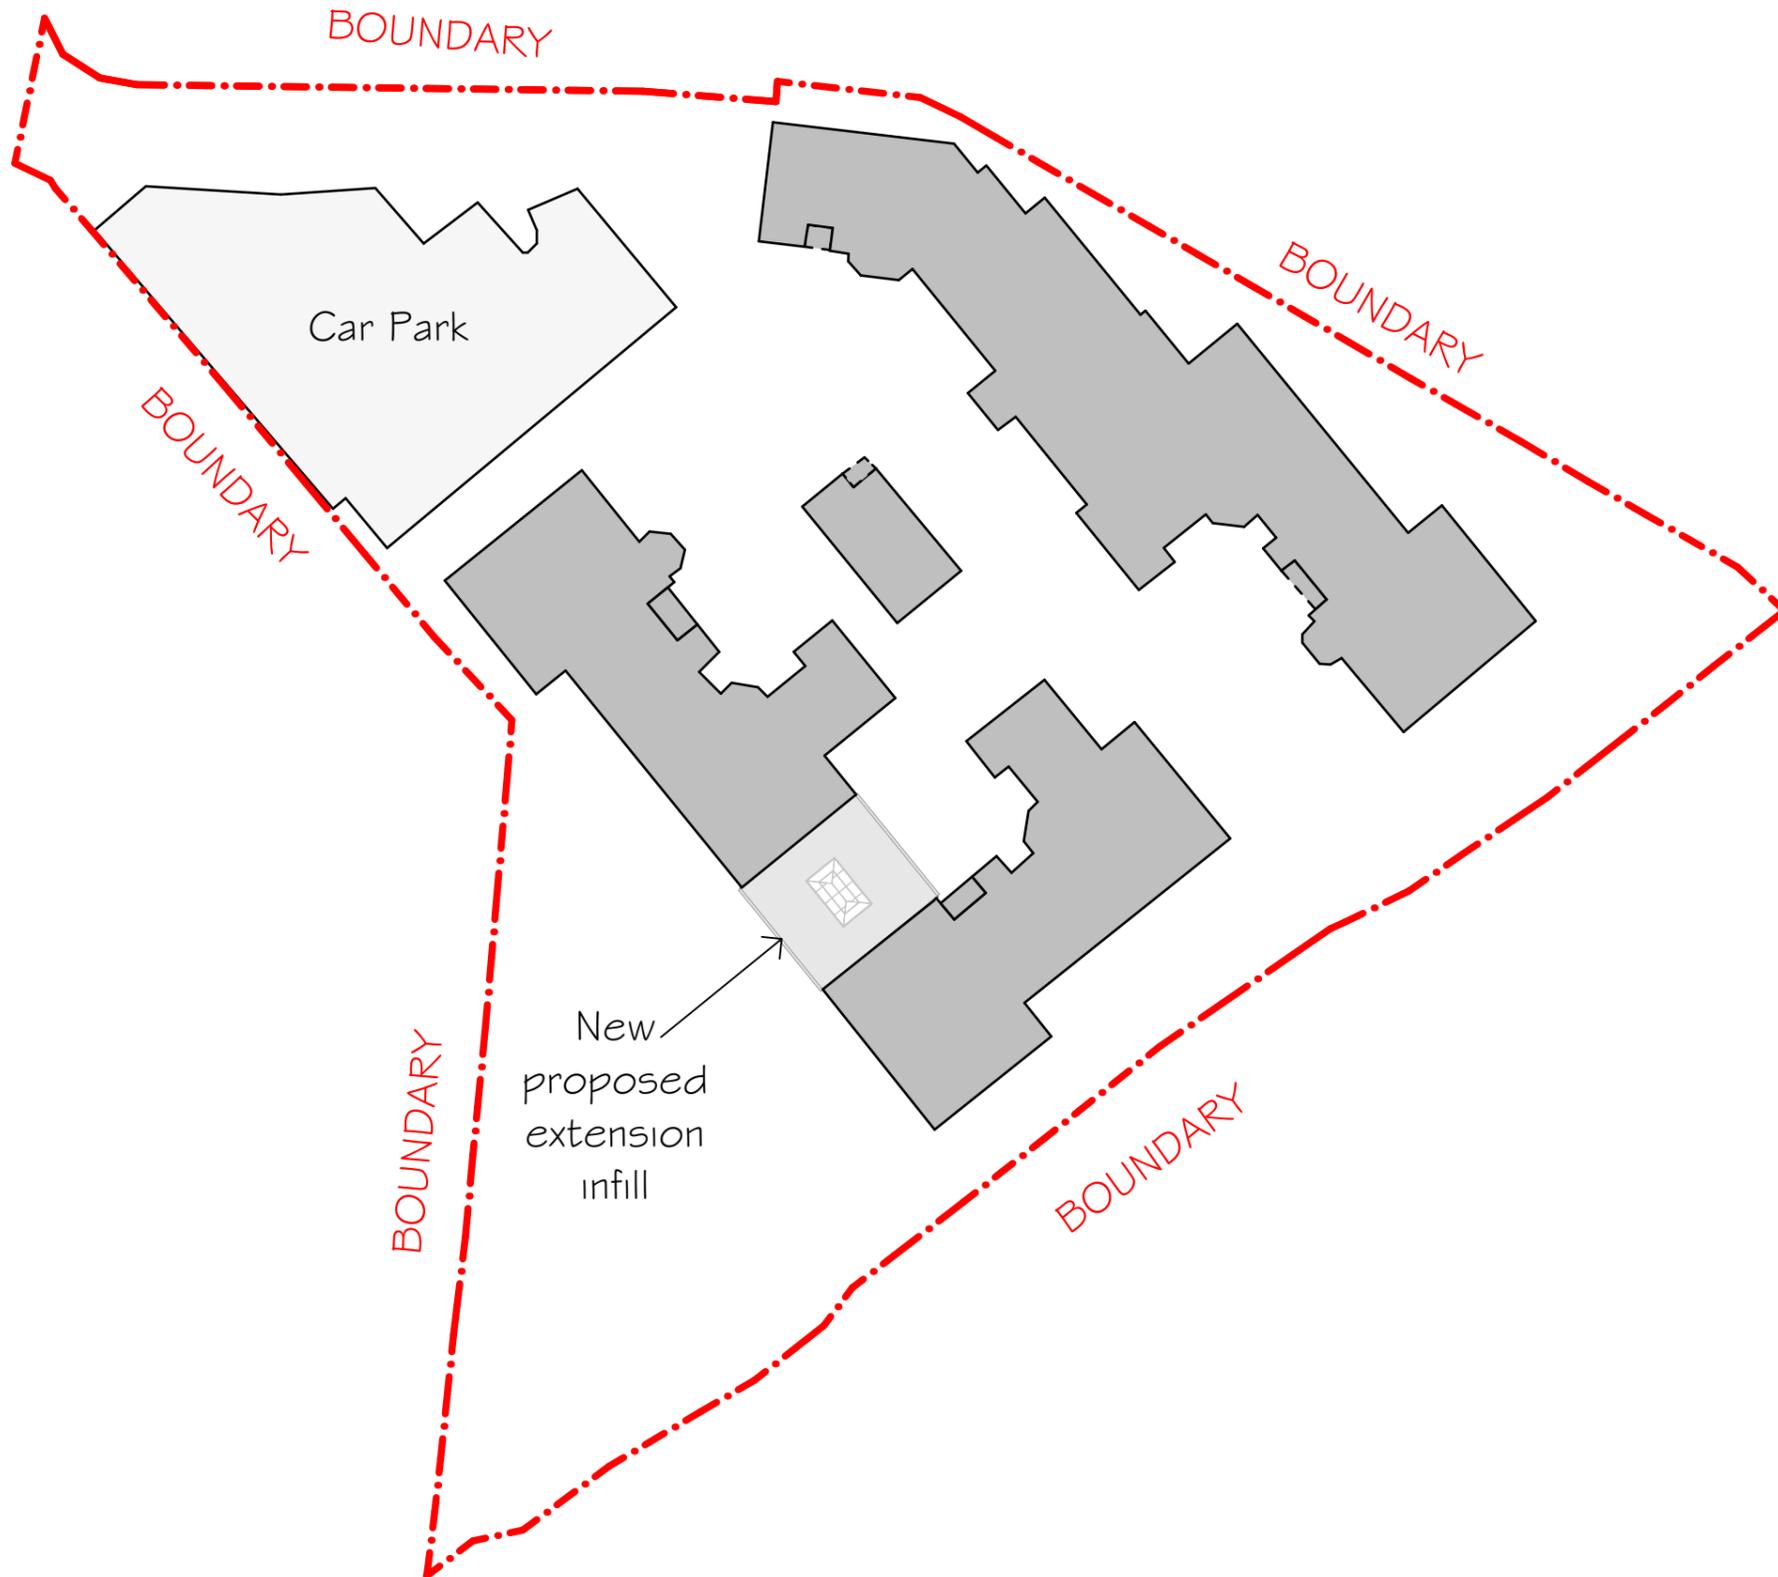
PROPOSED SITE PLAN  
1:500@A3

Title - <b>PROPOSED SITE PLAN</b>
Project - SINGLE STOREY EXTENSION INFILL
Client - 90 ABBEY ROAD, FARTOWN, HUDDERSFIELD, HD2 1BB, ABBEY CARE HOME

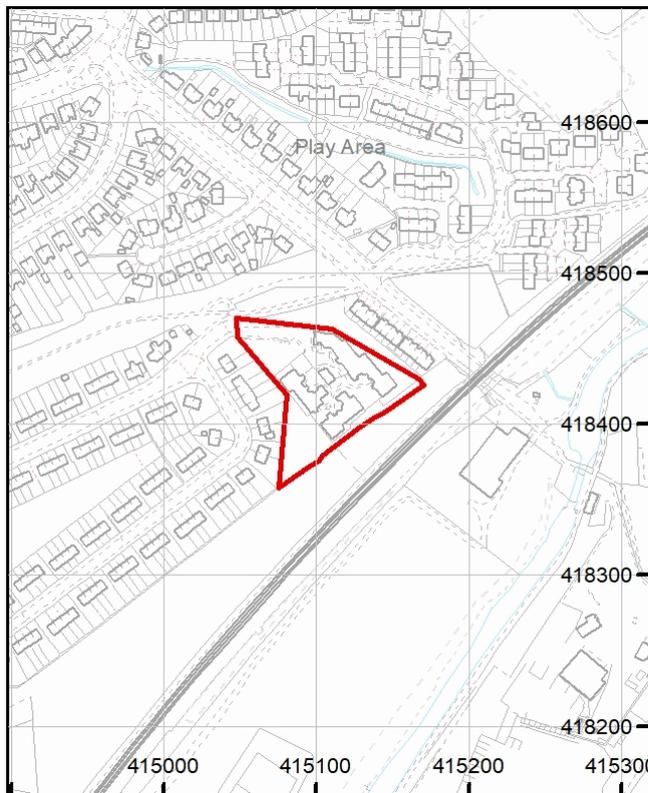
Approximate position of enquiry boundary shown

We can confirm that the location is **on the coalfield**
