REMEDIATION METHOD STATEMENT

BATLEY SHOPPING CENTRE, ALFRED'S WAY,

BATLEY, WEST YORKSHIRE

Report: 487044-RMS

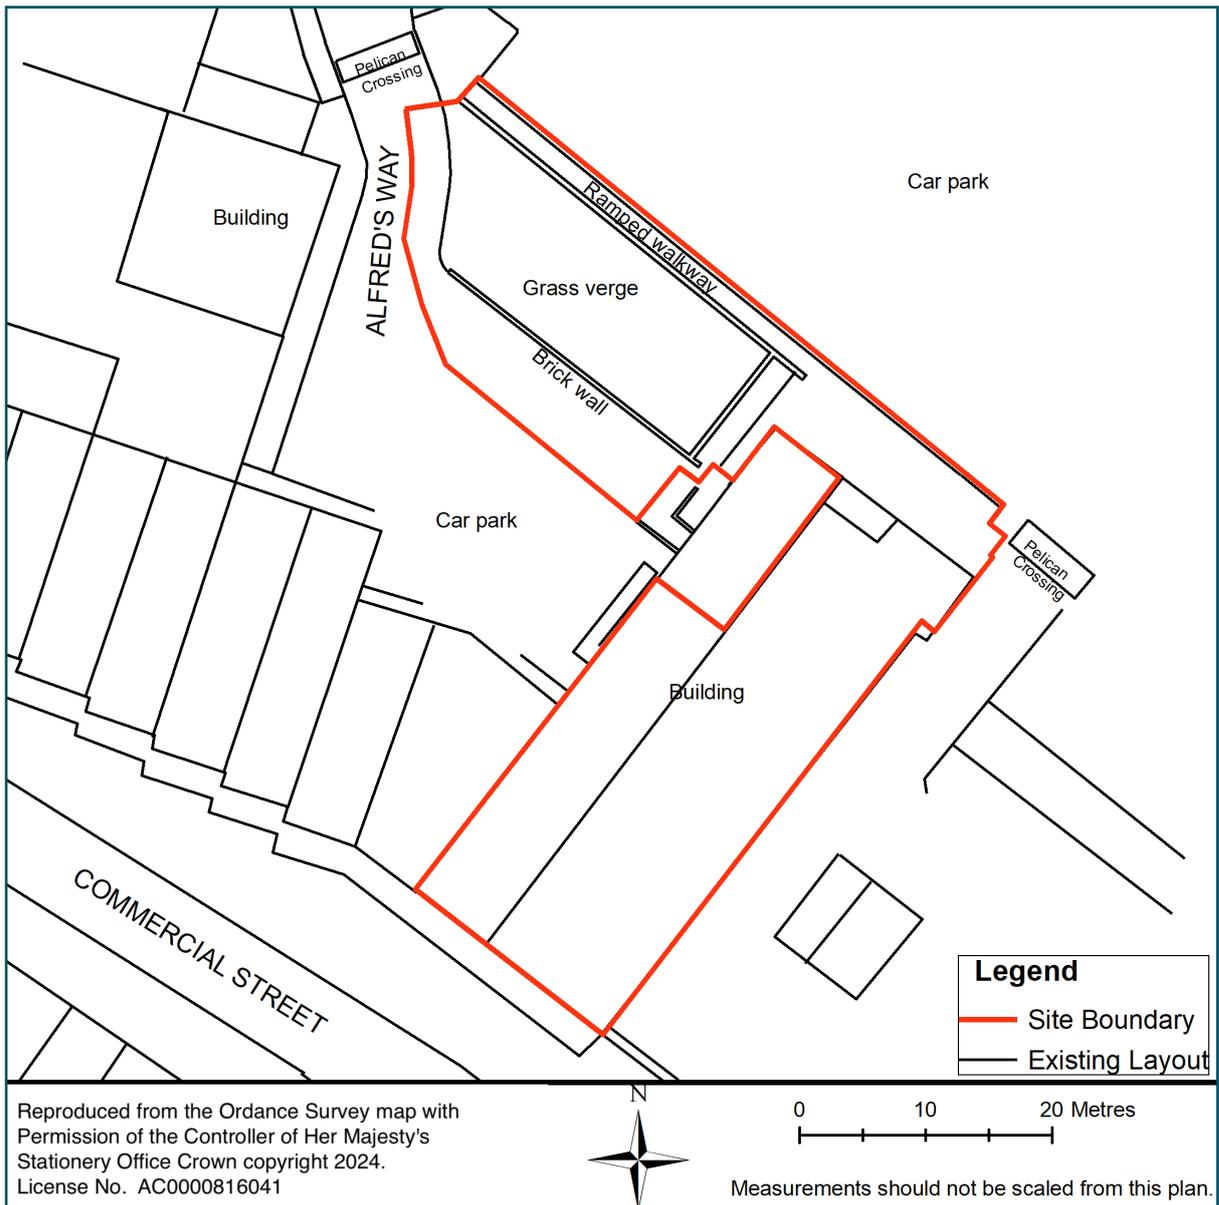
FIGURE 2 - SITE PLAN

The southern and and south-western part of the site comprises a car park, surfaced with asphalt, used for the adjacent shopping centre. The south-eastern part of the site comprises a vacant retail unit which is part of the Batley Shopping Centre.

Vehicular access to the site is from Alfred’s Way in the north-western corner of the site. Pedestrian access is also possible via the north-eastern corner, from the adjacent supermarket car park.

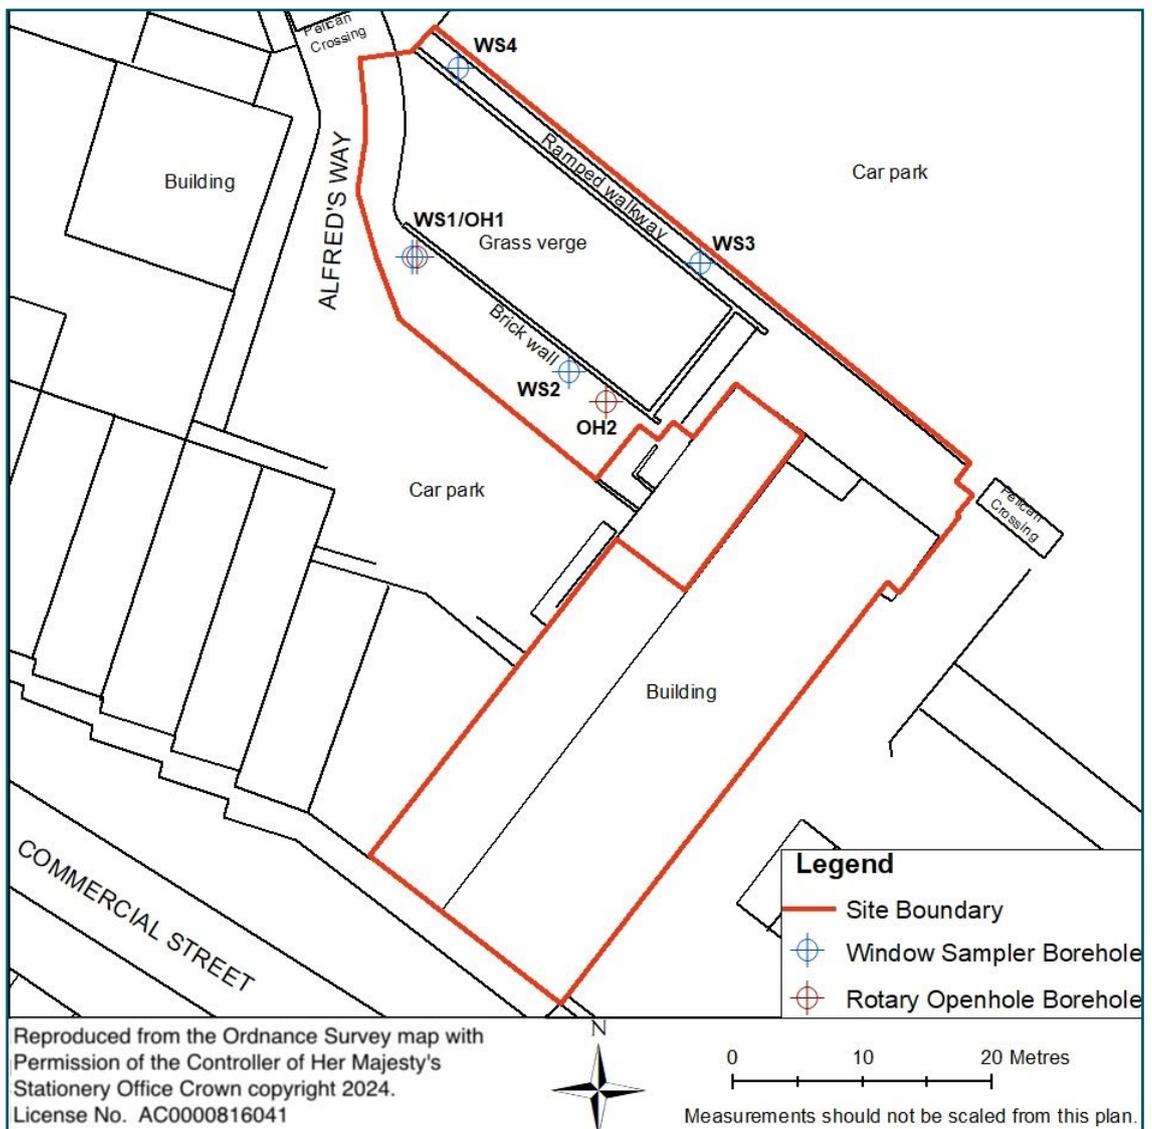
FIGURE 3 - EXPLORATORY HOLE LOCATIONS

The locations of exploratory holes, as shown on Figure 3, were restricted due to the presence of services and existing buildings that were present at the time of undertaking the intrusive works.

The Ground Investigation consisted of four window sample holes to confirm the shallow ground conditions and allow representative samples of the underlying soils to be taken. The exploratory holes were extended to depths of between 1.02m and 4.15m below ground level (bgl).

Fieldwork was undertaken on 1,8 and 9 June 2021. For detailed description of the strata encountered the previously prepared Ground Investigation report (Ref: 487003GI, dated July 2021) should be consulted. However, a summary of the intrusive investigation works is given below for ease of reference.
