# Coal Mining Risk Assessment

71009809518001

299 Huddersfield Road, Scout Hill, Dewsbury, Kirklees, WF13 3RW

Construction of extension at existing garage

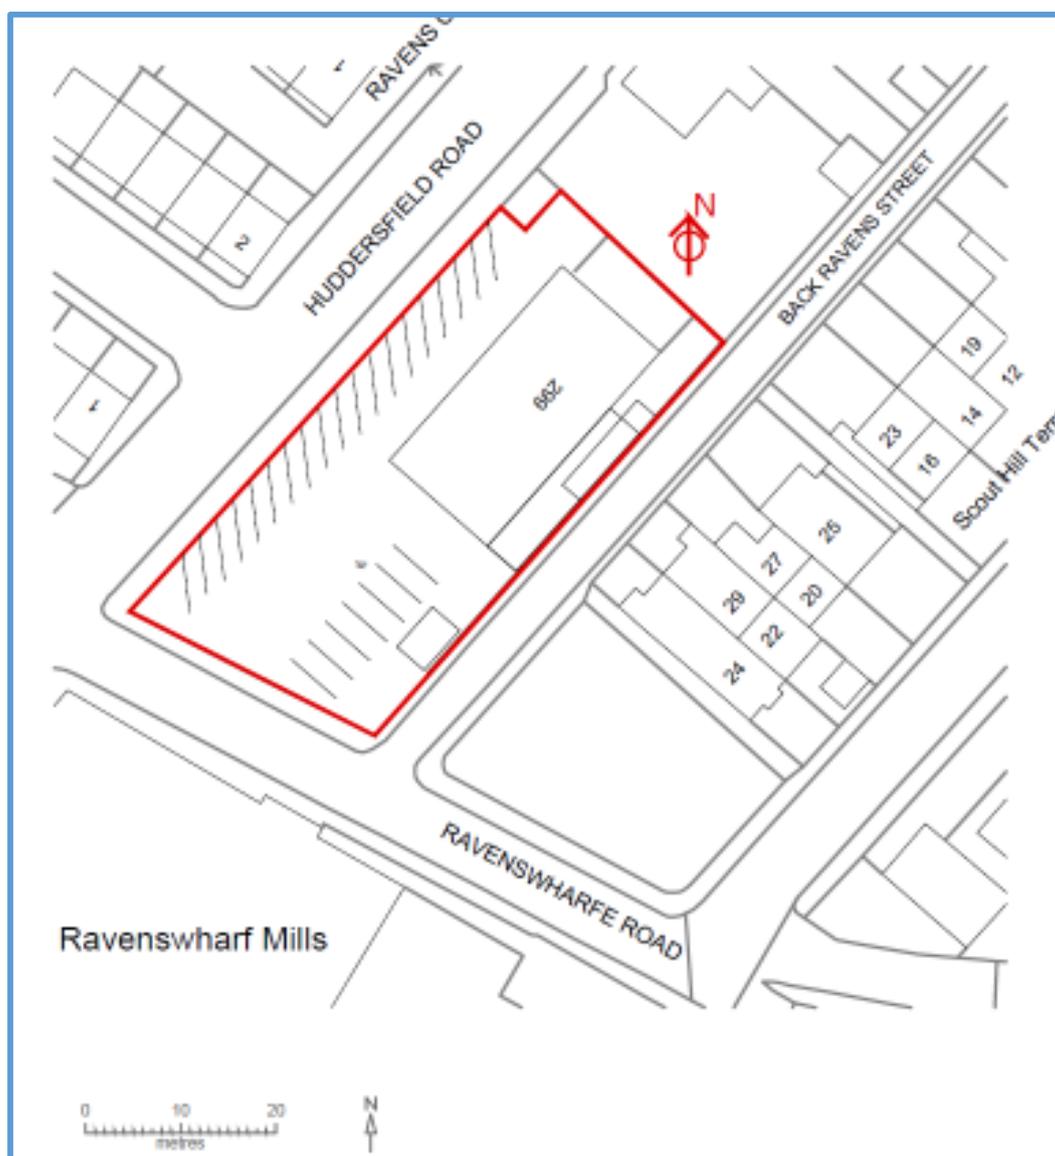
**Figure 1: Site location plan**

The Coal Authority has been commissioned to prepare a Coal Mining Risk Assessment Report for a proposed development at 299 Huddersfield Road, Scout Hill, Dewsbury, Kirklees, WF13 3RW (see Figure 1), in order to provide the Local Planning Authority with information on coal mining and an assessment of its impact on land stability.

The approximate site centre co-ordinates are E423173, N420635. The proposed development area requires access via Huddersfield Road. The site has an approximate elevation of 43-50m AOD.

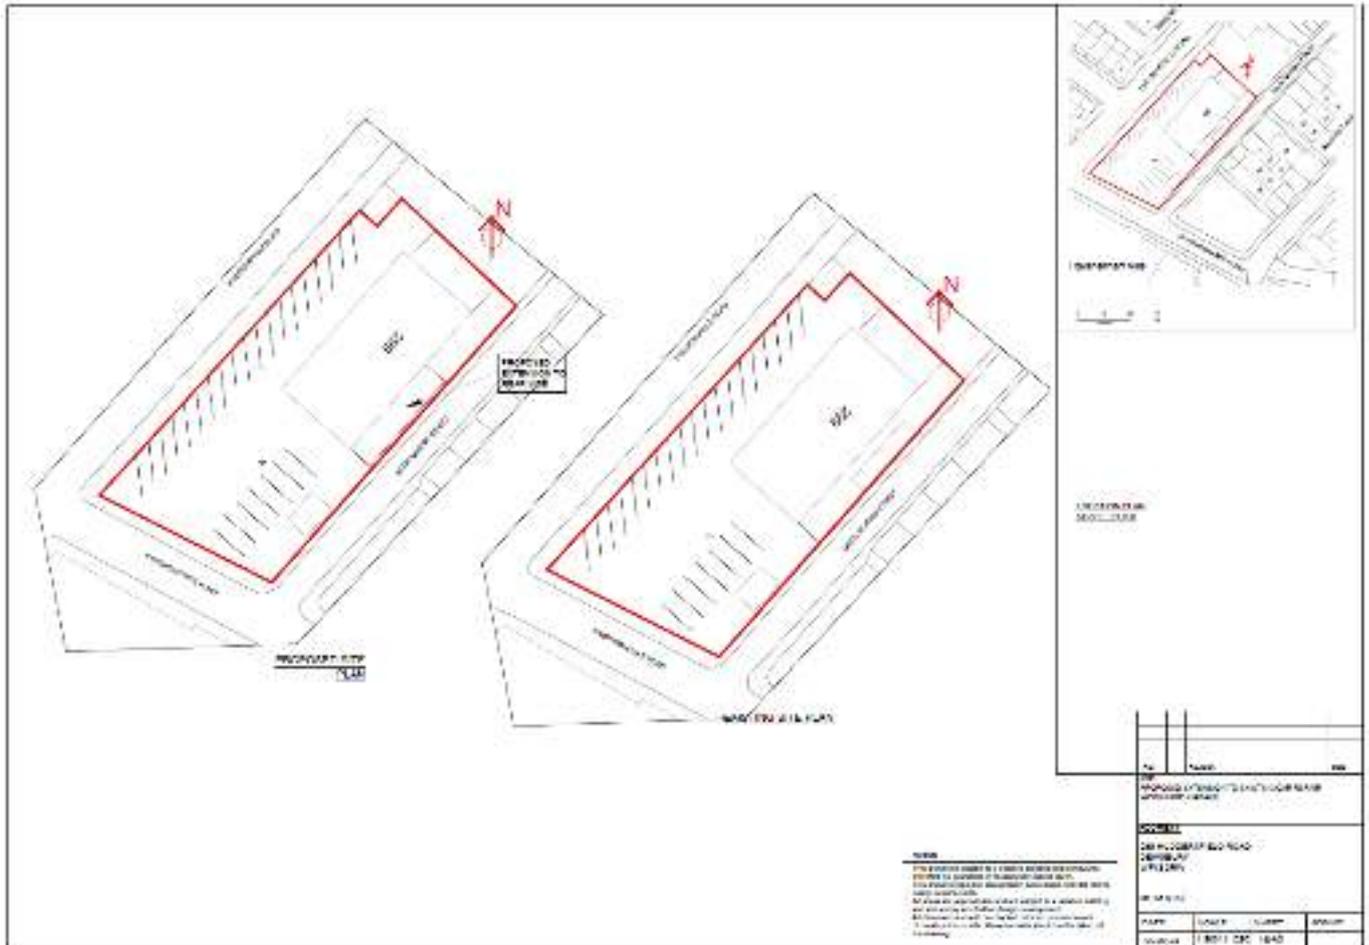
### Appendix A – Plan showing proposed development layout

The Coal Authority understands that the developer plans to construct an extension to an existing car repair workshop /garage (see appendix A).

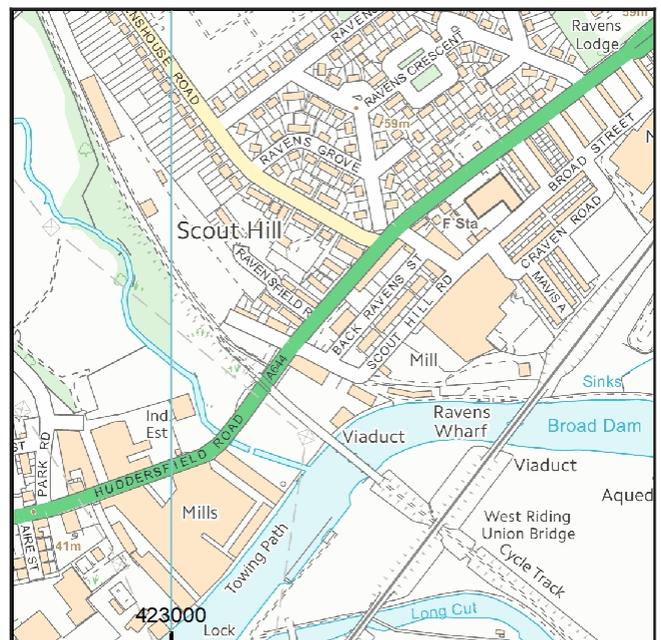
Approximate position of property
