Combined Remediation
Strategy, Drilling &
Grouting Plan

Client: Lidl Great Britain
Ltd

Lidl, Birstall

Report No: 1080.07.02

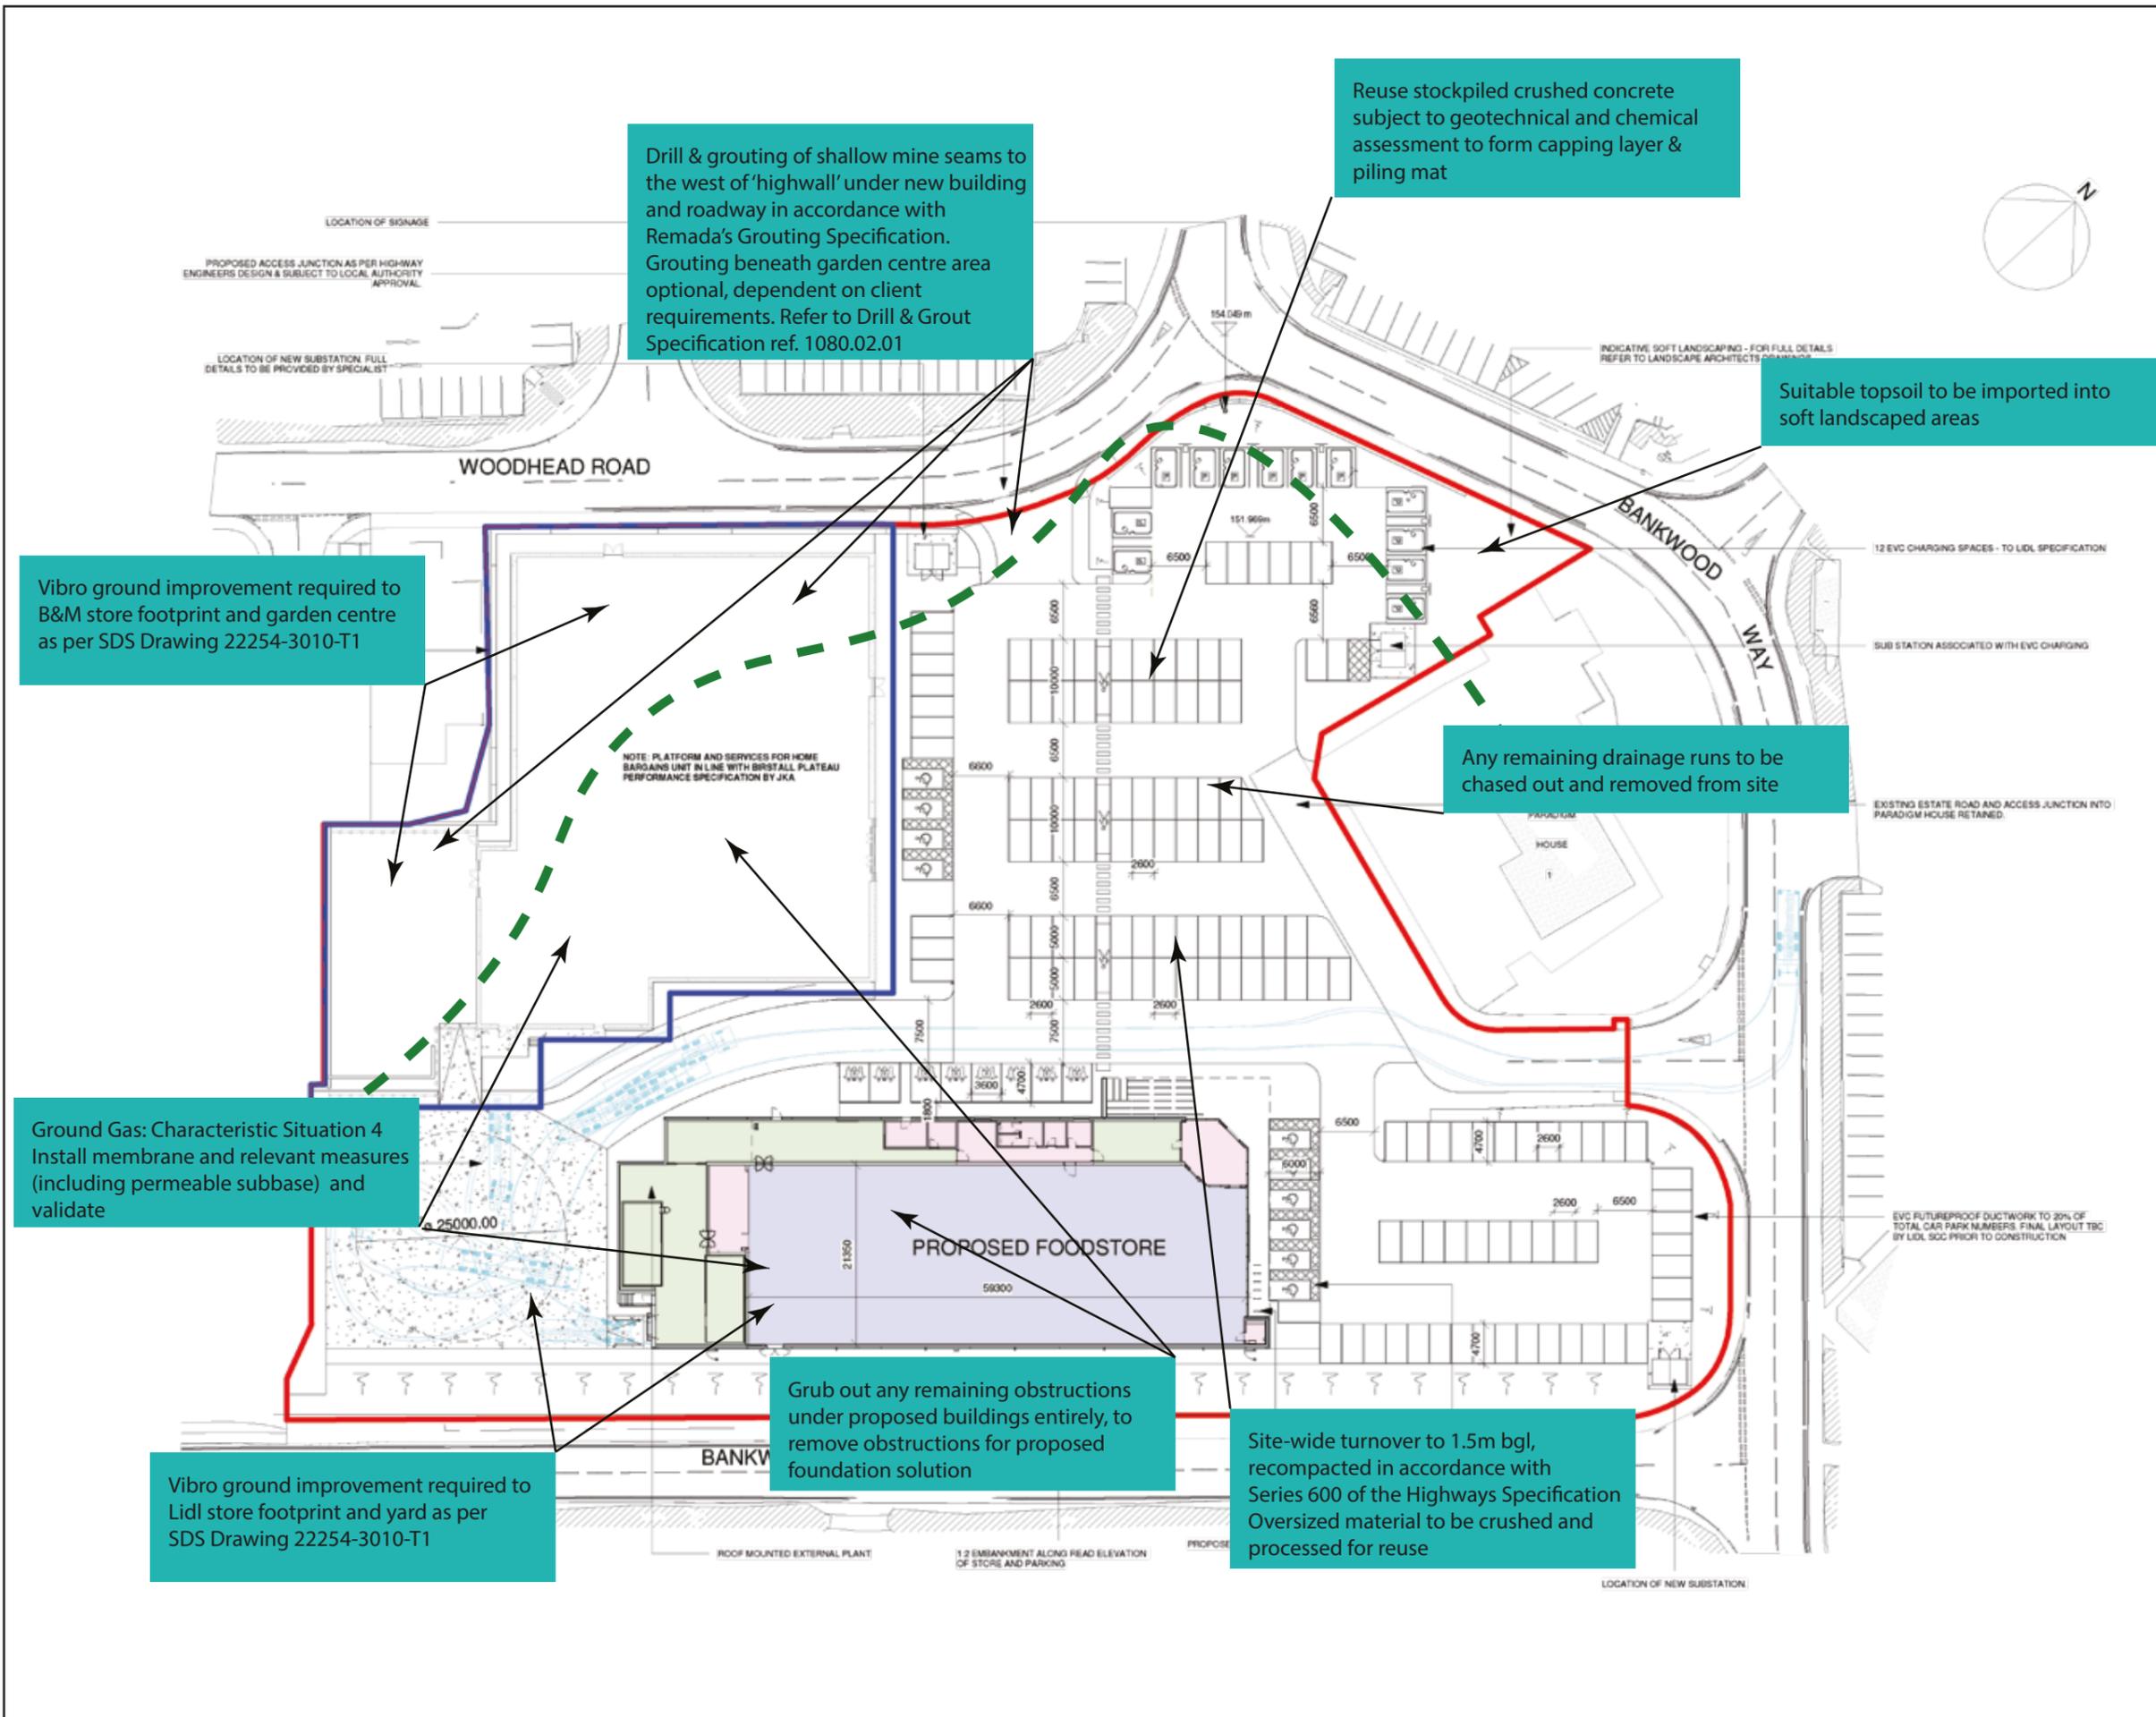
Drawing Reference
1080.07 Fig1

█ Approximate location of open cast 'highwall'

Remada Ltd was commissioned by Lidl Great Britain Ltd ('the Client') to prepare a Remediation Strategy for a proposed Lidl retail store on land off Bankwood Way, Birstall WF17 9TD. This report was prepared with regards to Kirklee Council's planning application ref: 2021/62/92528/E Conditions 18 and 19 relating to land quality and to present appropriate mitigation measures. The proposed site layout is presented on **Figure 1**.

A summary of remediation activities with cognisance to the proposed site layout is shown in **Figure 1**.

Formation levels for the remediation works are to be advised by the structural engineer in order to produce the development finished levels for the proposed site layout as per **Figure 1**. Based on the SDS Cut Fill Analysis (drawing ref 22349 3015 T1), included as **Appendix A**), it is understood that in general site levels are to be raised between in the east of the site and cut within the western area.

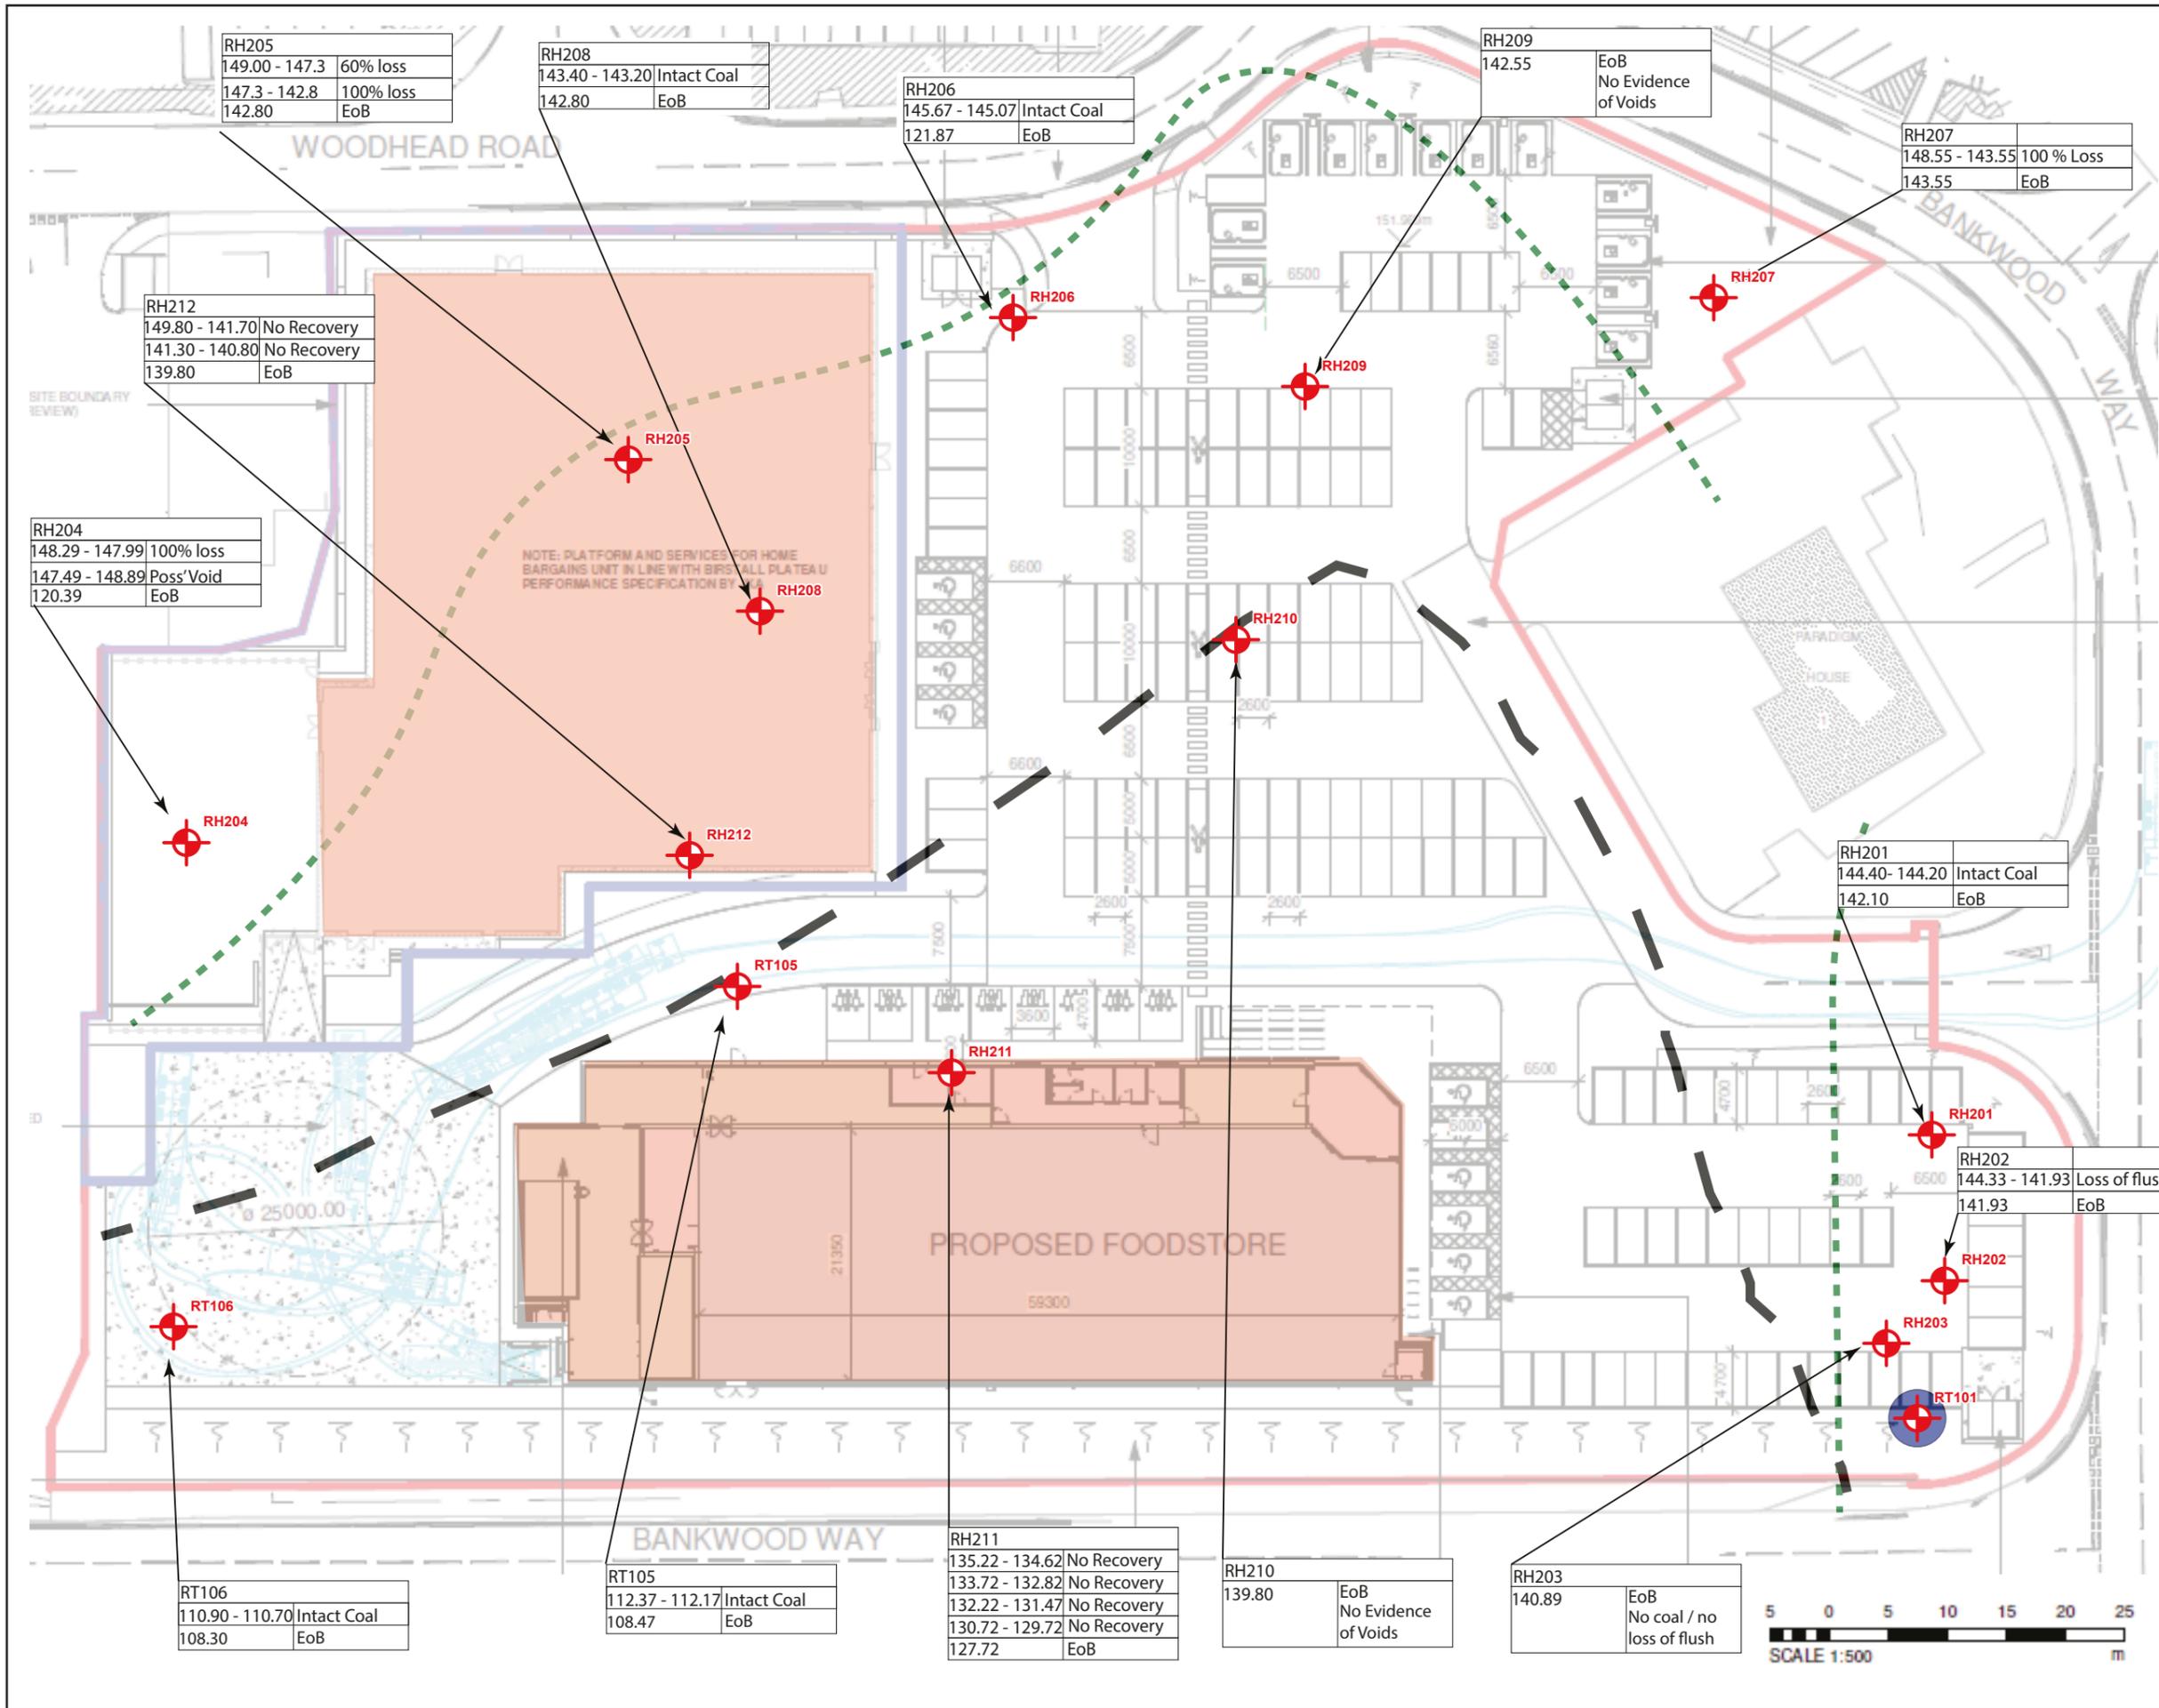
RH205	149.00 - 147.3	60% loss
	147.3 - 142.8	100% loss
	142.80	EoB

RH208	143.40 - 143.20	Intact Coal
	142.80	EoB

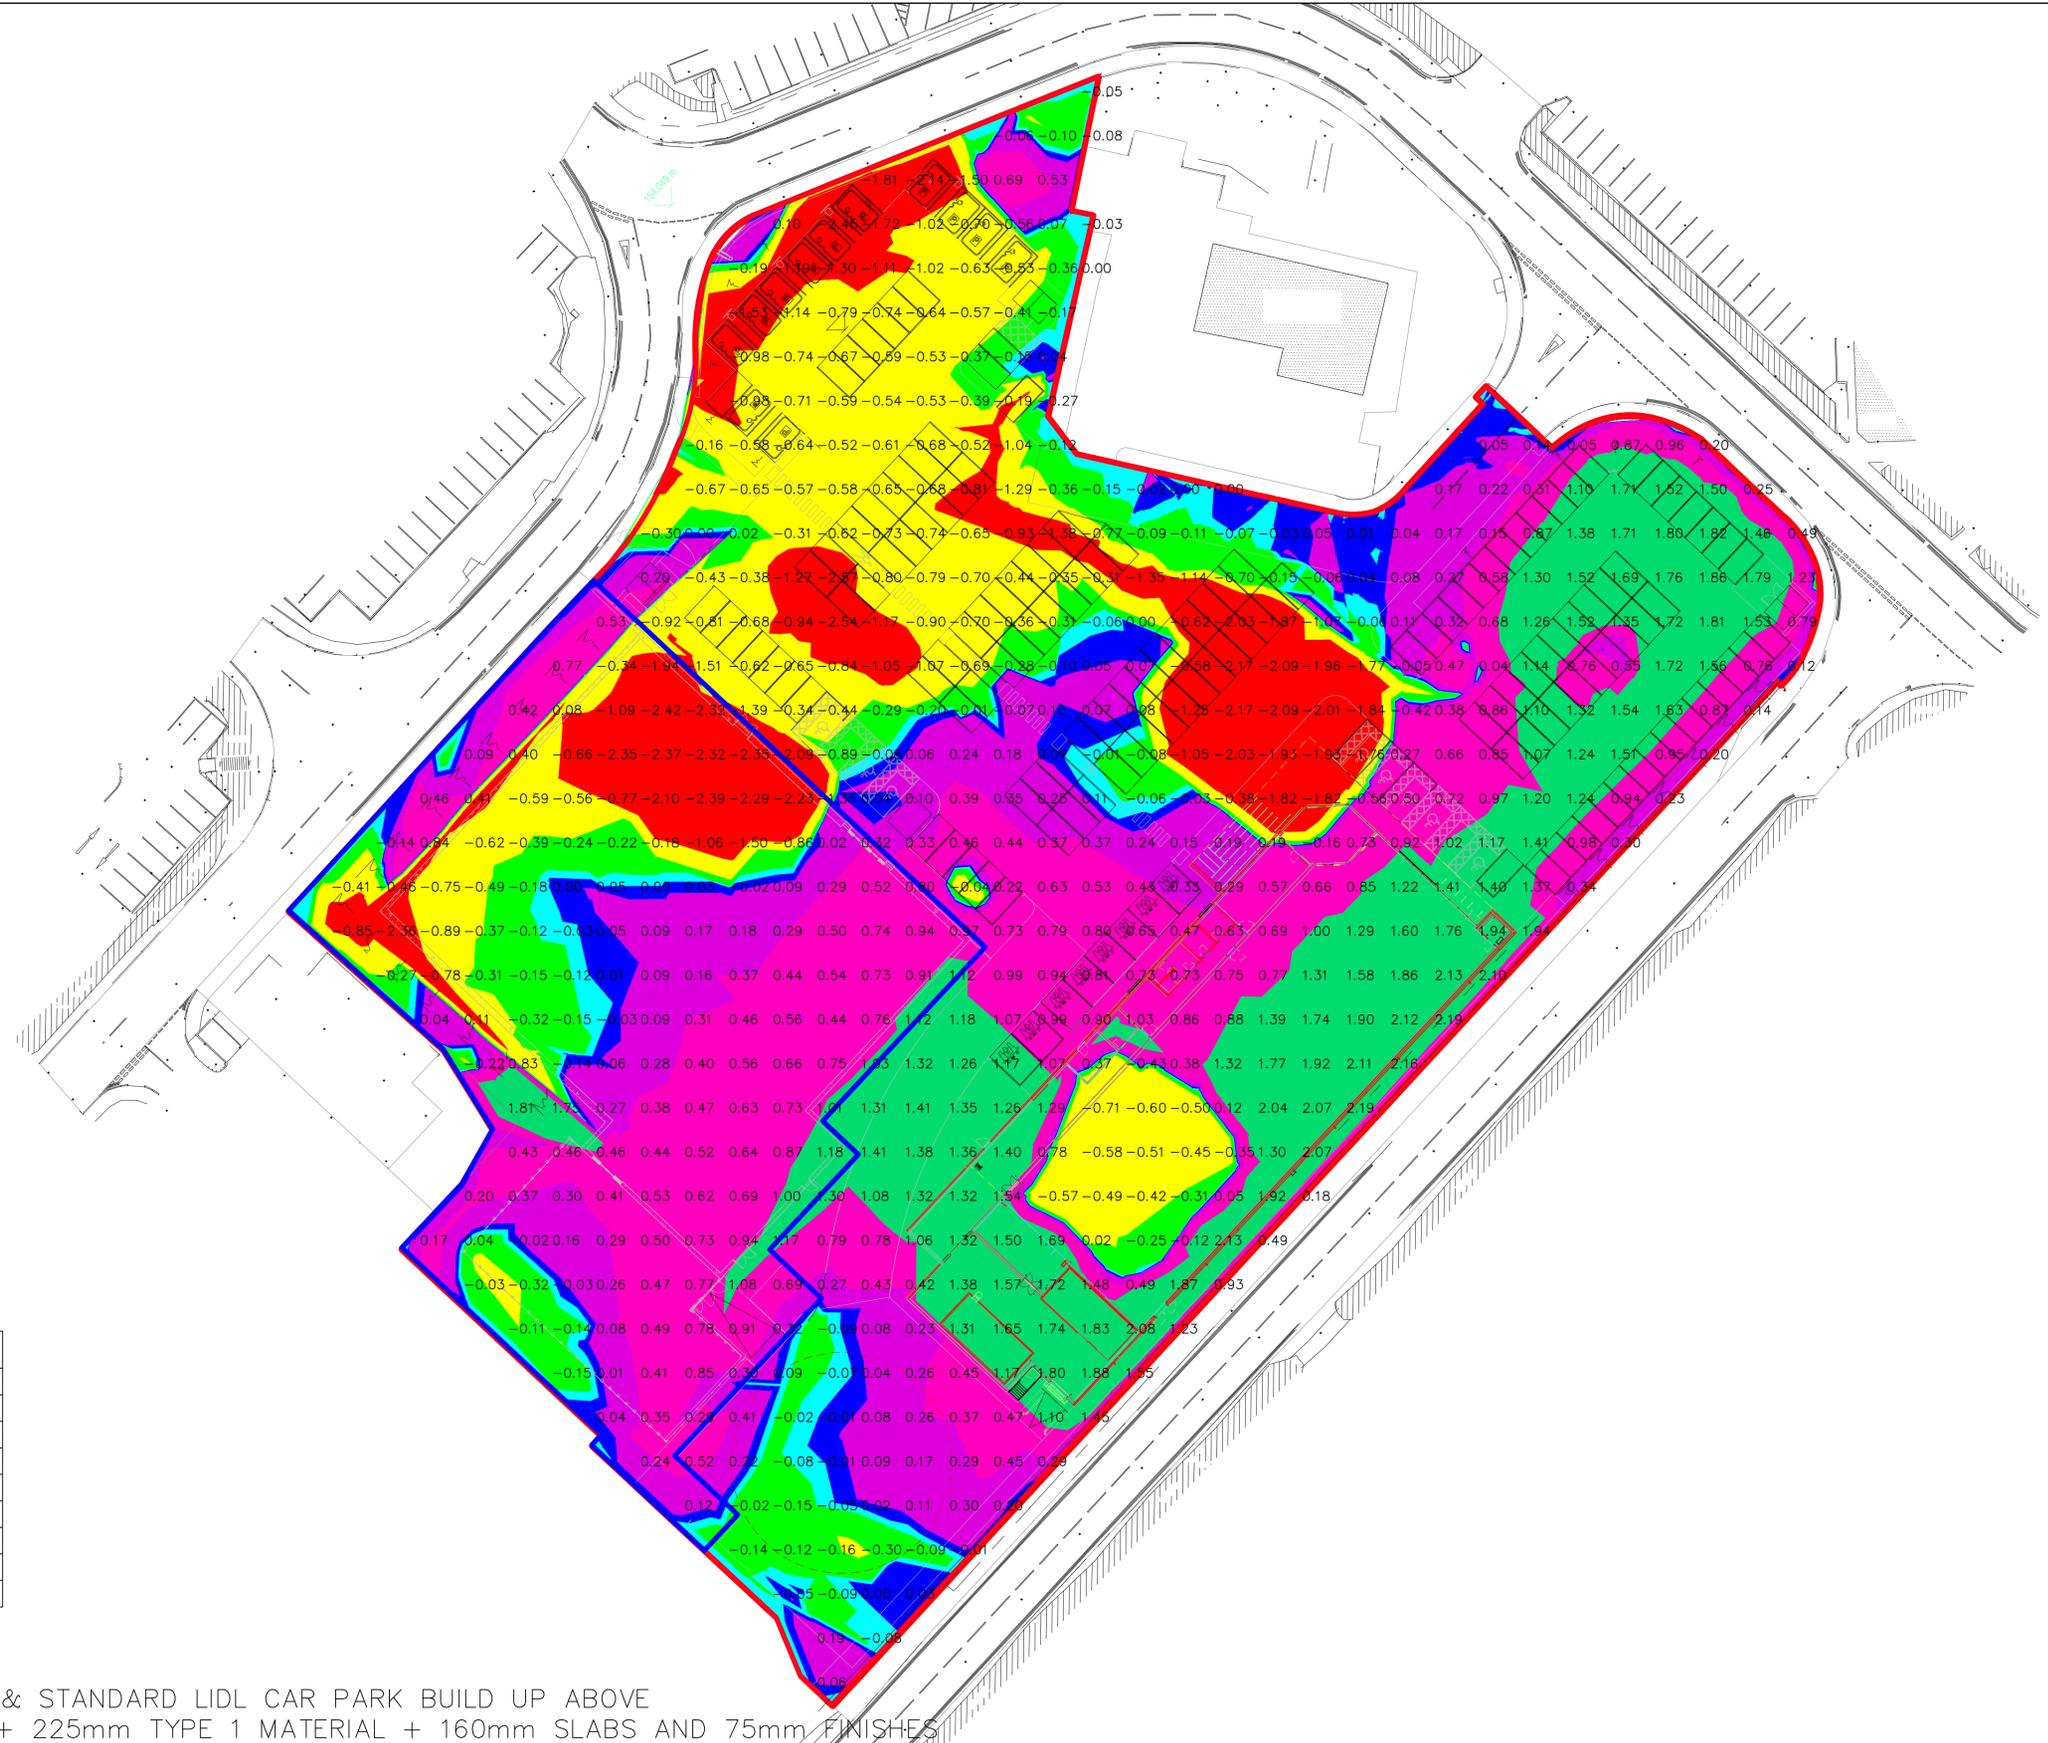
SDS Cut Fill Analysis

TOTAL FILL = 7038 m3
 TOTAL CUT= 4450 m3
 NET FILL=2587m3

Elevations Table					
Number	Minimum Elevation	Maximum Elevation	Area	Color	VOLUME m3
1	-3.01	-0.93	1618.36	Red	1261.68
2	-0.93	-0.28	2552.61	Yellow	1817.55
3	-0.28	-0.05	1368.08	Green	1077.25
4	-0.05	0.00	580.94	Cyan	300.86
5	0.00	0.06	773.72	Blue	545.75
6	0.06	0.37	2269.41	Magenta	2167.92
7	0.37	1.07	3361.11	Pink	3001.74
8	1.07	2.39	2768.01	Light Green	1316.10

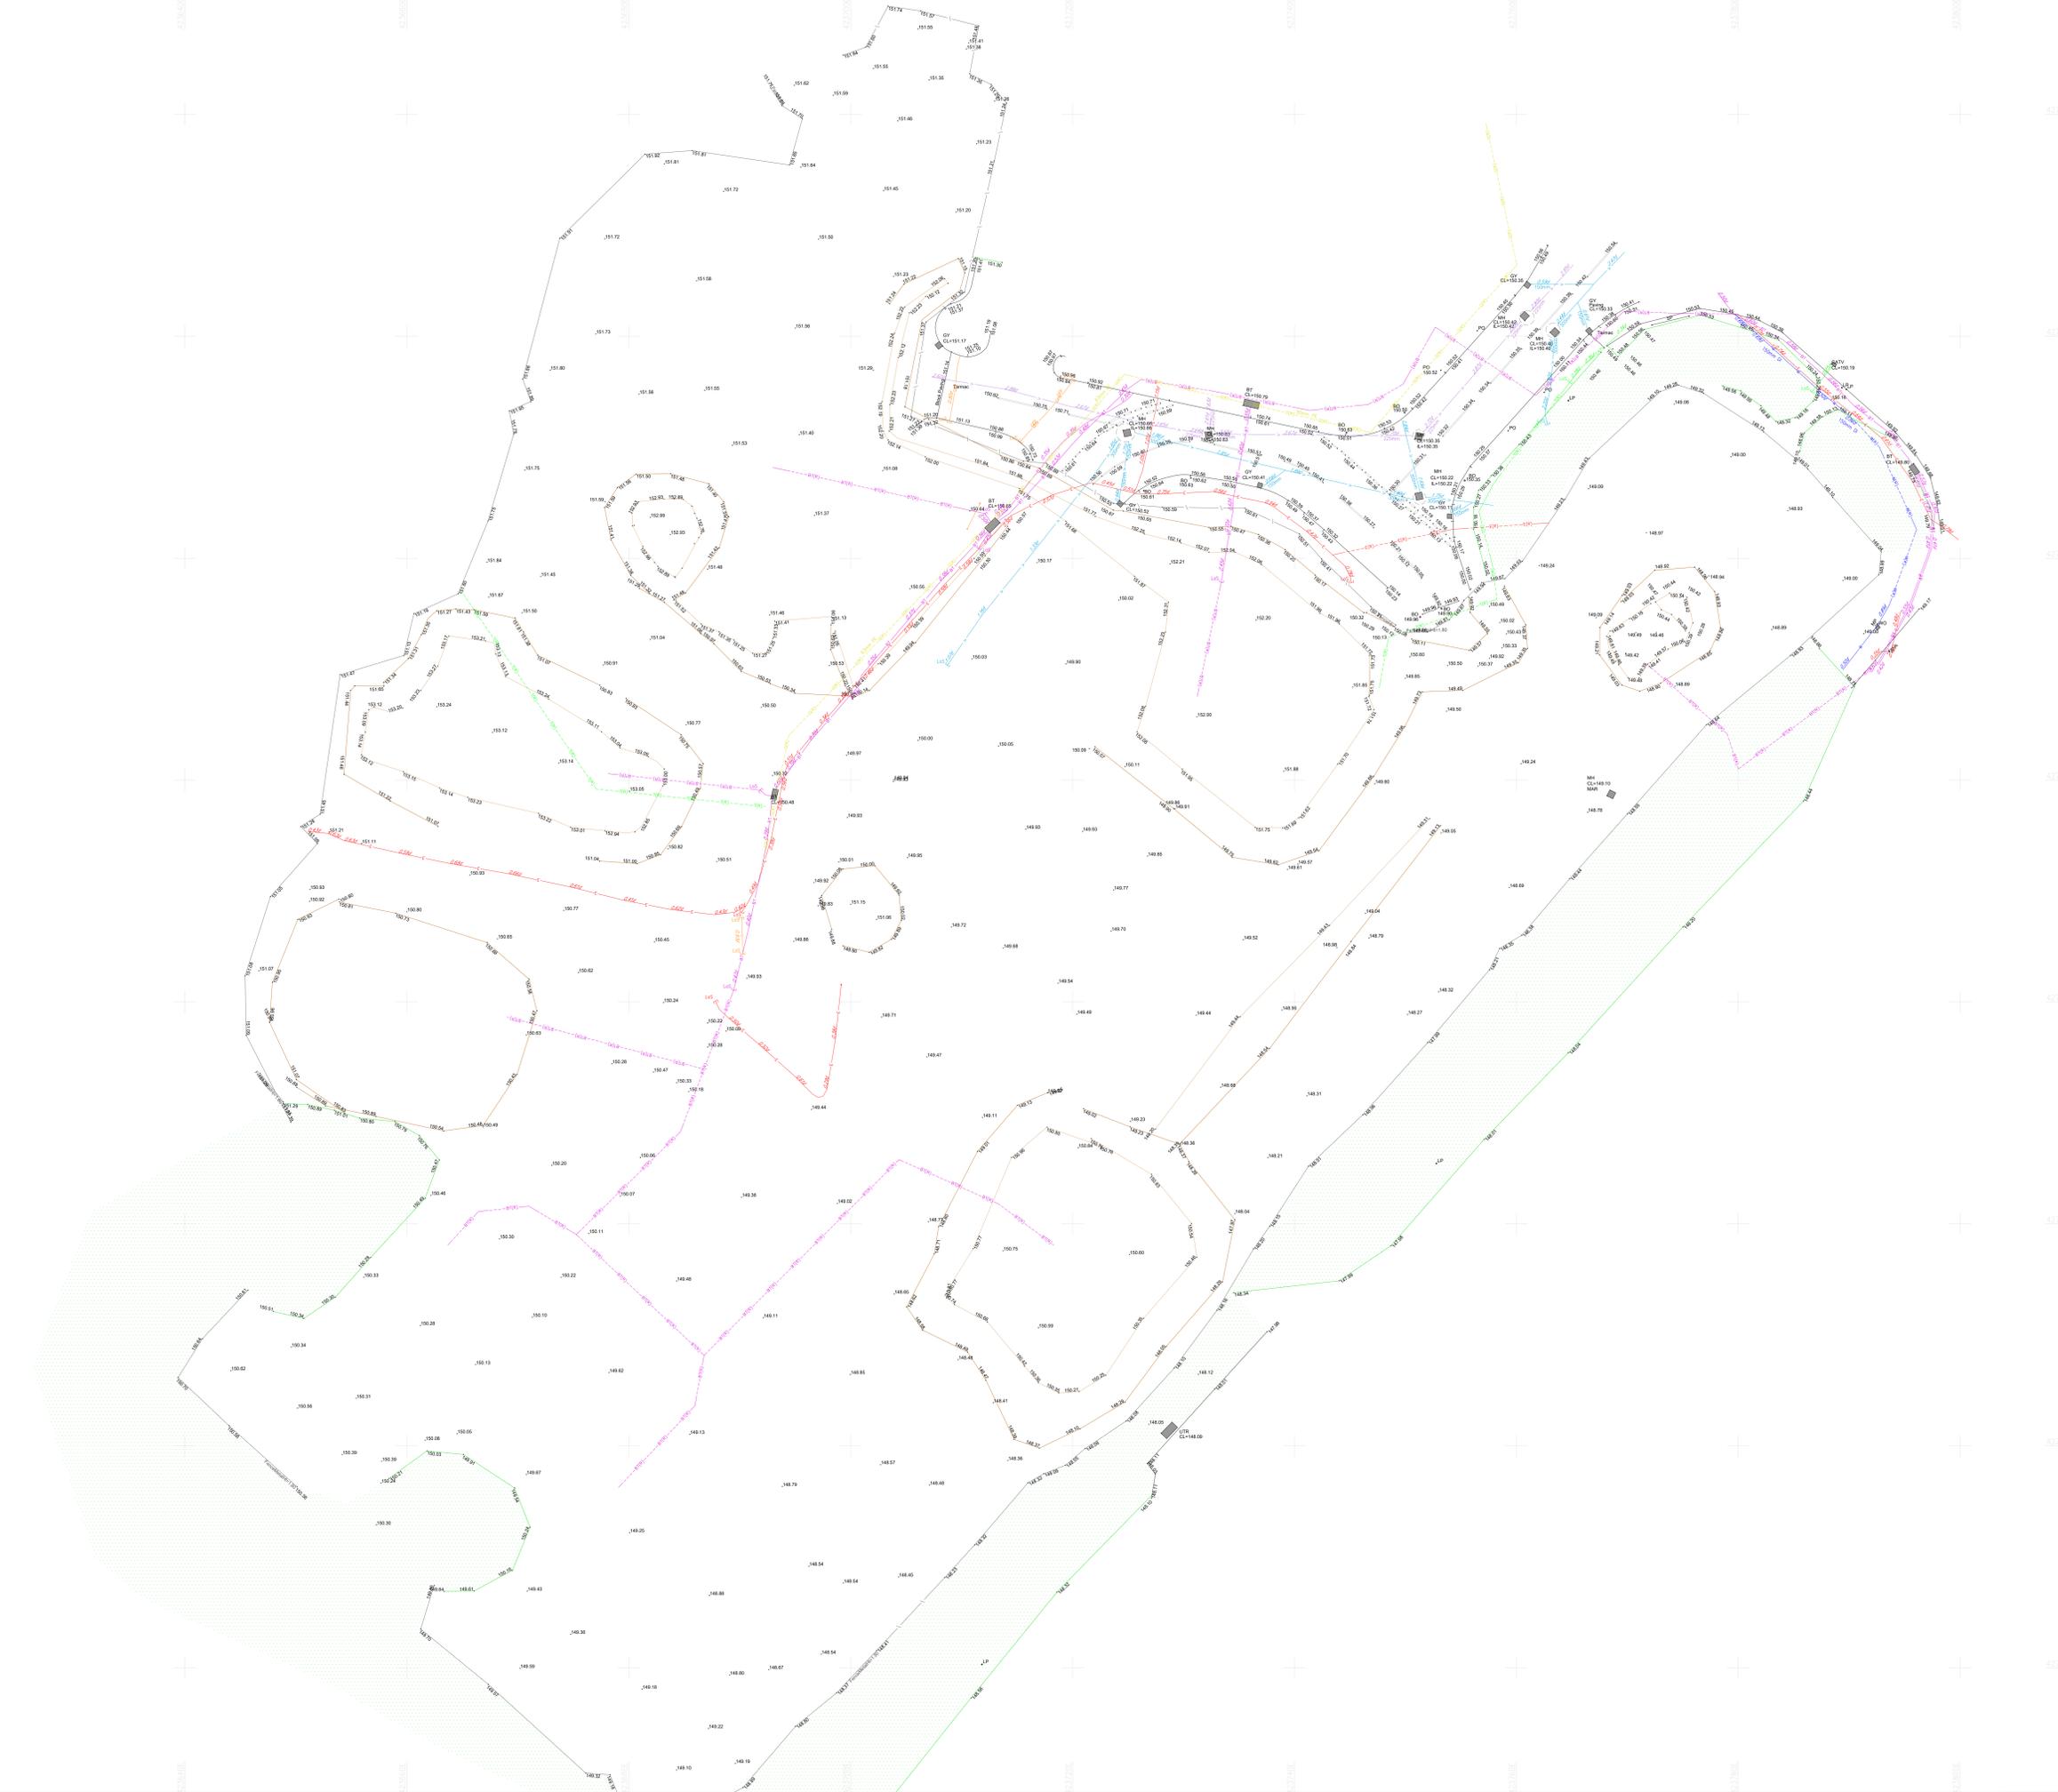
Centara: Utility & Topographical Survey

GRID: OS NATIONAL GRID
 Using the OS GPS Network and applying OSTN15 Transformation and then removing the scale factor for true distances with a one-step transformation centred on DNE1
 DATUM: OS LEVEL DATUM
 Using the OS GPS Network and applying OSGM15 National Geoid Model to obtain local area corrections

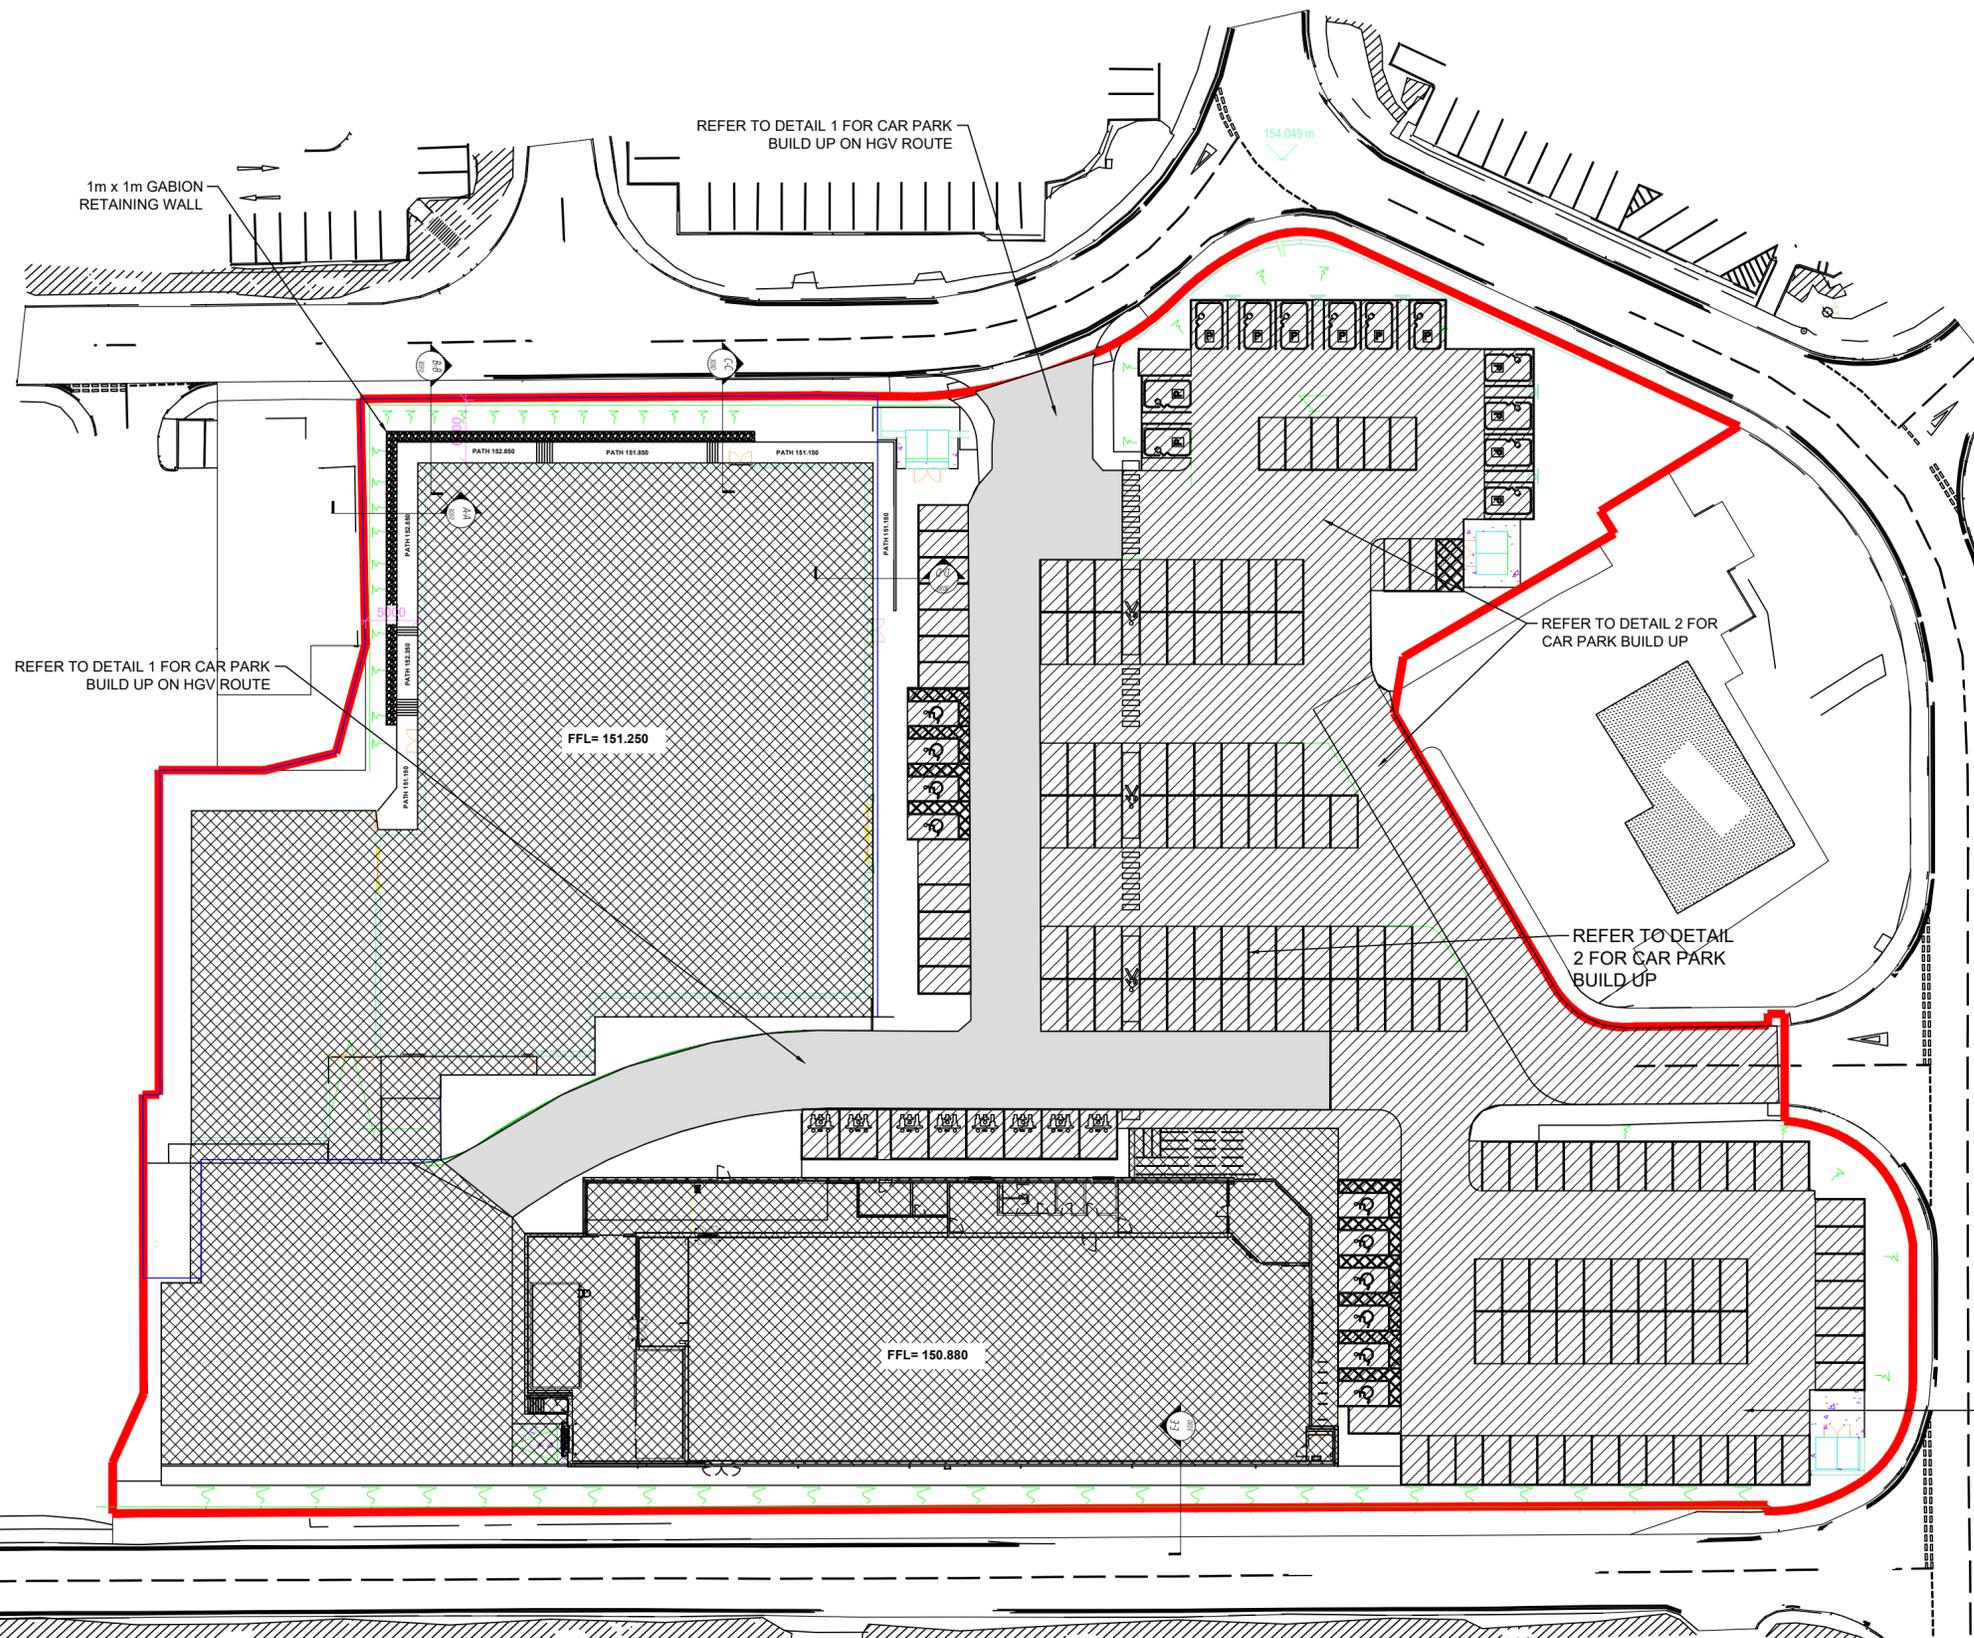
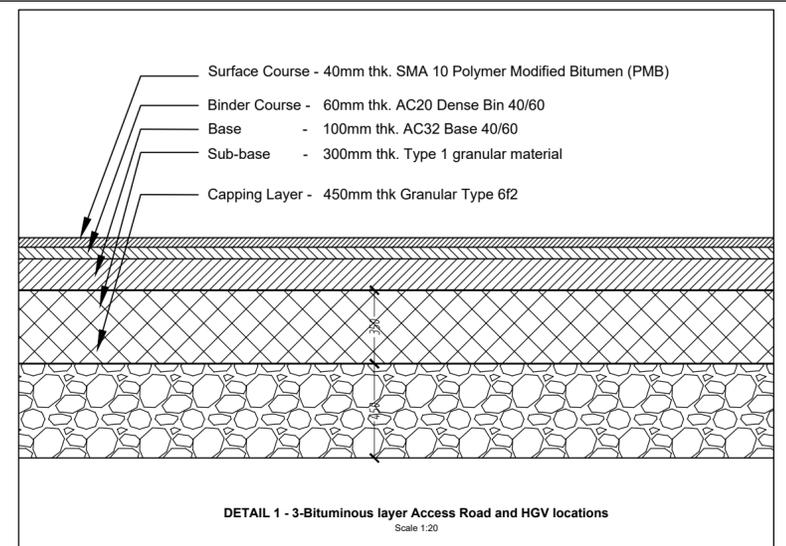
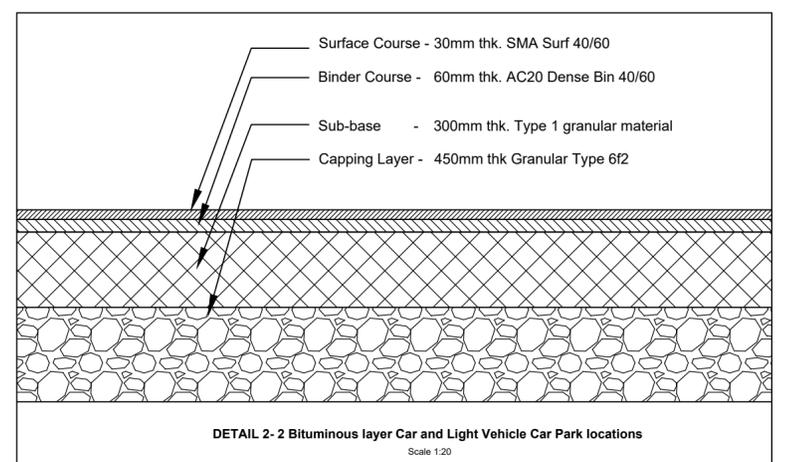
SDS Ground Improvement Plan

LEGEND -PROPOSED GROUND IMPROVEMENT PLAN		APPROX AREA
	SITE BOUNDARY	
	EXTENT OF VIBRO STONE COLUMNS GROUND IMPROVEMENT TO ACHIEVE A MINIMUM BEARING CAPACITY OF 150 kPa	6500sqm
	HGV ROUTE	2000sqm
	LIGHT VEHICLE CAR PARKING AREAS & NON-HGV ROUTE	5000sqm

REFER TO DETAIL 2 FOR CAR PARK BUILD UP
