# Ground Investigation Report (desk-based)

Bull Green Road House, Longwood, Huddersfield

Soil and Structures Ltd were instructed by Northlight Architectural Consultants Ltd (*the Client*) on behalf of Rose Taylor in November 2024 to prepare an intrusive Ground Investigation Report (*this Report*) to support development of a plot of land located to the north of Bull Green Road, Longwood, Huddersfield (*the Site*).

Development proposals include for the construction of a single dwelling with associated hardstanding (driveways) and soft landscaping (private gardens to rear on the upper level of the Site and small area to the lower-level) as illustrated on the appended development plan and within this Report.

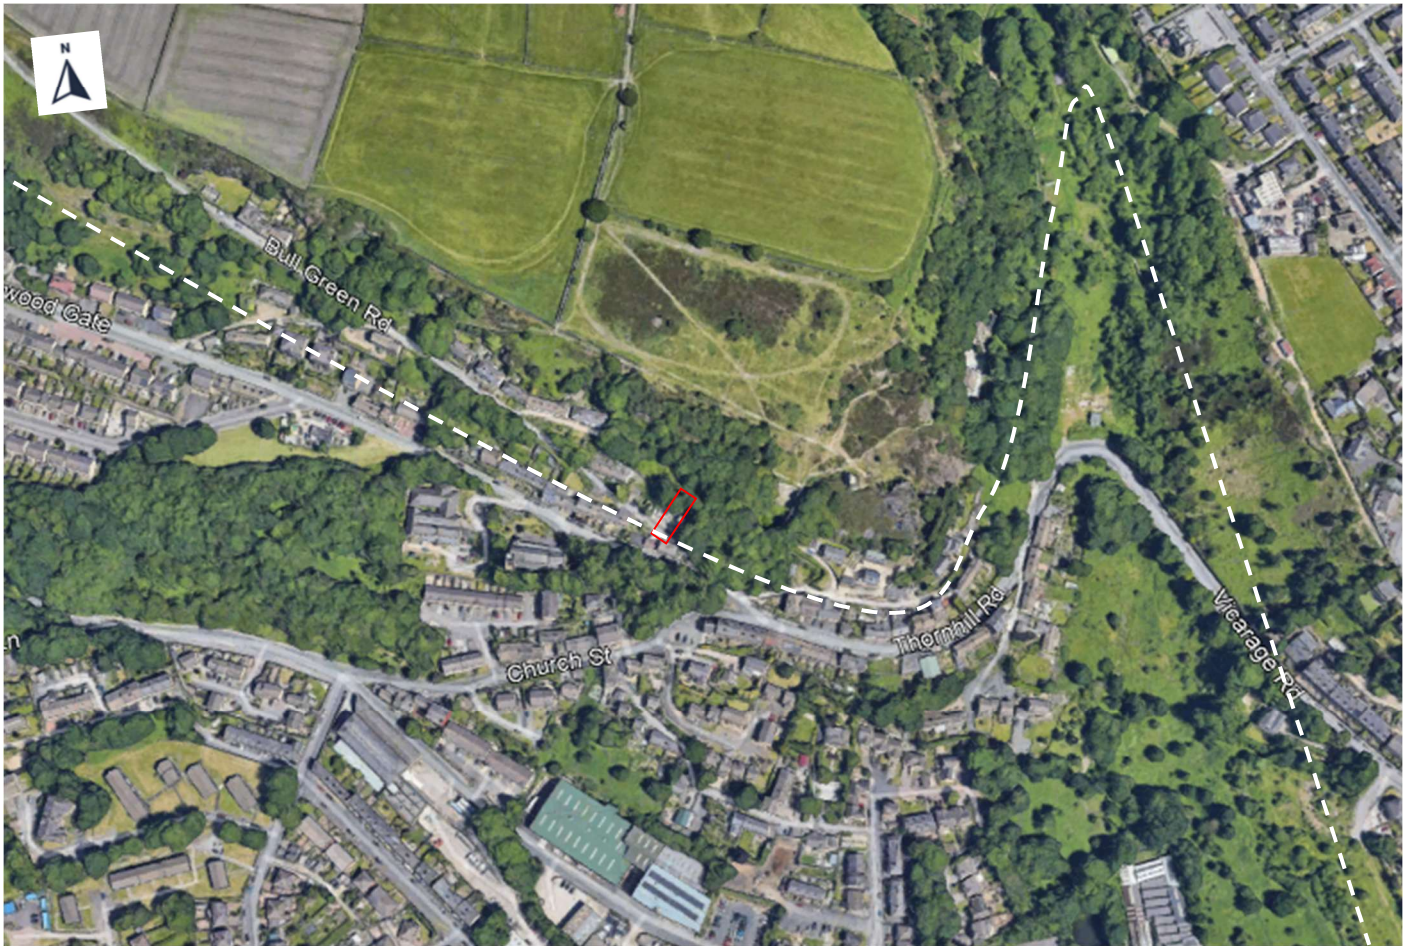
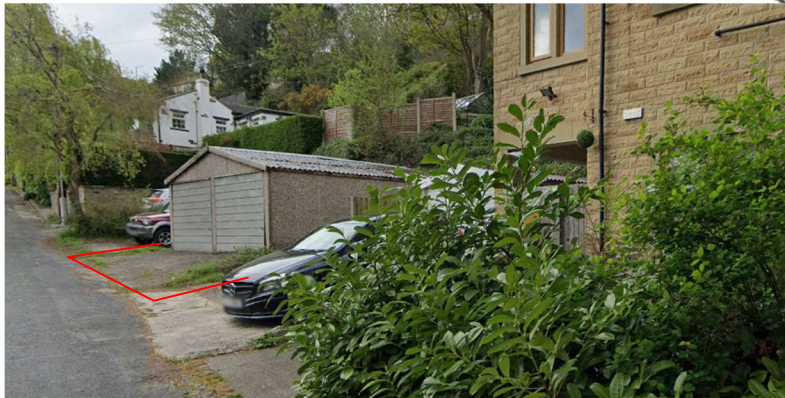
**Figure 1: Site Location**

- > Extract from Google Earth™.
- > Approximate Site boundary identified by red line.
- > Upper edge of the Rough Rock plateau illustrated with ground levels tapering away from this edge.
- > INSERT RIGHT: Location plan extract
- > INSERT BELOW: Streetview illustration of Site with existing garage structure illustrated

**Location and size:** The Site comprises a parcel of land approximately 0.01 ha in size that is located adjacent to No. 10 Bull Green Road, Longwood, Huddersfield (Figure 1).

**Topography:** The topography of the Site generally falls from north to south with the Site located on the upper reaches of a broad plateau of outcropping Rough Rock (sandstone) as illustrated on Figure 1.

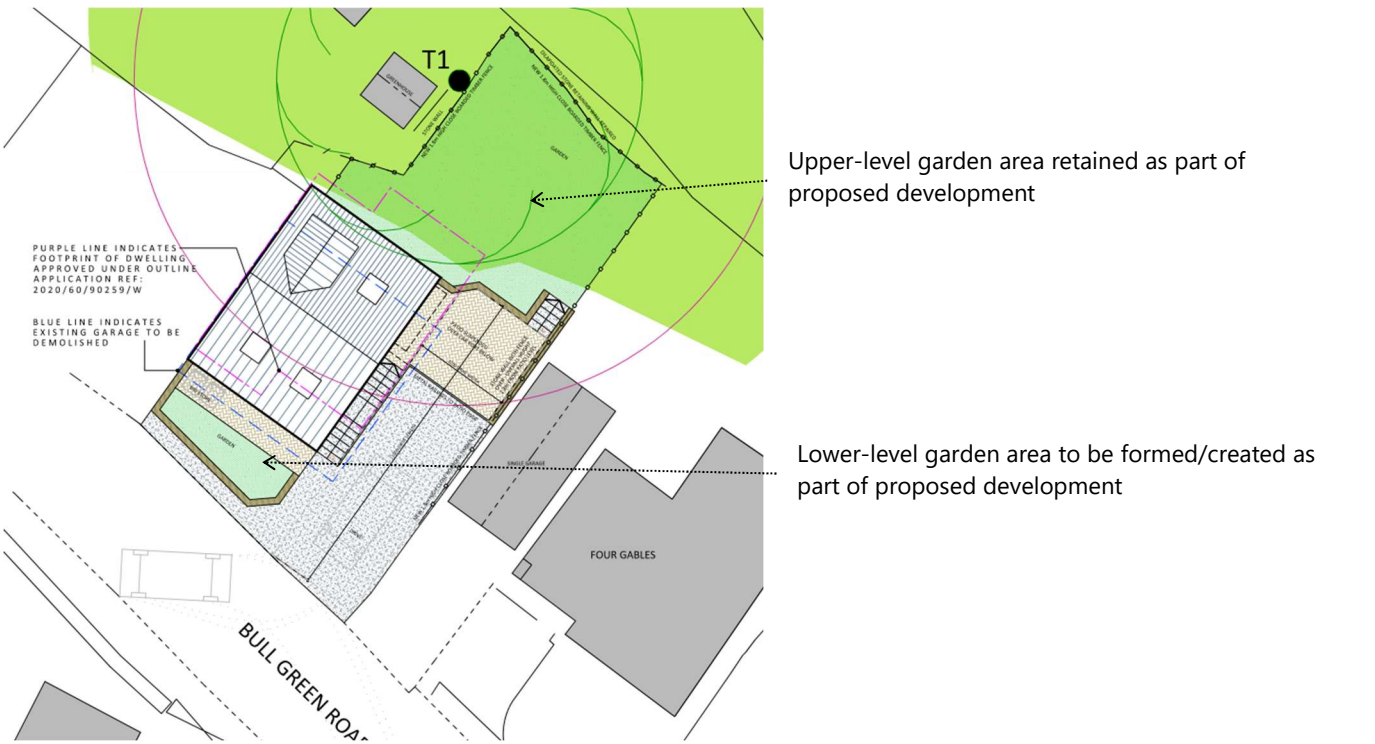
Figure 3: Landscaping plan extract  
> Extract from appended drawing

- Potentially harmful and polluting material:** the formation soils below the lower-level garden area may include residual Made Ground deposits that, in lieu of chemical testing, are assumed to be chemically unsuitable for retention within garden areas (potential for end users to be exposed to this material).
- It is also noted that this material is likely to be physically unsuitable with sharps, e.g. brick and glass fragments likely, that itself would render the material unsuitable as a landscaping fill.

**Soft landscaping** is expected to remain unaltered through the development works with the upper-level garden area retained as part of the development for which no further work is recommended. A small area of soft landscaping is proposed to the front of the property as illustrated on Figure 3 for which risk management is recommended

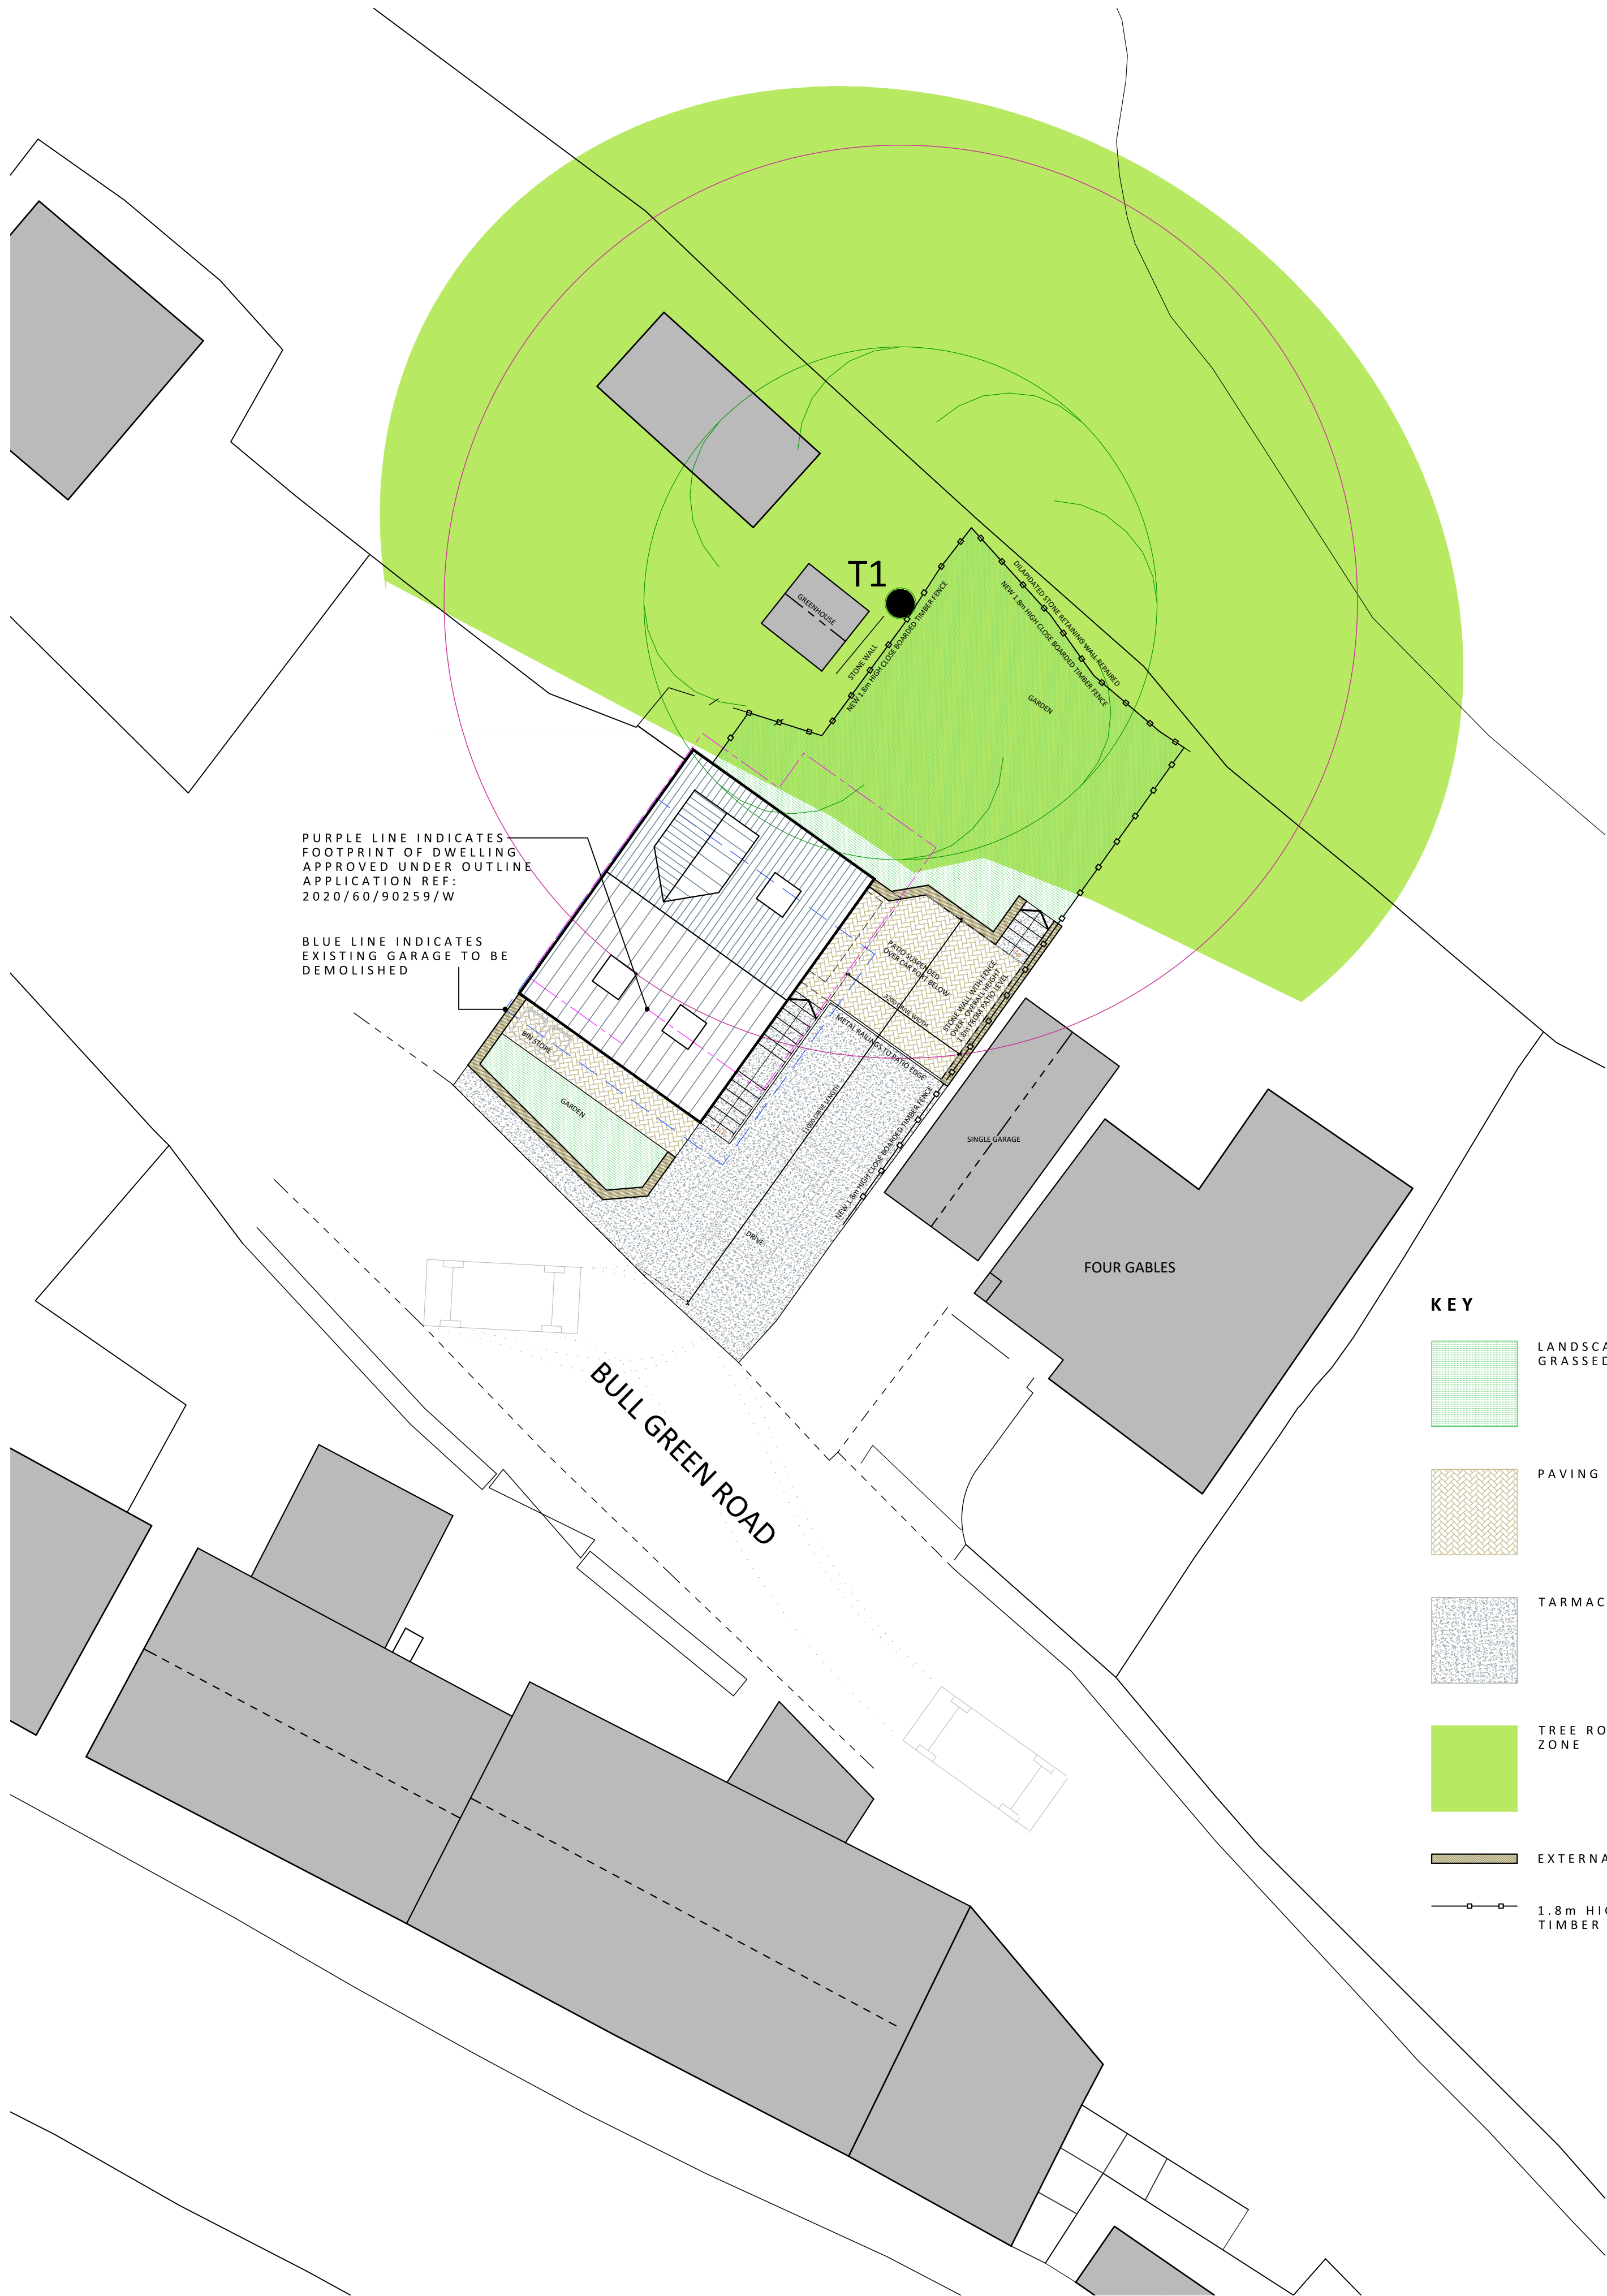
1 PROPOSED SITE BLOCK PLAN  
SCALE 1:100

Rev B - 21/02/24 - 3.2X11m driveway indicated as highways comments, patio at first floor extended above drive, house redesigned to accommodate driveway changes.

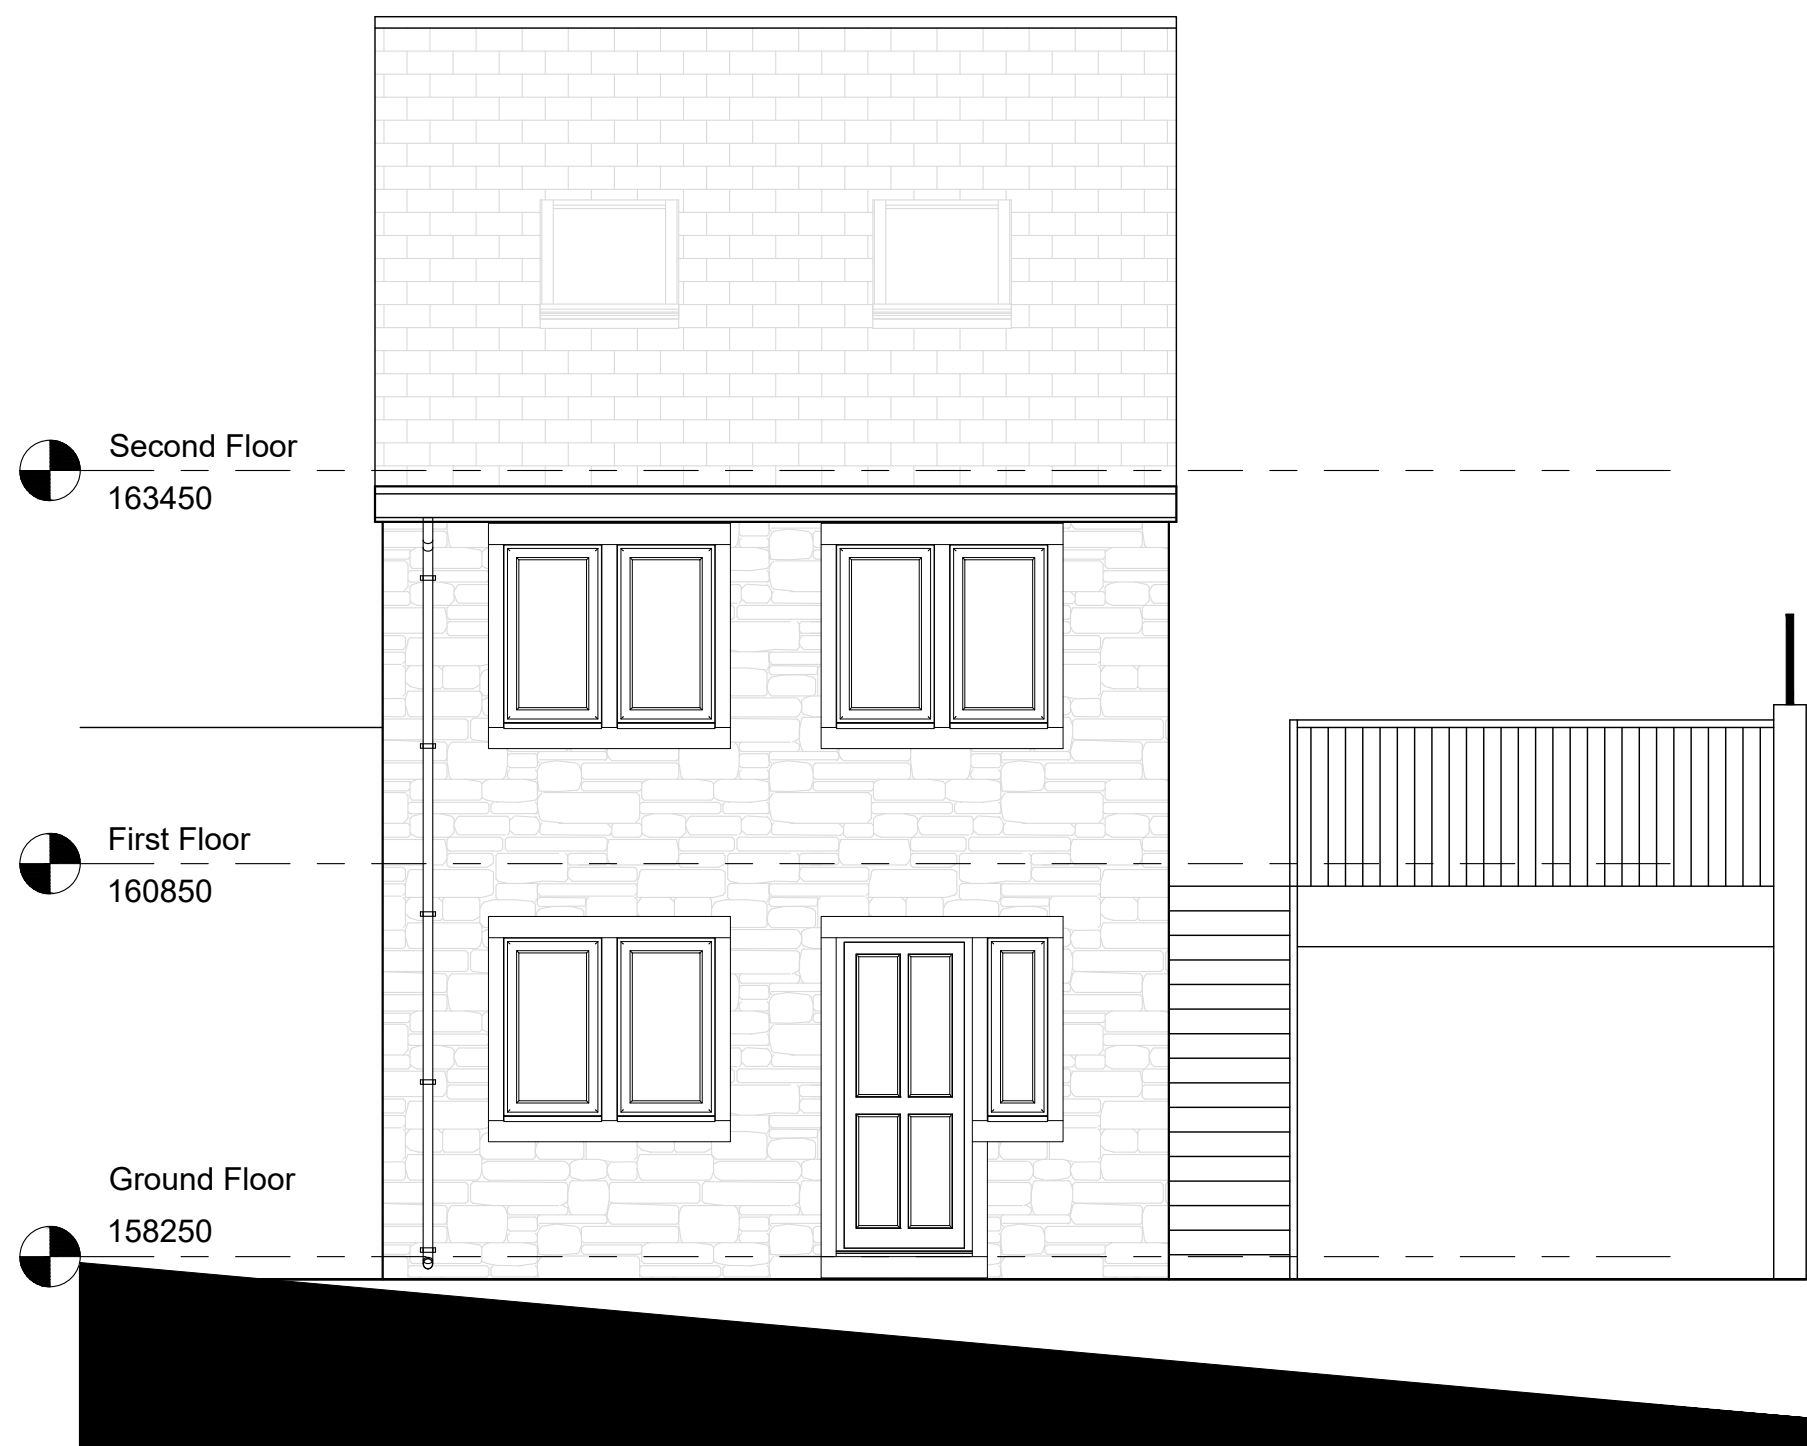
1 PROPOSED SOUTH-WEST ELEVATION  
SCALE 1:50

Rev A -22/01/24- Dormer to SW elevation replaced with roof window
