# The Former Combs Hostel Hall Lane, Thornhill, Dewsbury Feasibility Report

May 2025

Project Number: 2414

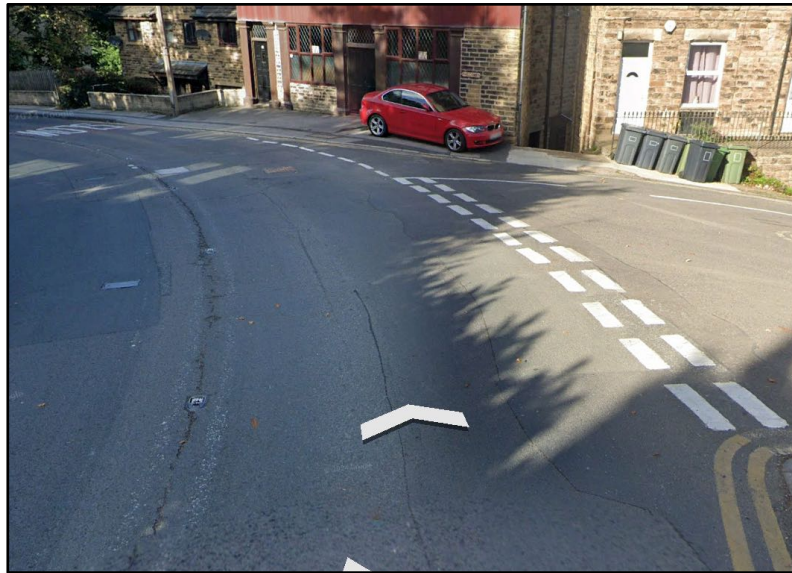
- 4.1.1 As mentioned in para 3 above the junction currently operates in a safe and efficient manner based upon the accident data. Therefore, the need to provide improvements to the sight lines for emerging drivers would appear to be unrequired.
- 4.1.2 Sight lines measured from the junction of Hall Lane with the B6117 would provide 2.4 x 90 metres to the north west and 2.4 x tangent to the south thereby meeting current guidance.
- 4.1.3 Notwithstanding this there is evidence that vehicles park on the wide footway outside no.51 The Combs (see Fig 3 below) and should they be say be parked outside the main door to the property this would obscure visibility for egressing drivers in the critical direction.

**Fig 3 Vehicle parked on the footway to the north of the Hall Lane junction with the B6117 (Google Earth image).**

- 4.1.4 To overcome this issue concrete bollards or similar should be erected 600mm back from the kerb line in locations that would prevent on footway parking but still allow for pedestrian / wheelchair through access.
