THE GEORGE HOTEL, HUDDERSFIELD

JOHN WILLAM STREET DECONSTRUCTION AND RECONSTRUCTION

L054-GMI-XX-XX-RP-A-08806_P1

Topic: John William Street – Deconstruction and Reconstruction

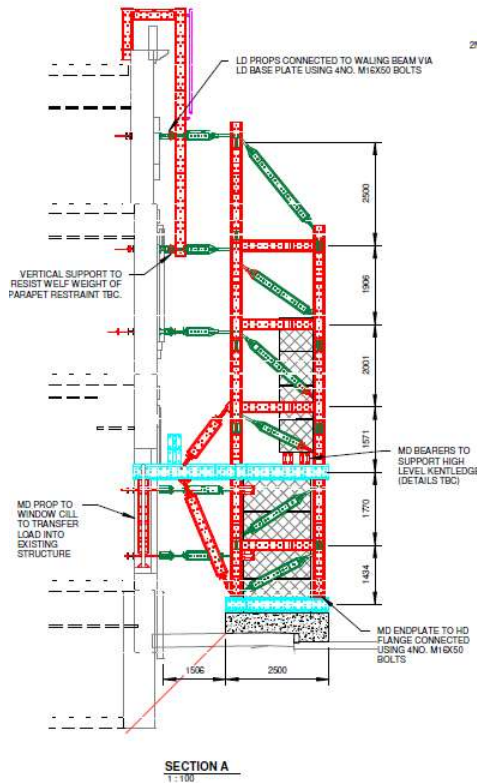
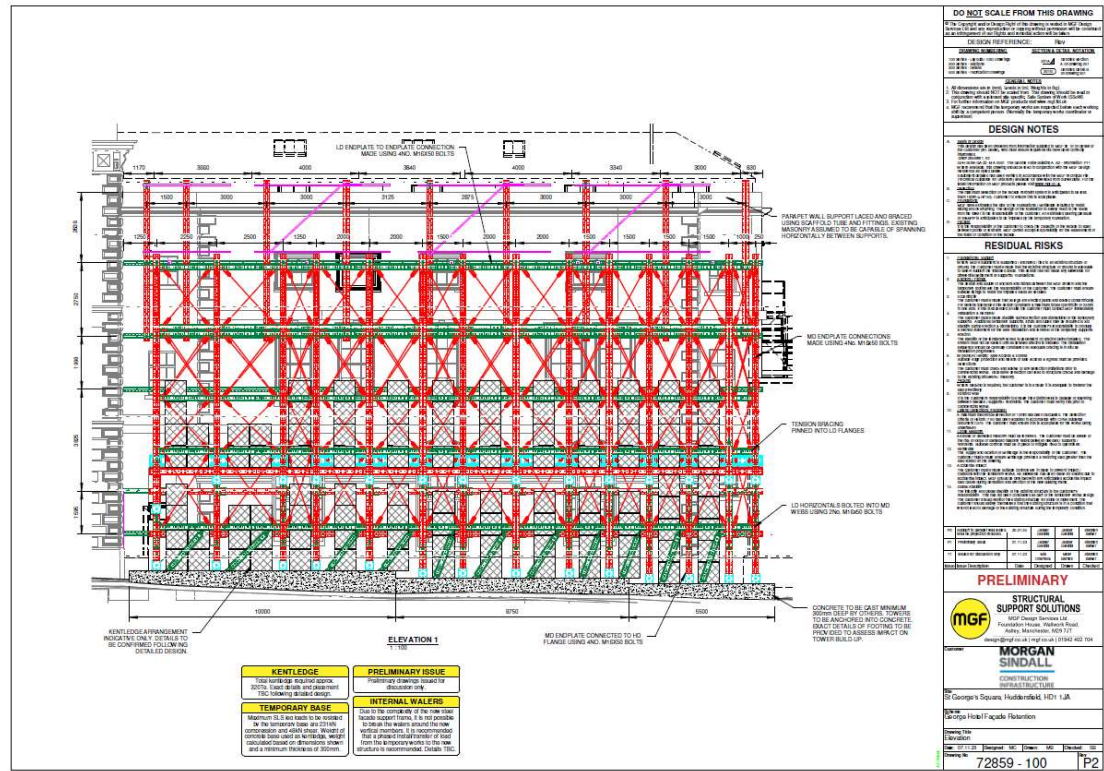
Project Analysis — Proposed JWS Elevation Risk Analysis

Whilst a lot of analysis was carried out, the façade retention proposal was not fully resolved.

Basement excavation.

- Undermining the existing structures.
- Risks associated with the operation of excavation & contiguous piling equipment.

Demolition of existing structure

- Structural inter dependency between the JW street wall and 1850s Block
- Facade retention scheme;
- Retention costs challenge viability of the scheme

- Movement of the supported JW façade, while under support, could impact significantly the existing George hotel to which it is tied.

- Ground bearing pressures of the footpath and highway will not take ground bearing requirements of the retention scheme.

- Significant number of services within the JW Street footpath are impacted – results in redesigned bearing system – more cost.

- Retention structure will dictate that JW Street will need to be reduced to 1 lane, potentially for 12 months

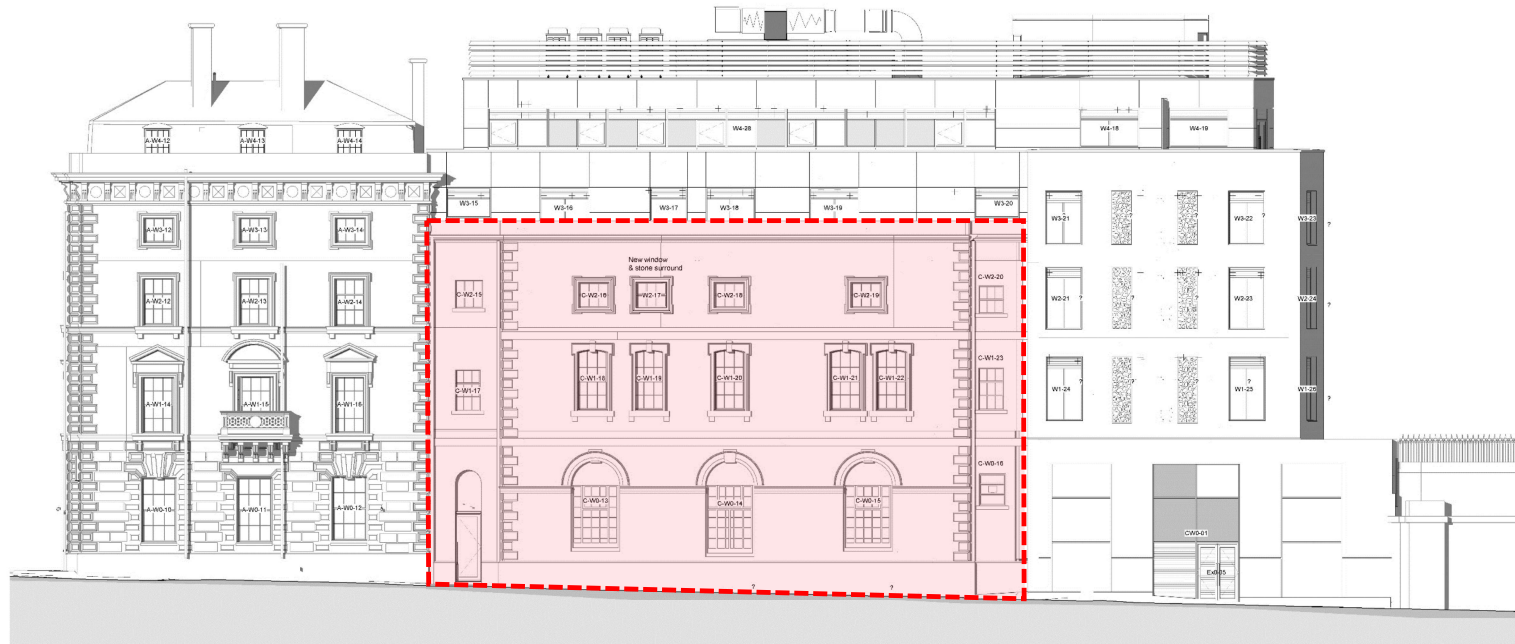
Project Analysis — Proposed JWS Elevation Risk Analysis

Consented scheme elevation indicates extent of the retained John William Street Façade .

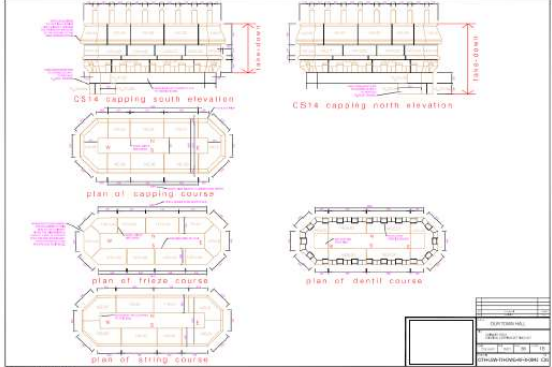
Existing Facade DWG

During the take down works Henley Restoration & Remedials's stonework have been recording, surveying and collating information regarding the existing Facades s. This information has been added to the Henley Restoration & Remedials Stonework existing Facade drawings (typical drawing of CS 14 has been attached) and where needed information has been transferred to the rebuild drawings. We have worked closely with Purcell's drawings, to provide drawings for the rebuilding element of our works and record the original details and new build details for cross checking. These drawings have been issued to the Architect and design team for approval.

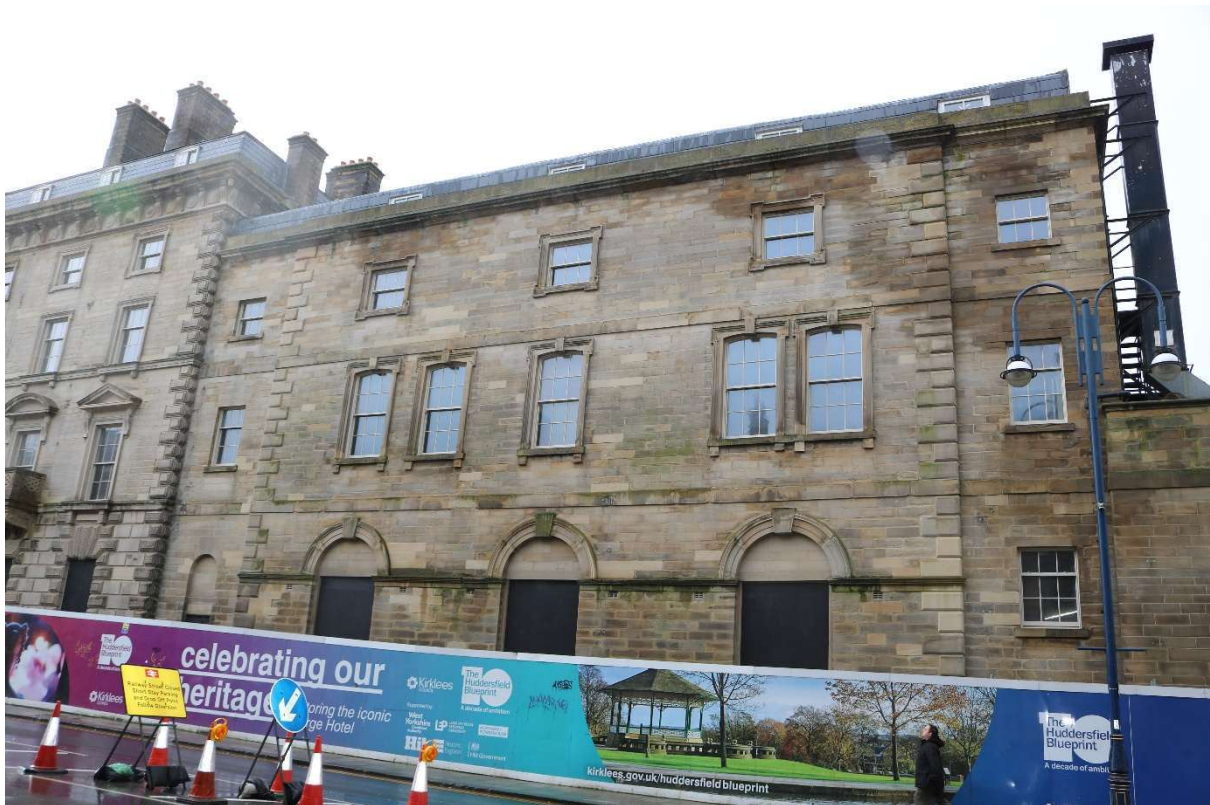
East elevation St John Williams Street, Huddersfield.

Henley Restoration and Remedials Limited, has been instructed by GMI to produce an initial high-level sequence of planned works intended to safeguard the façade during the planned take-down and rebuilding of the façade on the east elevation of St John Williams Street. This sequence will require further insight and development as we progress with the survey works currently instructed.

The sequence for the take-down and rebuild of the east elevation of the George Hotel, a listed building façade, involves several key phases to ensure the preservation of historical values and compliance with heritage regulations.
