Remediation and Validation Strategy

LOCATION	146 Commercial Road, Skelmanthorpe, Huddersfield HD8 9DS
ISSUE DATE	March 2022
CLIENT	Silverwood and GNS Property Development Ltd
CLIENT REF.	
OUR REF.	G22092

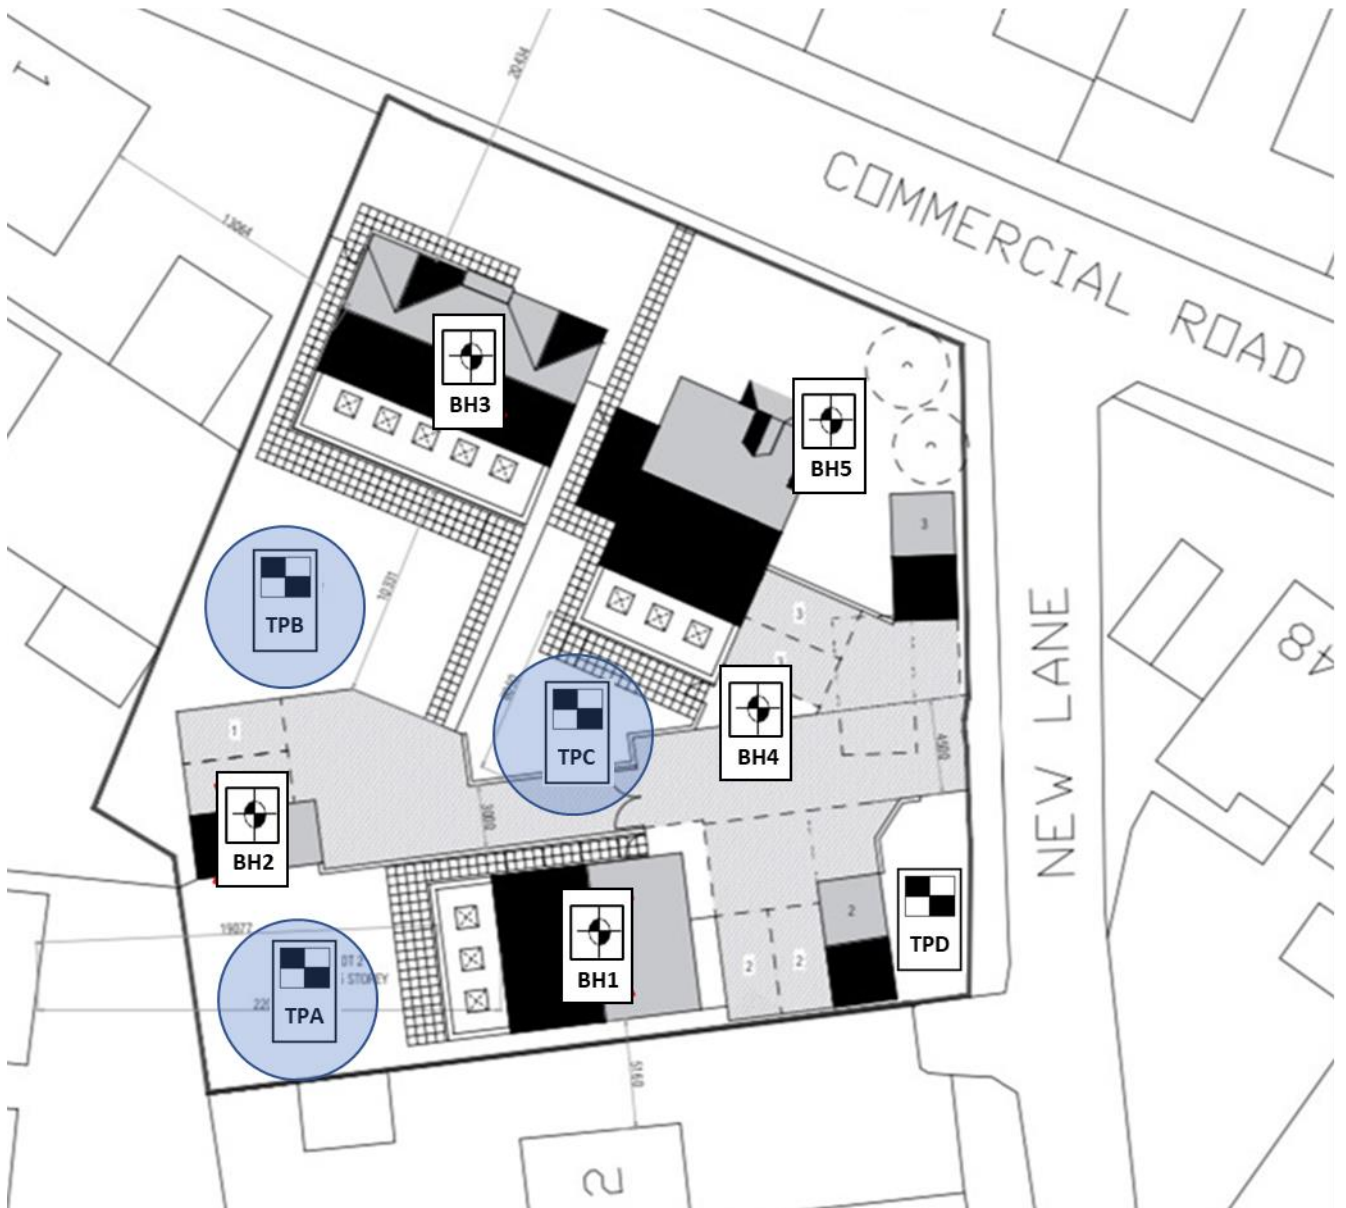
OUR REF: G22042	YOUR REF:	SITE PLAN (NOT TO SCALE)
DATE: 31/01/2022	LOCATION: 146 Commercial Road, Skelmanthorpe HD8 9DS

Elevated Lead Hot Spot
Location
