## **Condition Appraisal**

**December 2024**

**JLB Group Site  
Turnbridge Mills  
Quay Street  
Huddersfield  
HD1 6QT**

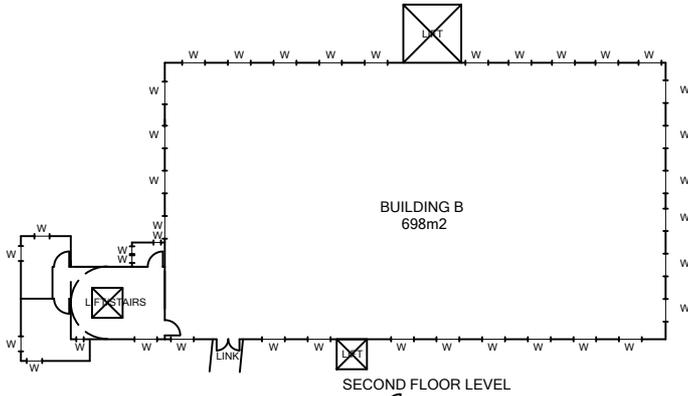
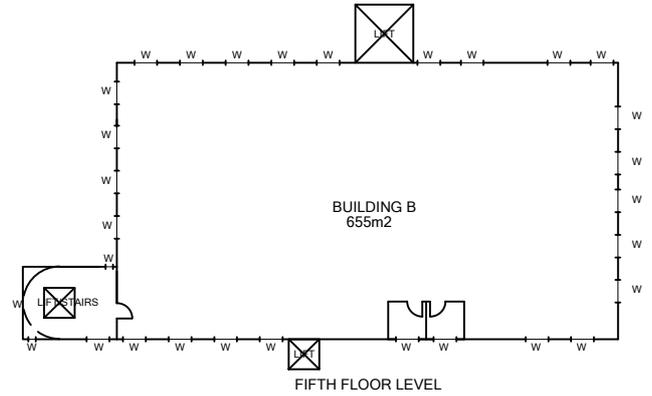
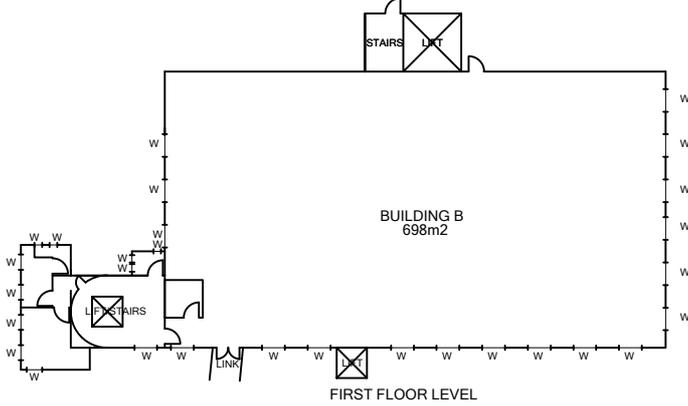
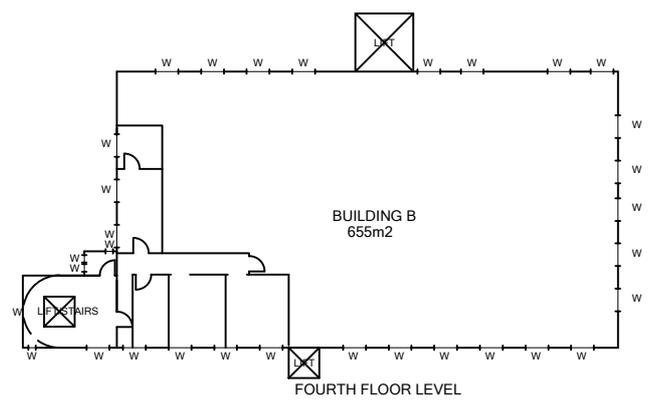
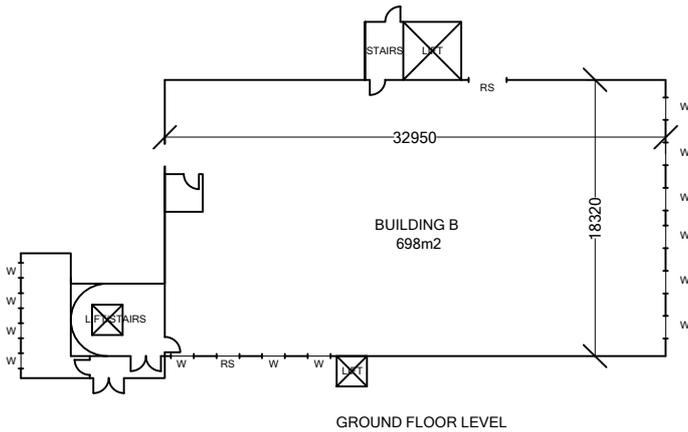
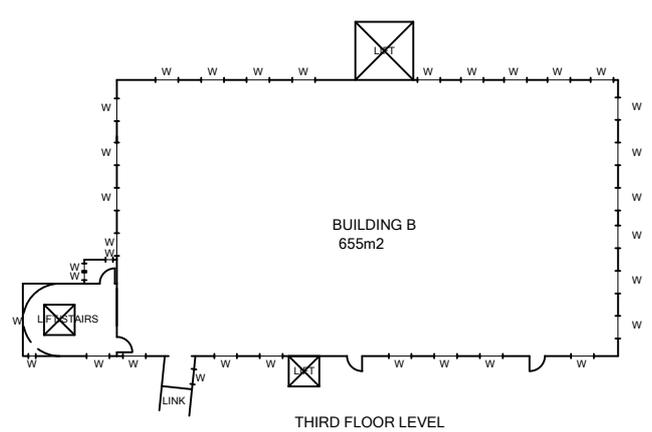
Client	JLB Group		
Project	Condition Appraisal Turnbridge Mills Quay Street, Huddersfield		
Drawing	Building B Existing Plans		
Date	June 2014	Drawn	RL
		Checked	Scale
			1:500@A4
Drawing No.	1908-14-02		Revision
			-
