**GROUNDTECH**  
CONSULTING

*COAL MINING RISK ASSESSMENT*

*ORION HOMES*

Document Control Form	
<b>PROJECT</b>	WHITEHALL ROAD, BIRKENSHAW
<b>REPORT NAME</b>	COAL MINING RISK ASSESSMENT
<b>REPORT REFERENCE</b>	GRO-24208-5354
<b>STATUS</b>	FINAL
<b>ISSUE DATE</b>	16 AUGUST 2024
<b>REVISION</b>	
<b>CLIENT</b>	ORION HOMES
<b>CLIENT CONTACT</b>	IAN HALLIDAY
For and Behalf of Groundtech Consulting	
<b>SIGNATURE</b>	
<b>AUTHOR</b>	Rebecca Rowlinson BSc (Hons) FGS
<b>SIGNATURE</b>	
<b>CHECKED</b>	Luke Harrison BSc (Hons) FGS
<b>SIGNATURE</b>	
<b>REVIEWED</b>	James Doyle BSc (Hons) CGeol FGS

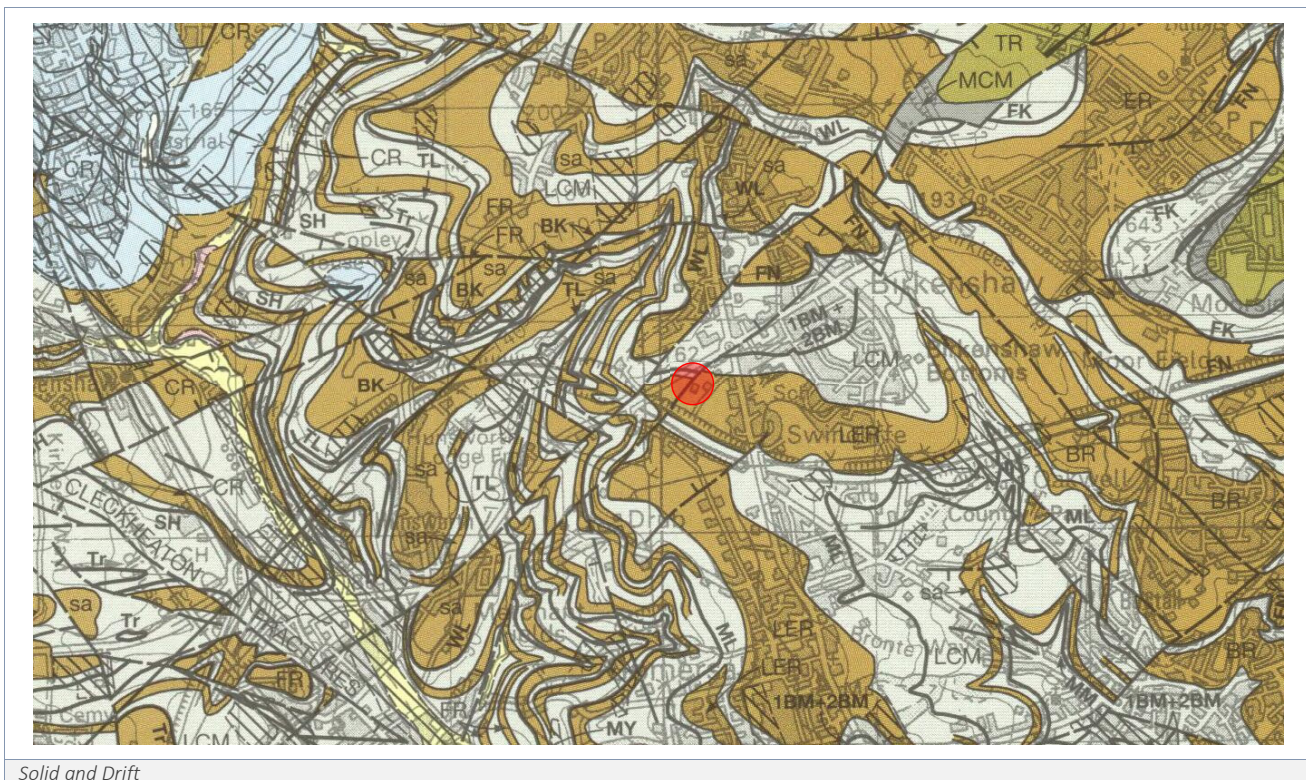
CA information indicated that the Blocking Coal is the shallowest worked coal seam at circa 91m begl followed by the Shirtcliffe Coal at circa 130m begl.

A summary of the identified coal seams is provided below.

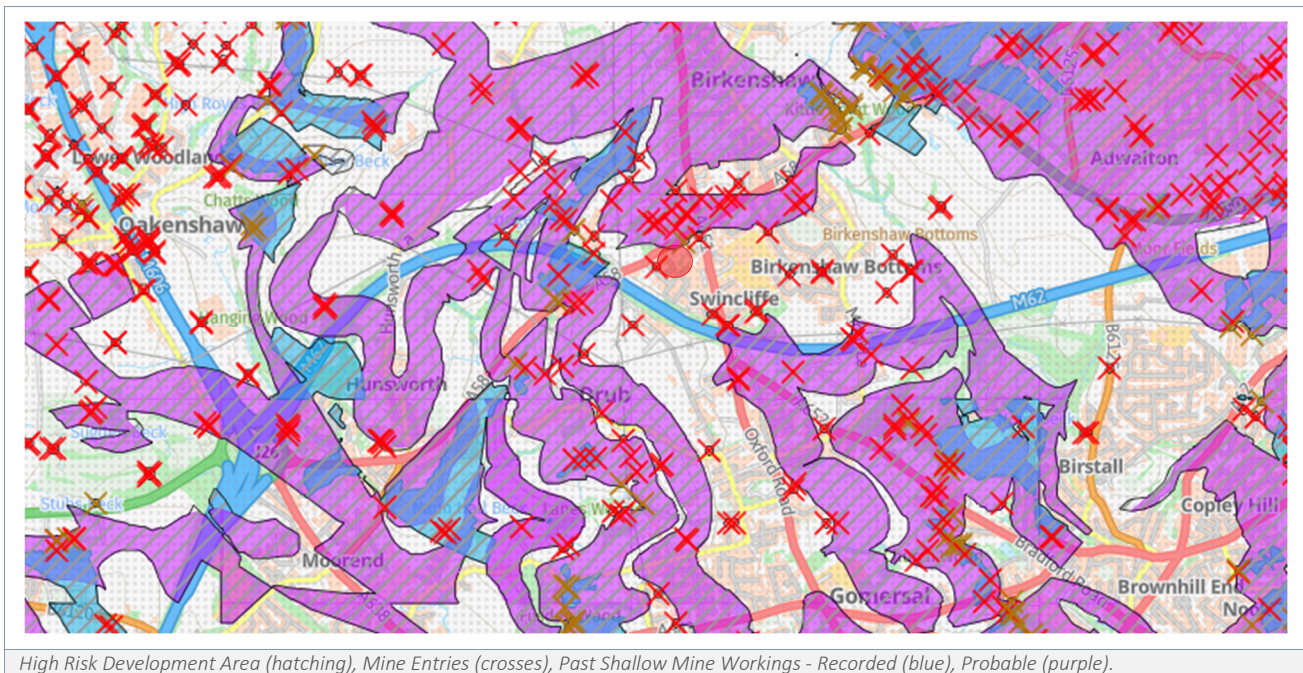
The following information has been obtained from the online Interactive Coal Authority Map:

- *There are no mine shafts within 20m of the site, nearest is an adit located circa 35m east*
- *No fissures or break lines are shown to be affecting the site*
- *There is a coal seam outcrop in the Northern Parcel of the site*
- *There are no known past workings recorded beneath the site*
- *The site is not indicated to lie in an area of probable past shallow mine workings*
- *The site is not located within 1km of a surface mining area*
- *The site does not lie within a Development High Risk Area*
