**Remediation and Verification Strategy for Ground Gases**

**FORMER GREENSIDE MILLS  
SKELMANTHORPE**

**Lovell Partnerships Limited**

Report Number 4494

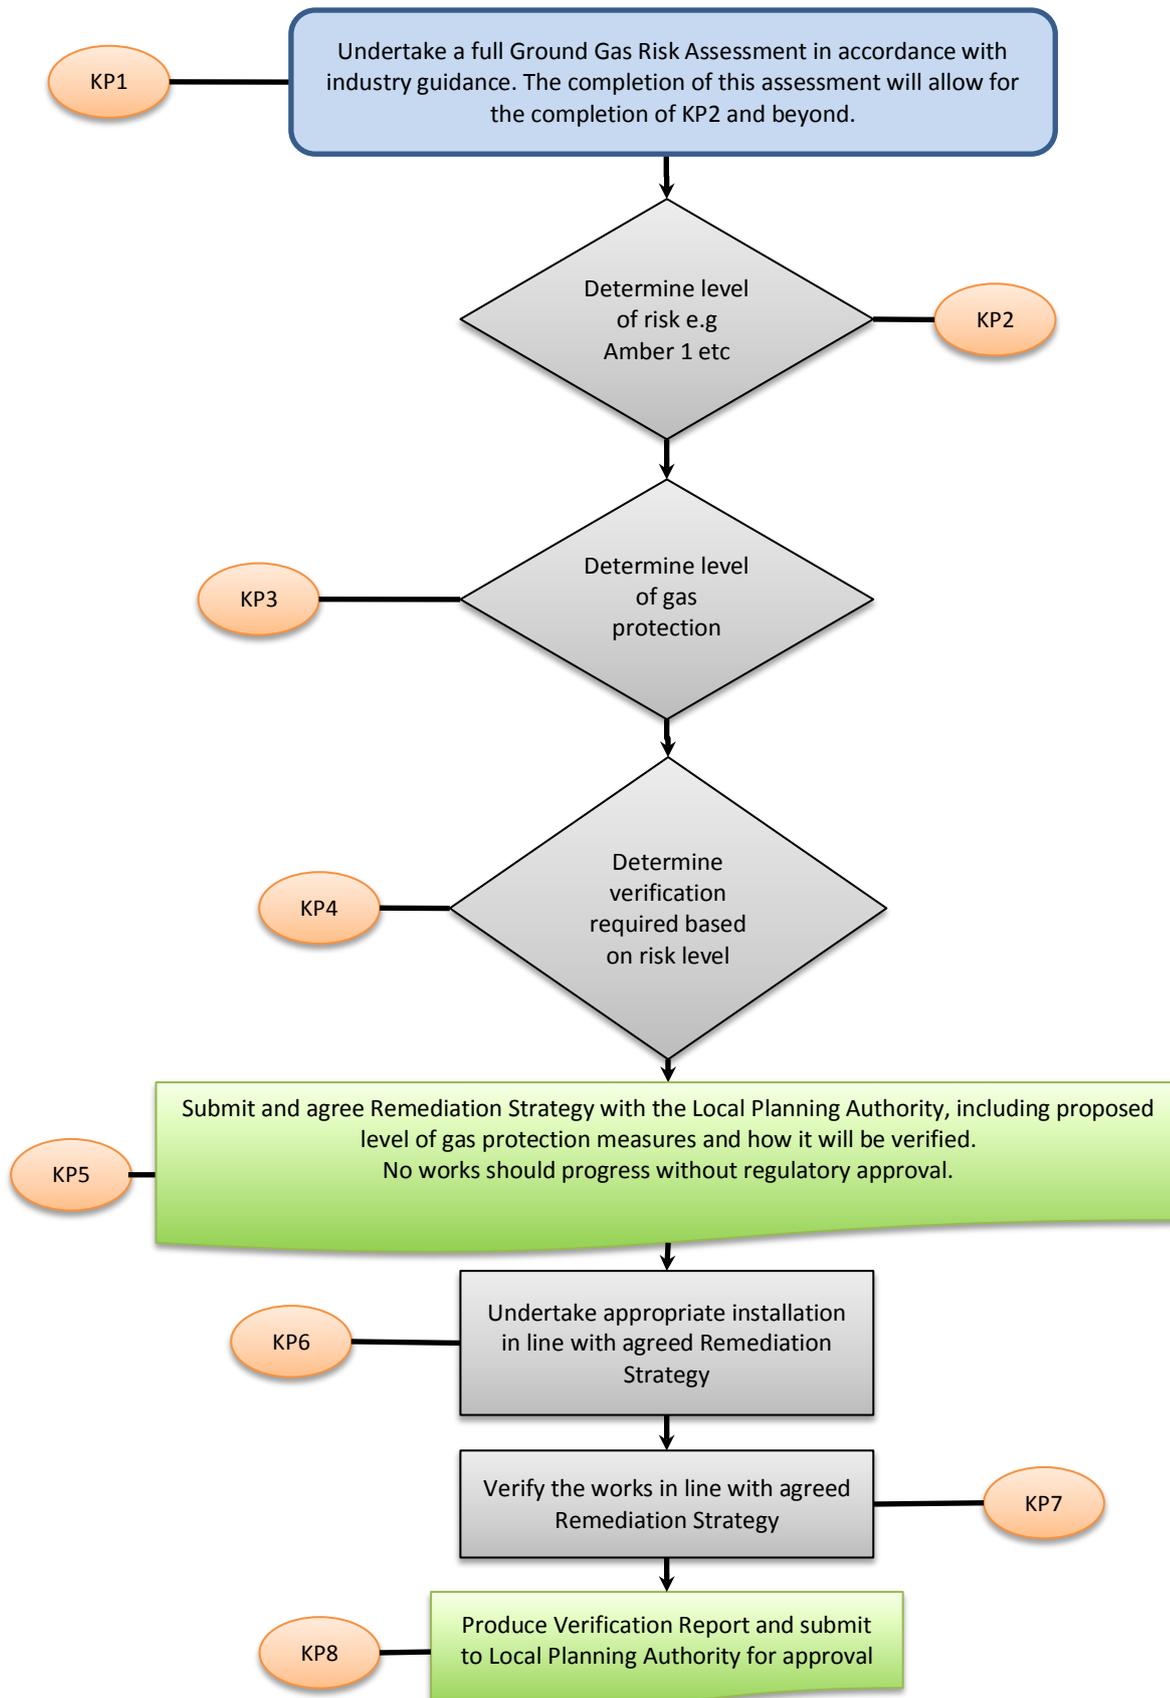
# Overview Flowchart

<p>KP1</p> <p>Ground Gas Risk Assessment</p>	<p>Undertake an appropriate gas risk assessment for the site in accordance with industry guidance*. On completion of the risk assessment and the generation of the appropriate Gas Screening Value (where required) and on a full understanding of the gas regime/ CSM, move to KP2 to determine the level of risk for the site.</p> <p><i>*Where the desk study has identified the need for gas monitoring to be carried out it would always be <b>expected</b> that site specific gas monitoring data would be used in the gas risk assessment.</i></p>
<p>KP2</p> <p>Level of Risk</p>	<p>The level of gas risk needs to be determined by using the appropriate gas guidance document/s relative to the development (e.g. low rise housing, residential apartment blocks with areas of public open space, commercial or public buildings etc).</p> <p>For example Amber 1 (Low rise housing) equates to Low Risk in Table A1 CIRIA 735.</p> <p>Once the level of risk has been determined move to KP3 and determine the appropriate level of gas protection.</p>

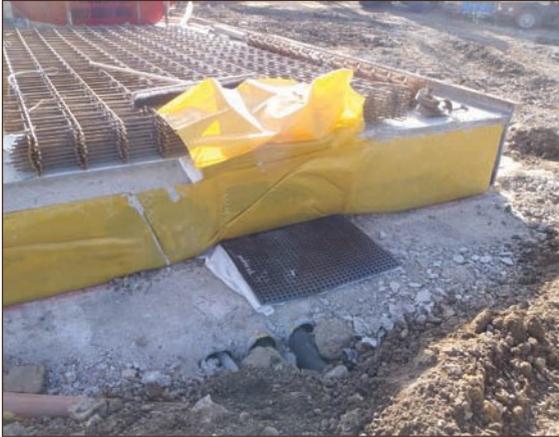
**Figure A4.7** Geovent protruding out of the frontage of the unit. Gas membrane along the sides of the slab preventing lateral gas ingress (courtesy Alderburgh Group)

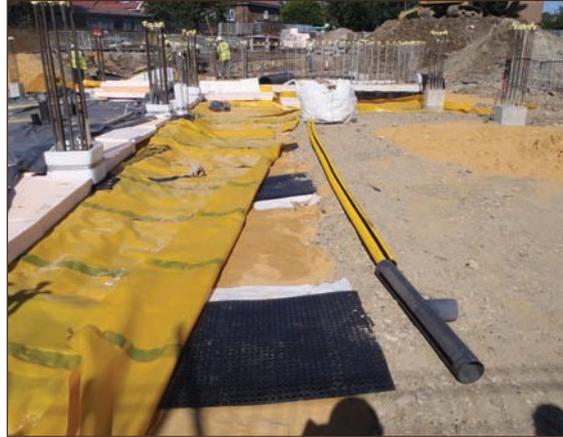
**Figure A4.8** Geovent beneath the 2000g taped gas membrane lined up with collector pipes (courtesy Alderburgh Group)

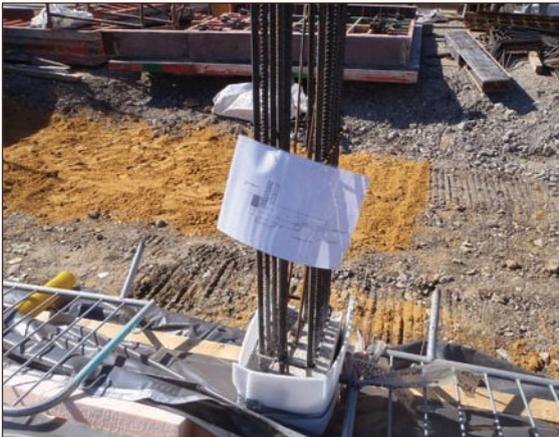
**Figure A4.9** On site schematics to aid construction workers build the gas protection system (courtesy Alderburgh Group)

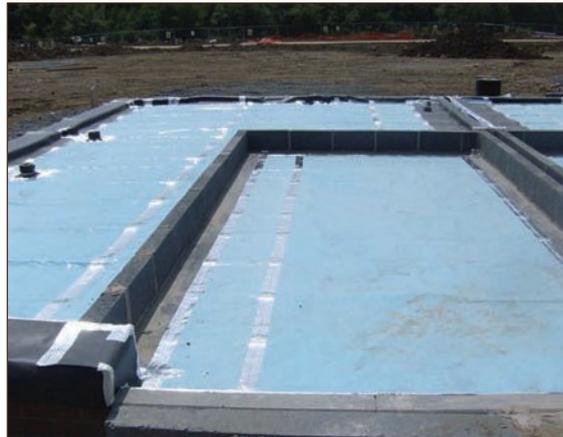
**Figure A4.10** Almost complete coverage available for inspection, minimal jointing, service entries suitable distance from walls, light traffic (courtesy Smith Grant)

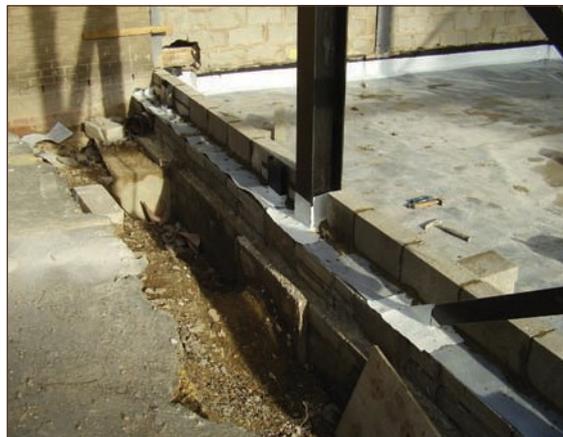
**Figure A4.12** Good edge detail across cavity (courtesy PAGEotechnical Ltd)

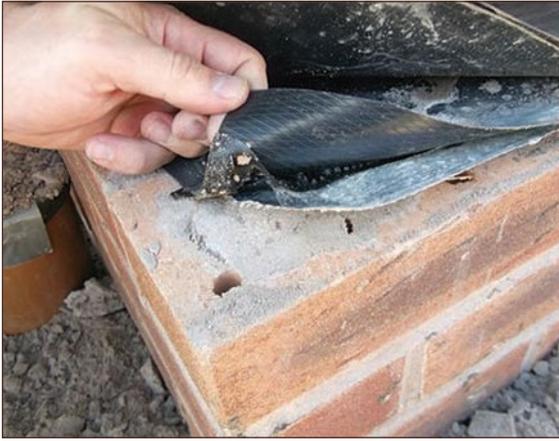
**Figure A4.13** Gas proof DPC adhered on top of gas membrane using butyl strips across cavity space (courtesy NHBC)

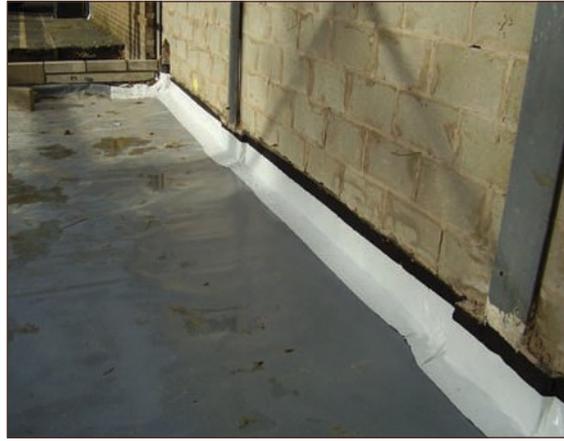
**Figure A4.14** Good perimeter seal (courtesy PAGEotechnical Ltd)

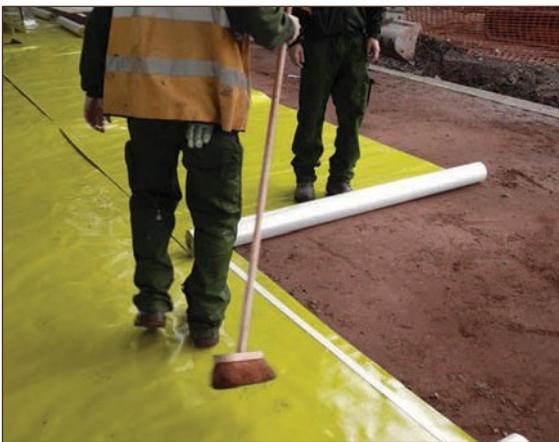
**Figure A4.15** LDPE type gas membrane overlap and double sided tape. Sand blinding to protect underside of gas membrane (courtesy A Proctor Group)

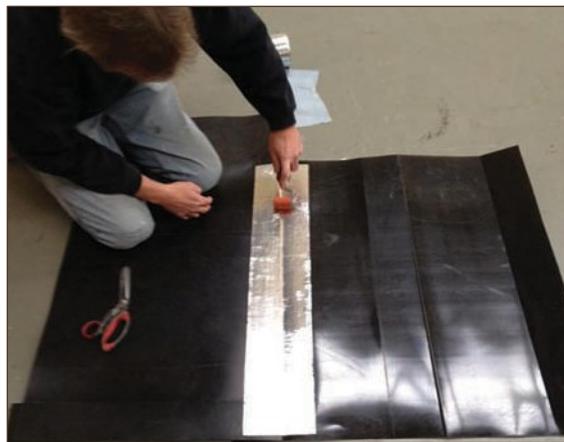
**Figure A4.16** Example HDPE type gas membrane and steam roller used to ensure self-adhesive tape is correctly installed (courtesy A Proctor Group)

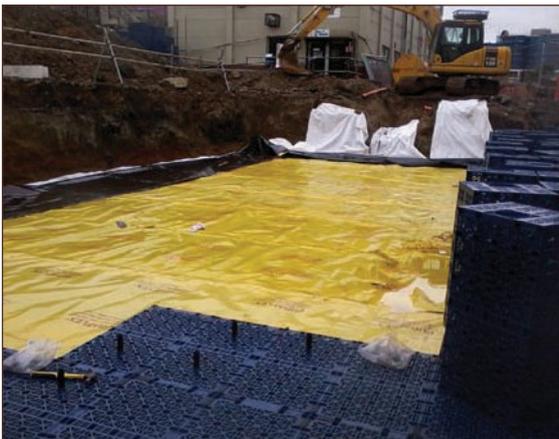
**Figure A4.17** Gas membrane installed in attenuation tank (courtesy Industrial Textiles & Plastics Ltd)

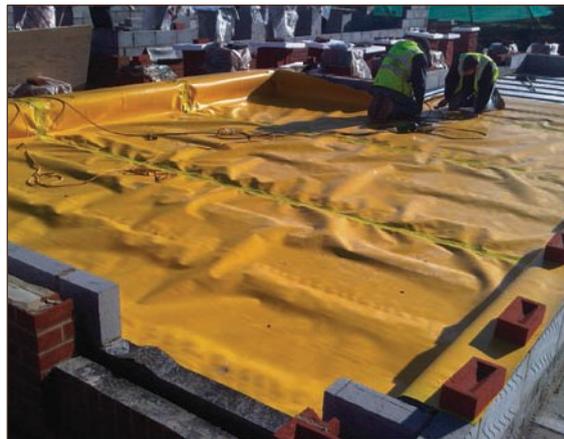
**Figure A4.18** Gas membrane installed as part of foundation barrier (courtesy Industrial Textiles & Plastics Ltd)

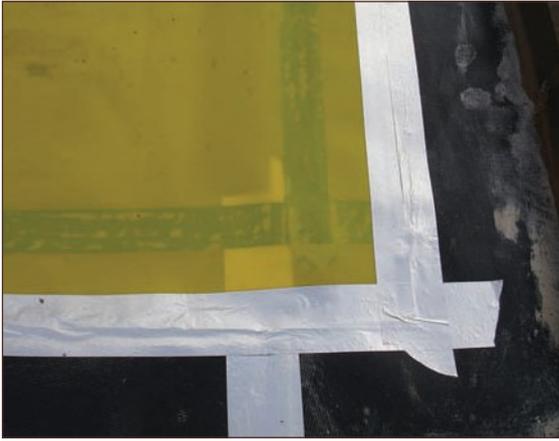
**Figure A4.19** Well-constructed joints with gas resistant DPC, lap and double sided butyl joints visible beneath semi-transparent gas membrane, secondary seal with proprietary single sided tape (courtesy Smith Grant)

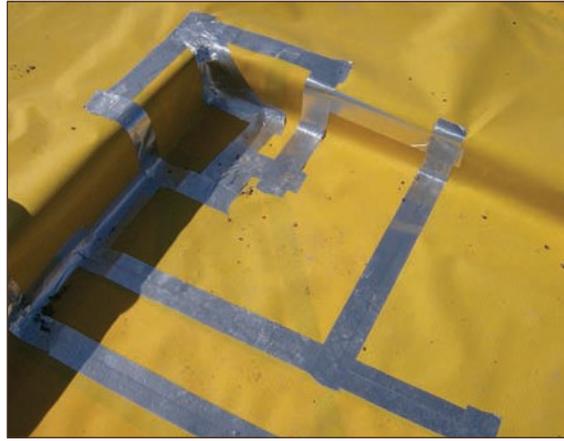
**Figure A4.20** A pre-formed corner unit would have been preferable as fewer joints would have been formed, however the installer has achieved a good level of workmanship in this corner detail (courtesy Smith Grant)

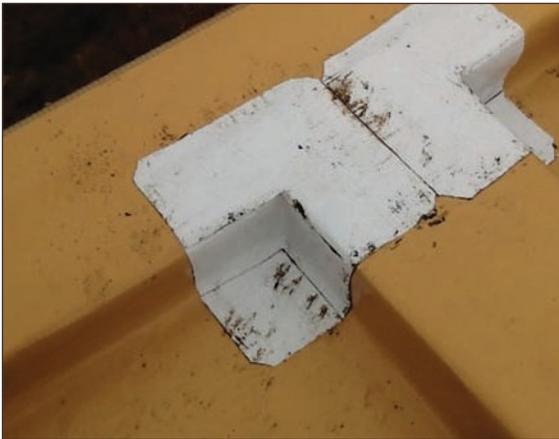
**Figure A4.21** Good prefabricated corner detail (courtesy MEC Environmental Ltd)

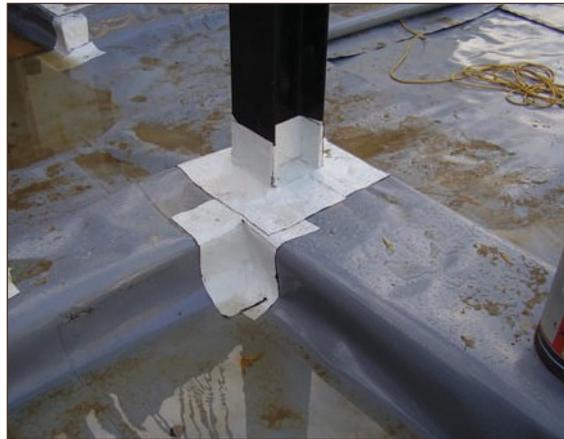
**Figure A4.22** Good detail around stanchion and corner (courtesy PAGEotechnical Ltd)

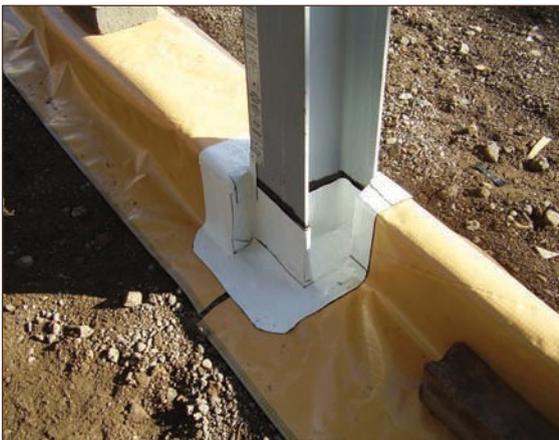
**Figure A4.23** Complex column seal (courtesy PAGEotechnical Ltd)

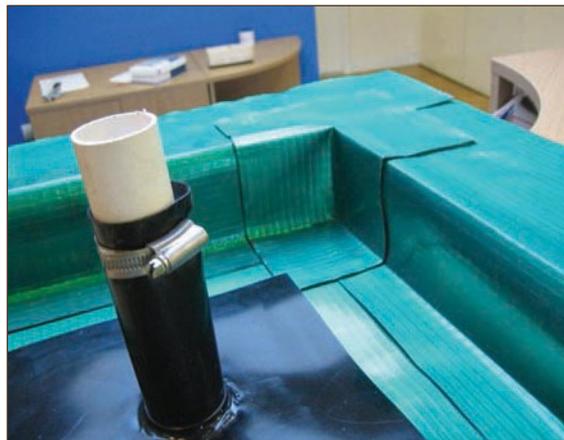
**Figure A4.24** Prefabricated corner detail and top hat (courtesy A Proctor Group)

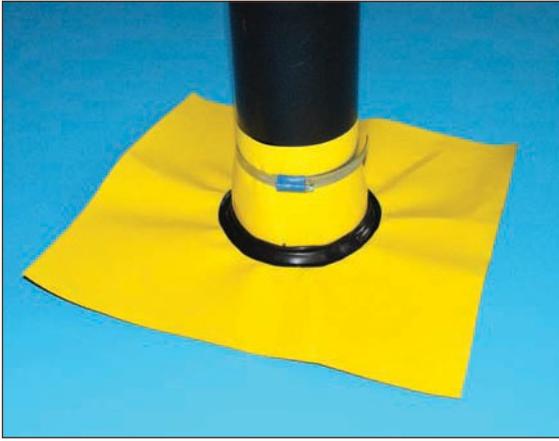
Figure A4.25 Top hat around service entry (courtesy Industrial Textiles & Plastics Ltd)

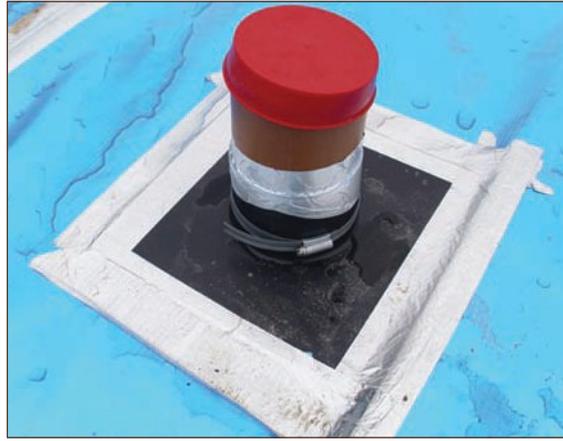
Figure A4.26 Well-constructed service entry: top hat fits well with service pipe and taped down to gas membrane, secondary seal with proprietary single sided tape (courtesy Smith Grant)

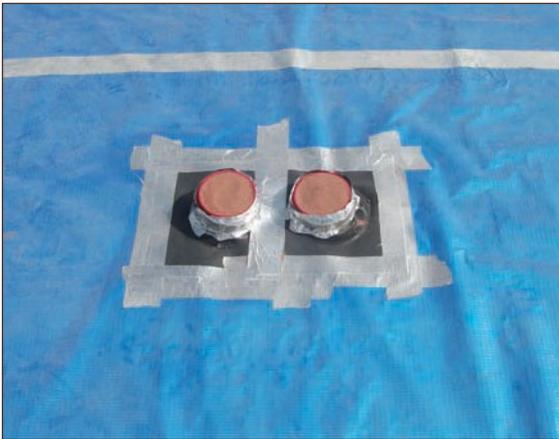
Figure A4.27 Top hats placed around service entries secured with jubilee clip seals. Top hats secured to gas membrane with double sided butyl tape (courtesy Hydrock)

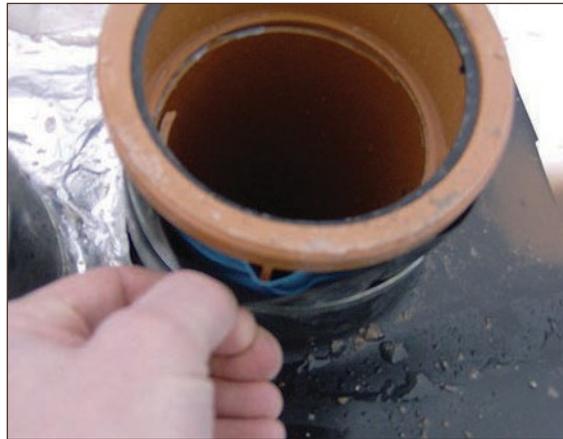
Figure A4.28 Bead of double sided butyl tape provided between interfaces of ID top hat and OD service pipe. When compressed with jubilee clip, forms an effective seal (courtesy Smith Grant)

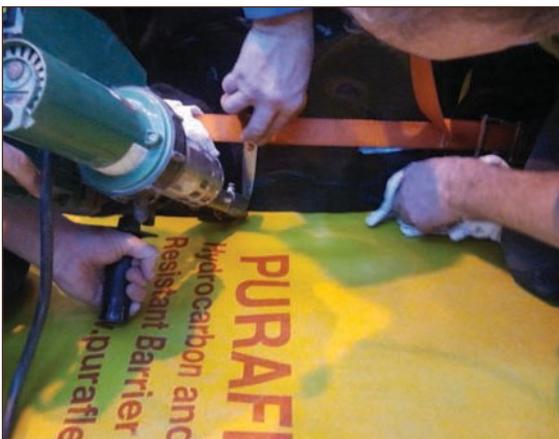
Figure A4.29 Extrusion welding technique (courtesy Industrial Textiles & Plastics Ltd)

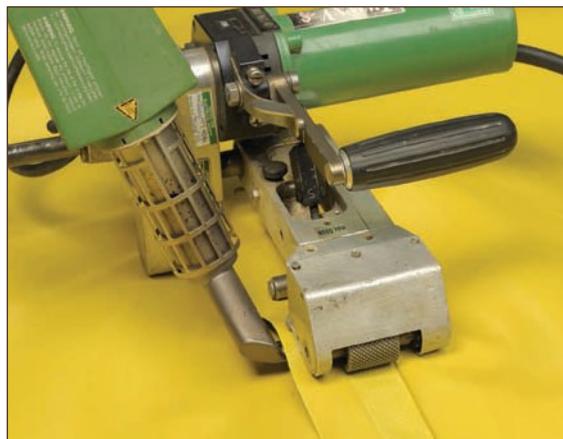
Figure A4.30 Thermal welding technique (courtesy Industrial Textiles & Plastics Ltd)

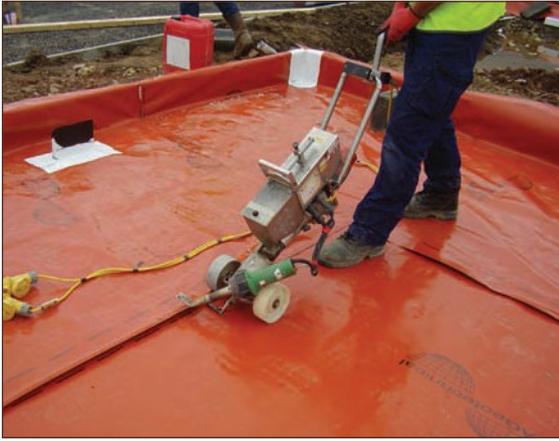
**Figure A4.31** *Extrusion welding (courtesy PAGeotechnical Ltd)*

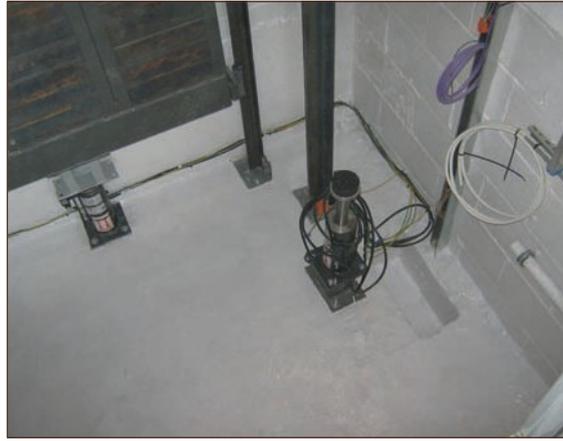
**Figure A4.32** *High quality installation of liquid gas membrane to lift pits, including resin gas protection on all screw penetrations (courtesy Card Geotechnics Limited)*

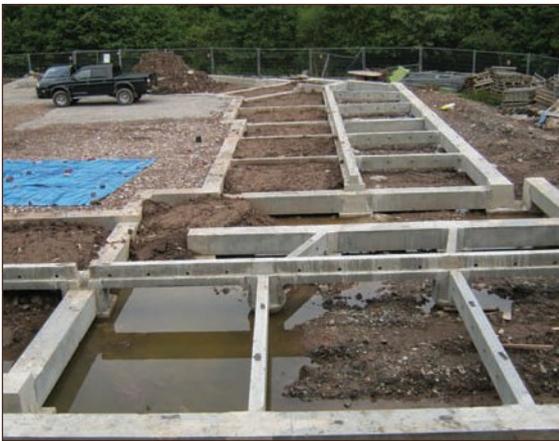
**Figure A4.33** *Good ventilation in internal sleeper walls, cast into prefabricated beams (courtesy Smith Grant)*

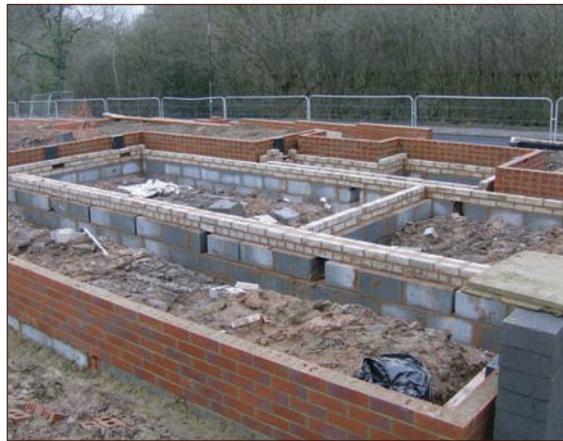
**Figure A4.34** *Open void >300mm deep, good ventilation through internal sleeper walls (courtesy Smith Grant)*

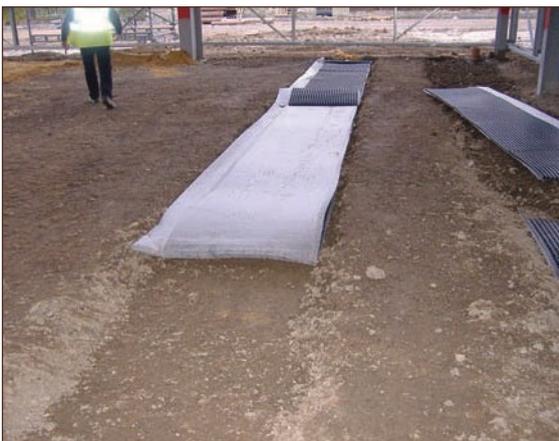
**Figure A4.35** *Good installation of passive gas venting trenches and 'egg-crate' (courtesy Card Geotechnics Limited)*

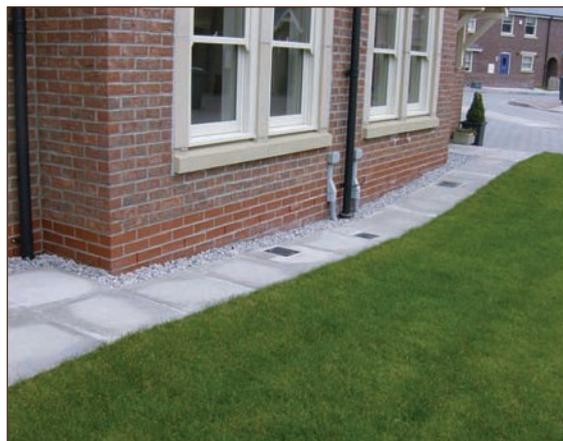
**Figure A4.36** *Raised air bricks are preferable due to the reduced potential for blockage but the vent trench specified is provided with clean single sized stone (courtesy Smith Grant)*

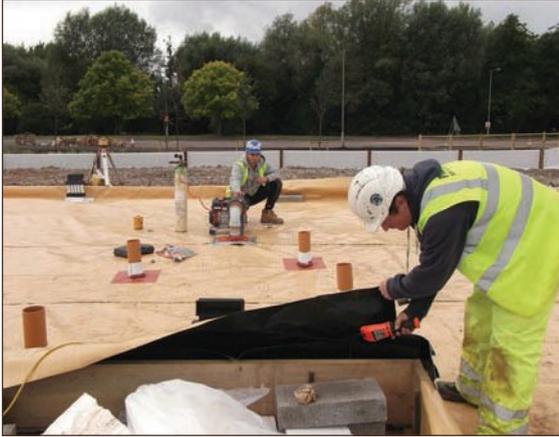
Figure A4.37 Tracer gas testing, whereby gas or smoke is applied under pressure beneath the installed gas membrane and detectors are used to screen for leaks above (courtesy NHBC)

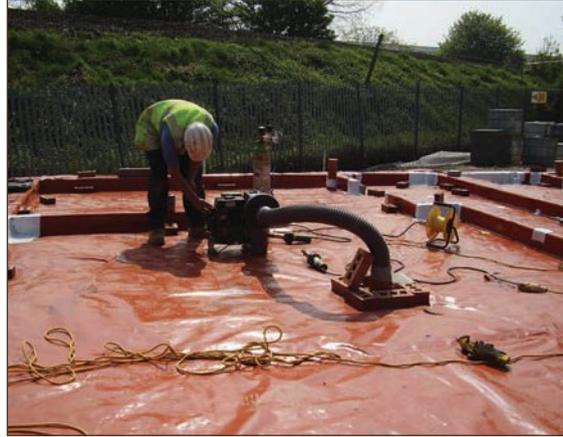
Figure A4.38 Tracer gas testing (courtesy PAGEotechnical Ltd)

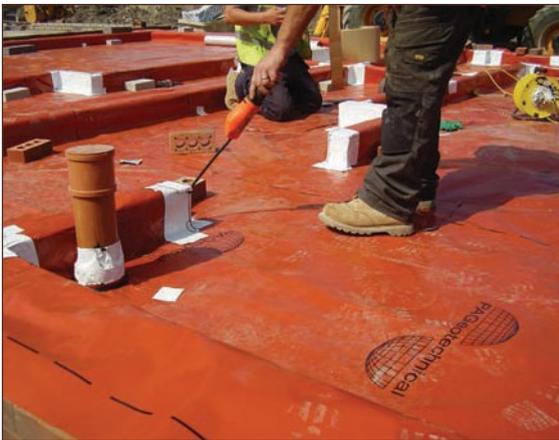
Figure A4.39 Scanning for leaks (courtesy PAGEotechnical Ltd)

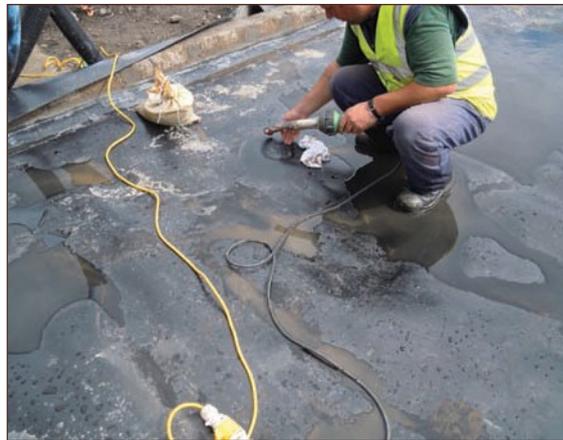
Figure A4.40 CO<sub>2</sub> injection integrity testing (courtesy Landline Ltd)

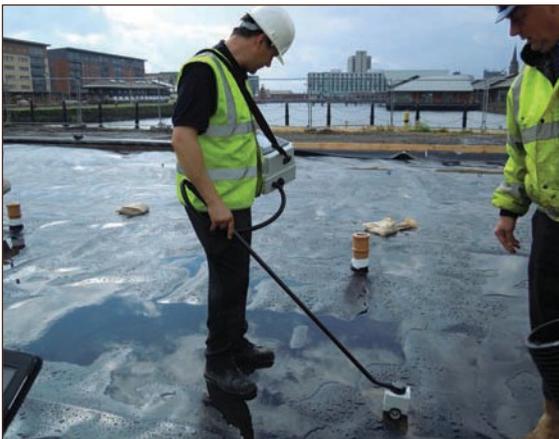
Figure A4.41 Small sand bags are marking holes made in the gas membrane used to check whether injected CO<sub>2</sub> has worked its way beneath whole area (courtesy Landline Ltd)

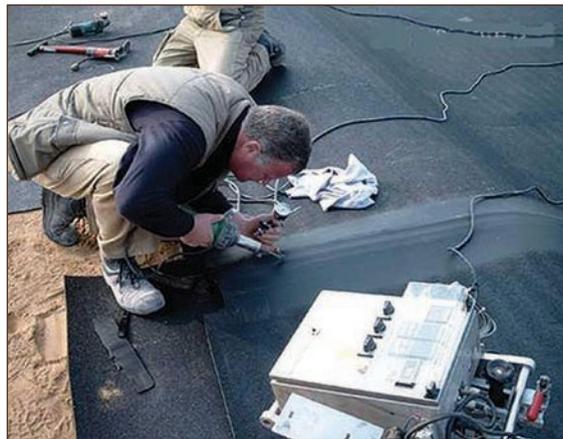
Figure A4.42 Air pressure testing (courtesy GSE Environmental)

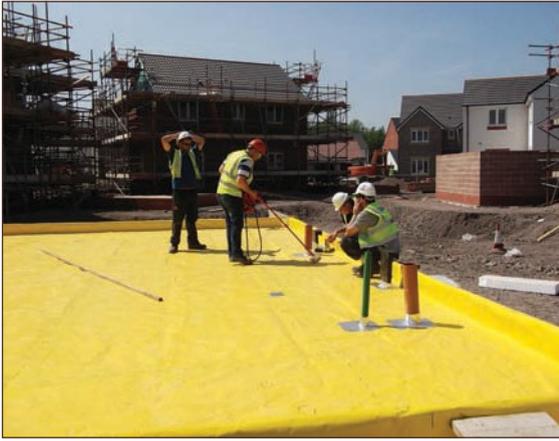
Figure A4.43 Dielectric porosity testing for housing scheme (courtesy NHBC)

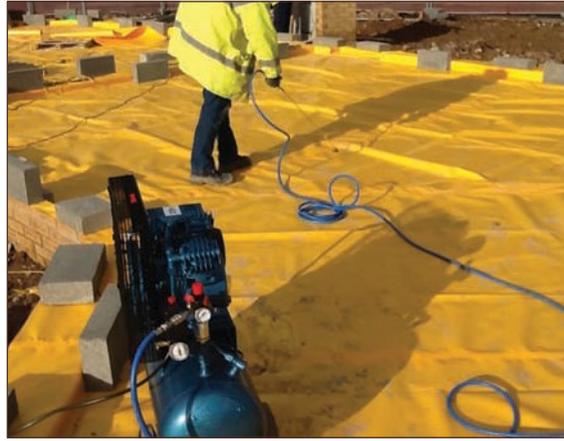
Figure A4.44 Air lance test, used to test the quality of welded seams along gas membrane joints (courtesy MEC Environmental Ltd)

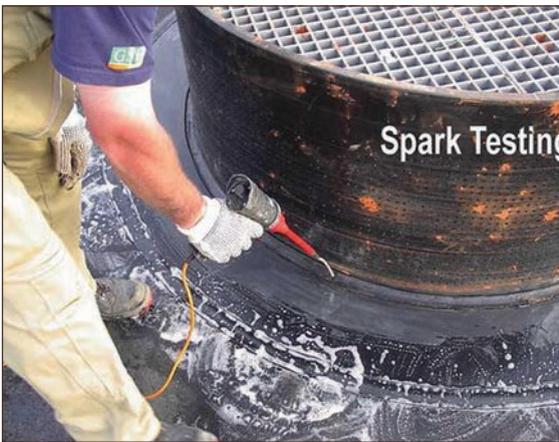
Figure A4.45 Spark testing (courtesy GSE Environmental)

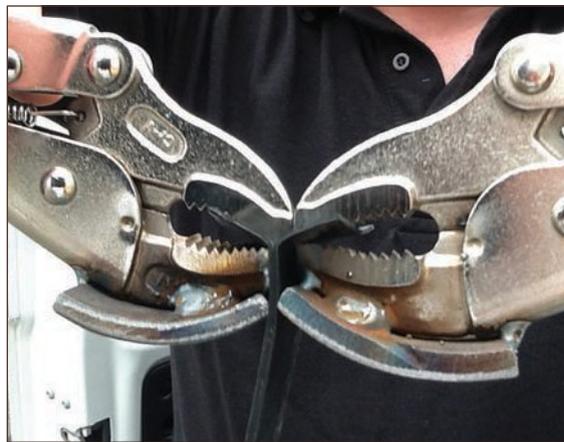
Figure A4.46 Testing a weld with 'dog bone' grips (courtesy MEC Environmental Ltd)

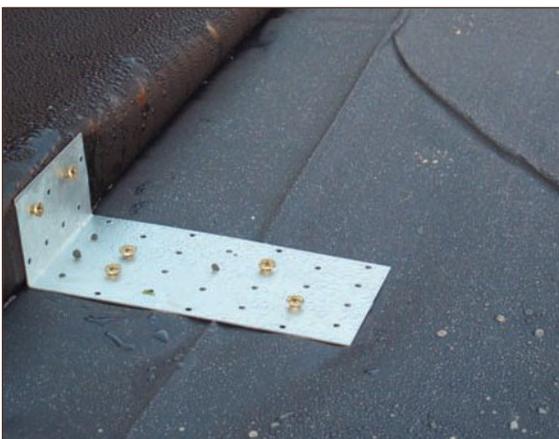
Figure A4.47 Follow-on works purposefully penetrating gas membrane (courtesy Card Geotechnics Limited)

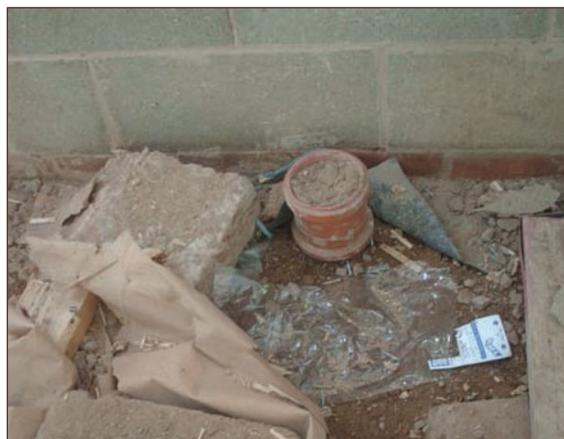
Figure A4.48 Loose nails and over construction debris likely to be left in place beneath gas membrane – poor preparation of gas membrane prior to sealing service penetration (courtesy Card Geotechnics Limited)

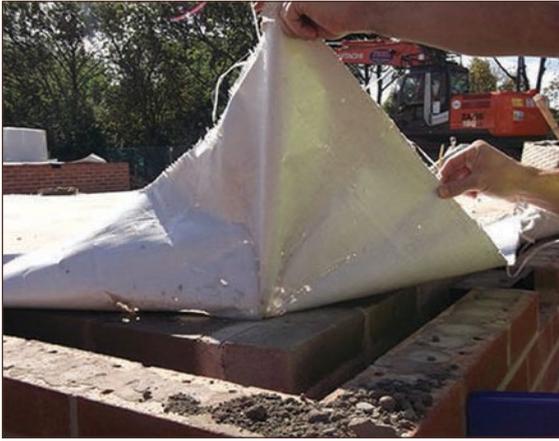
**Figure A4.49** *Lifted gas membrane at corner position. Light penetrating through confirms damage to aluminium internal core layer (courtesy NHBC)*

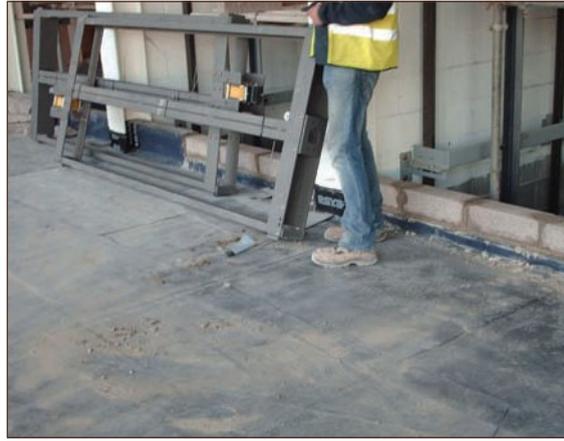
**Figure A4.50** *Large/heavy/sharp objects being moved over unprotected gas membrane (courtesy Card Geotechnics Limited)*

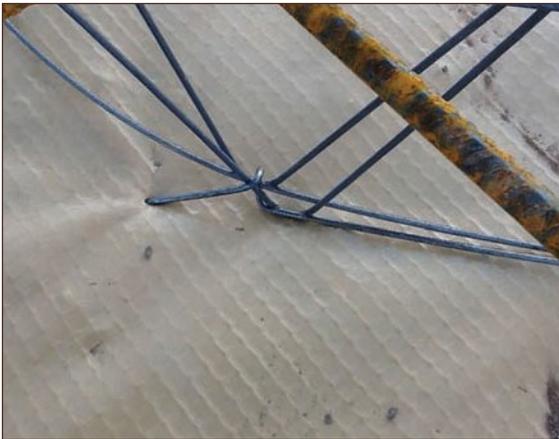
**Figure A4.51** *Gas membrane torn by reinforcement (courtesy MEC Environmental Ltd)*

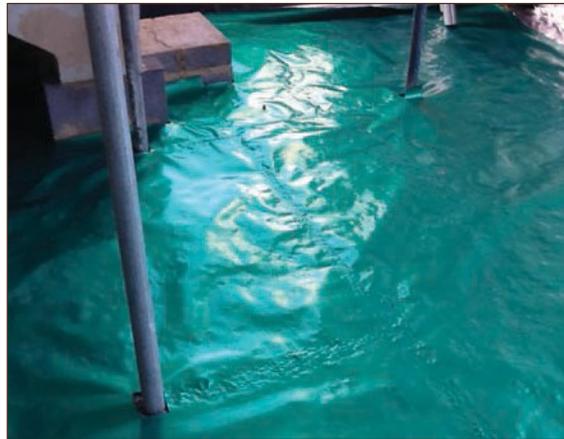
**Figure A4.52** *Gas membrane cut by scaffolders and bricklayers after installation (courtesy MEC Environmental Ltd)*

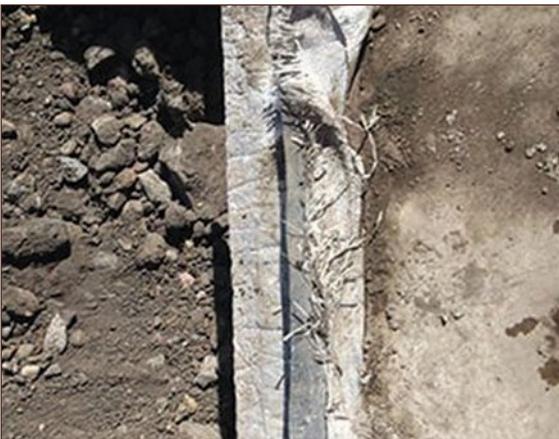
**Figure A4.53** *Gas membrane left exposed for long period of time, shows significant fraying at cavity edge (courtesy NHBC)*

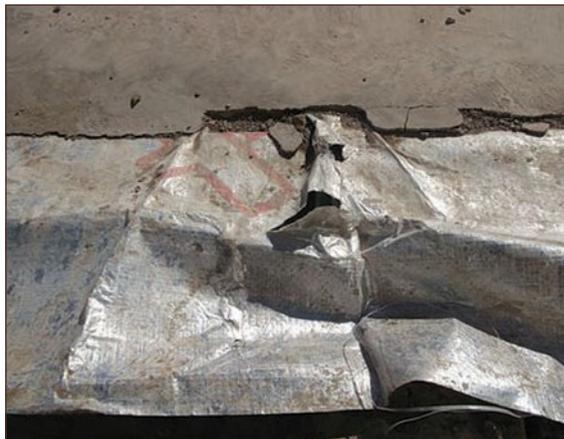
**Figure A4.54** *Gas membrane damage/tearing at edge of ground floor slab screed layer where it was left exposed to elements for period of time (courtesy NHBC)*

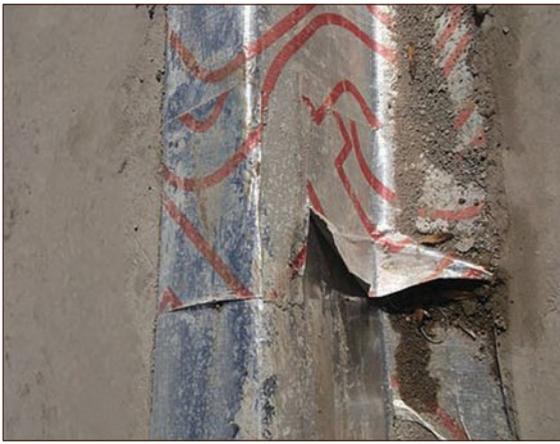
**Figure A4.55** Gas membrane at stepped junction of slab to integral garage, appears to be susceptible to tearing when screed is poured. Screed may also weigh down on gas membrane if fitted too tight (courtesy NHBC)

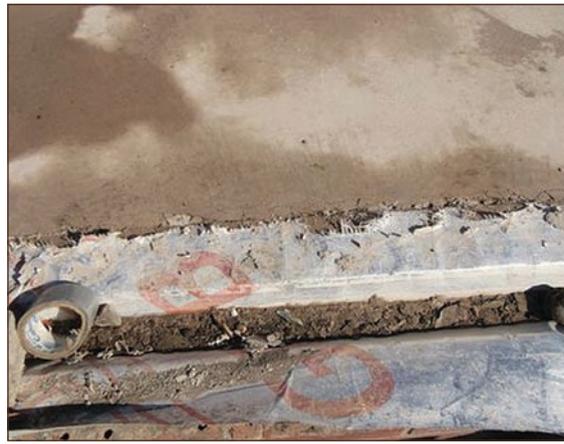
**Figure A4.56** Gas membrane at edge of concrete screed. Screed has been grinded to achieve desired levels, gas membrane shows extreme wear and damage as a result (courtesy NHBC)

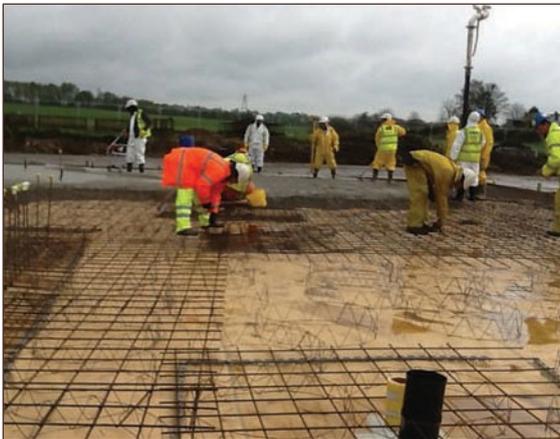
**Figure A4.57** Unprotected gas membrane damaged by heavy traffic (courtesy MEC Environmental Ltd)

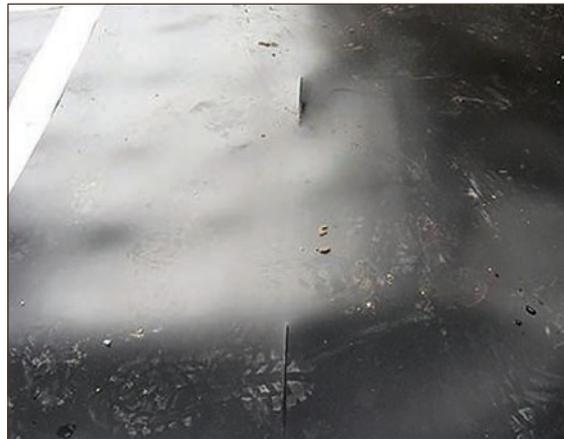
**Figure A4.58** Damage caused to gas membrane by follow-on trade who cut/shaped the dry lining board directly on the unprotected installed gas membrane (courtesy NHBC)

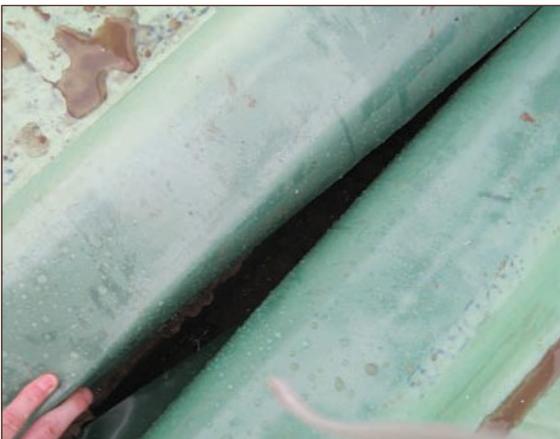
**Figure A4.59** Gas membrane slit at the bottom of a cavity tray to enable water to drain away (courtesy Smith Grant)

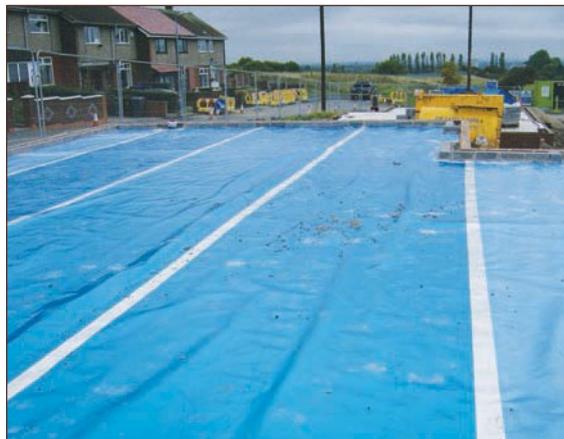
**Figure A4.60** Some stones could penetrate gas membrane if sufficient force is applied (courtesy Smith Grant)

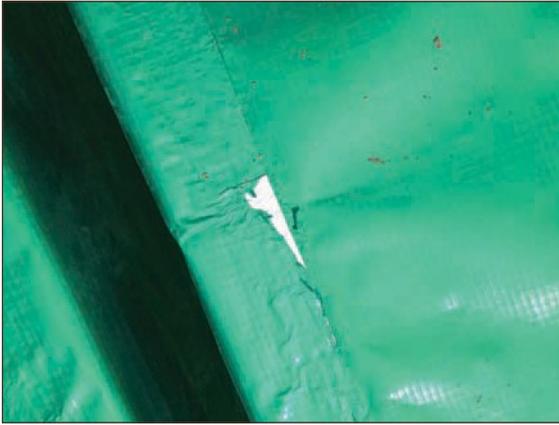
**Figure A4.61** 'Stripping' occurs on gas membranes that contain aluminium foil. The foil gets too hot under the outer layer of LDPE or PP and the top layer of the gas membrane sticks to the roller which strips it off, leaving the aluminium completely exposed (courtesy MEC Environmental Ltd)

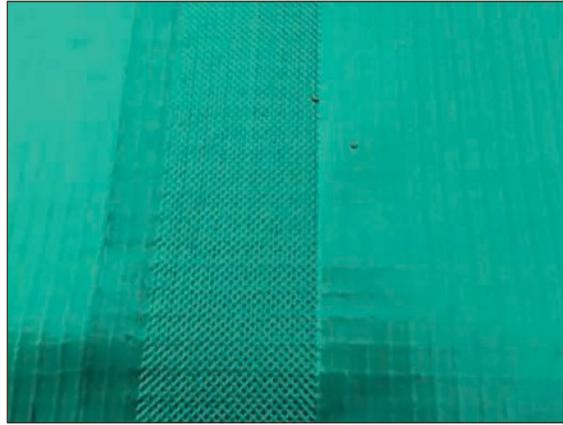
**Figure A4.62** Wedge weld on an LDPE aluminium gas membrane, where the installer used metal nip rollers. This destroyed the top layer and probably the bottom layer, leaving aluminium exposed between the weaves. This failed dielectric testing along all joints (courtesy MEC Environmental Ltd)

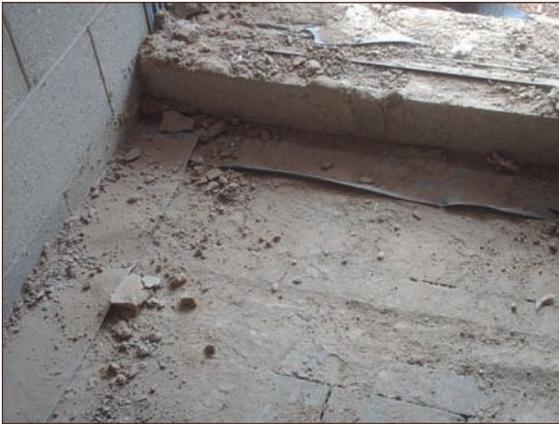
**Figure A4.63** Absence of surface preparation prior to laying of gas membrane, debris likely to pierce gas membrane (courtesy Card Geotechnics Limited)

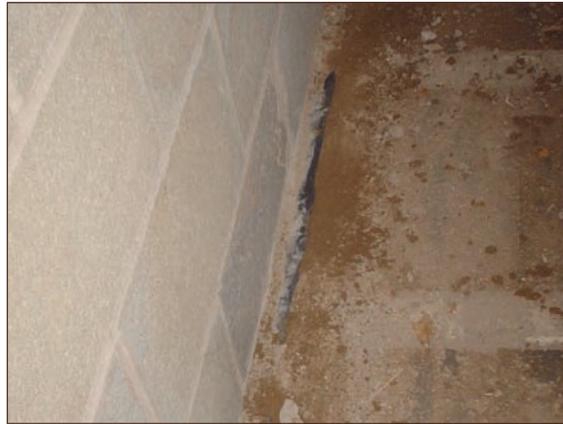
**Figure A4.64** Insufficient length of gas membrane protruding through wall to overlap with gas membrane within building (courtesy Card Geotechnics Limited)

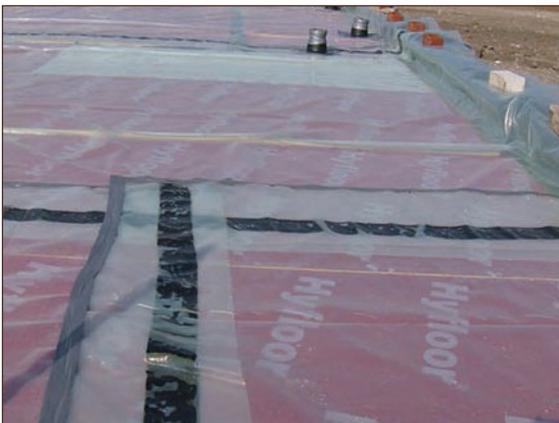
**Figure A4.65** Wrinkling of gas membrane over joint has resulted in gaps (only visible due to the use of a transparent gas membrane) and the secondary seal uses ordinary gaffer tape rather than a proprietary product (courtesy Smith Grant)

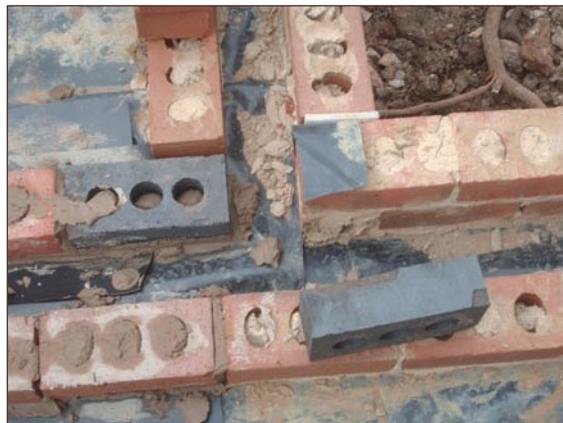
**Figure A4.66** Follow-on trades proceeded work before gas membrane joints sealed (courtesy Card Geotechnics Limited)

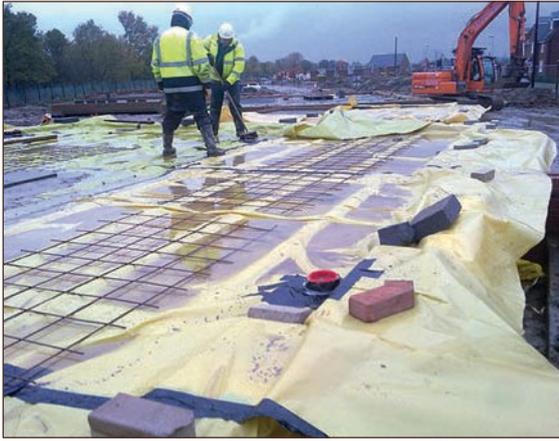
**Figure A4.67** Traffic over mesh resulted in several punctures, in addition most joints were found to be poorly constructed. Taped joints are difficult to construct in adverse weather (courtesy Smith Grant)

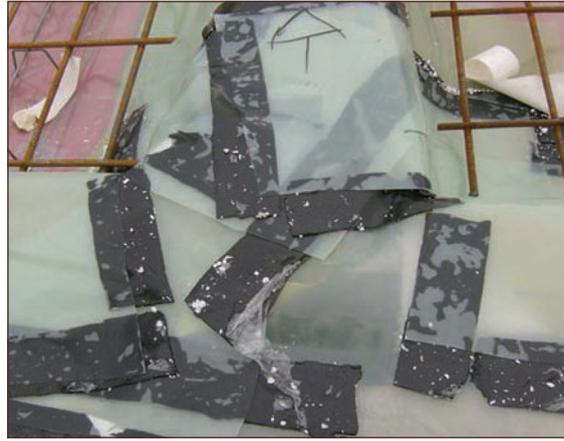
**Figure A4.68** A pre-formed corner unit would have been preferable. The installer could not produce sufficient quality despite the amount of tape applied (courtesy Smith Grant)

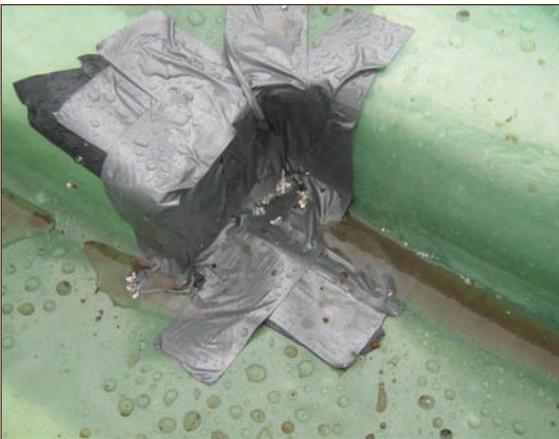
**Figure A4.69** Attempt at corner detailing using non-proprietary duct tape (courtesy Smith Grant)

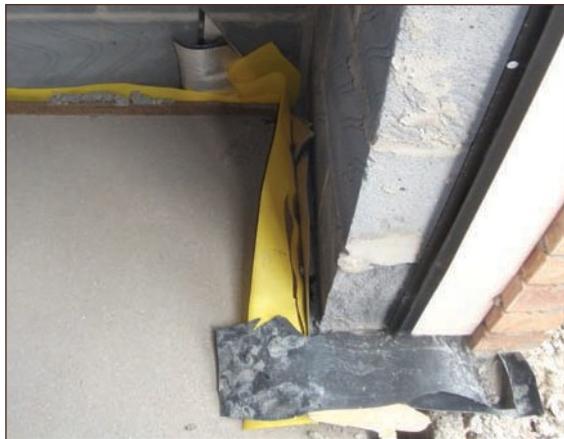
**Figure A4.70** Inadequate corner detailing. The use of preformed proprietary products would have avoided such bad practice (courtesy NHBC)

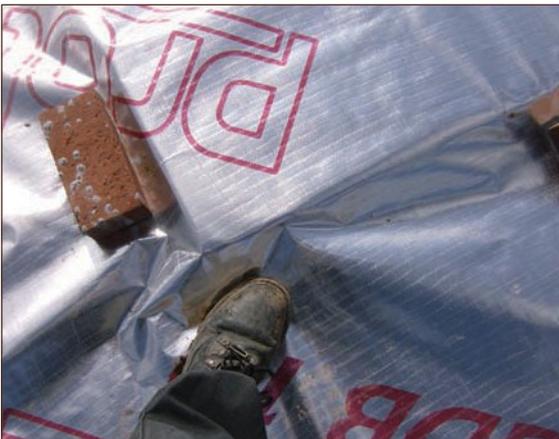
**Figure A4.71** No corner detailing leading to stress point on gas membrane (courtesy Smith Grant)

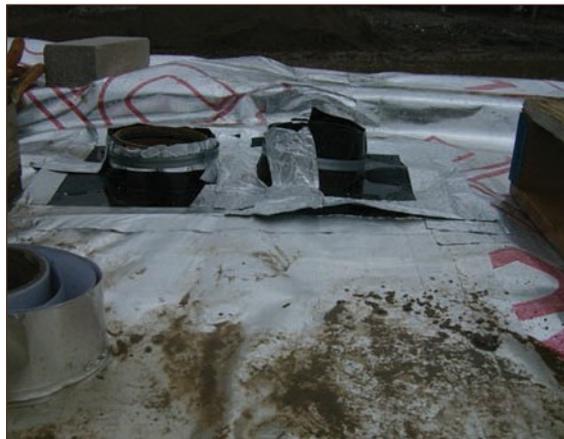
**Figure A4.72** Joint between top hat and gas membrane has lifted due to poor fit and attempt to construct in very wet conditions (courtesy Smith Grant)

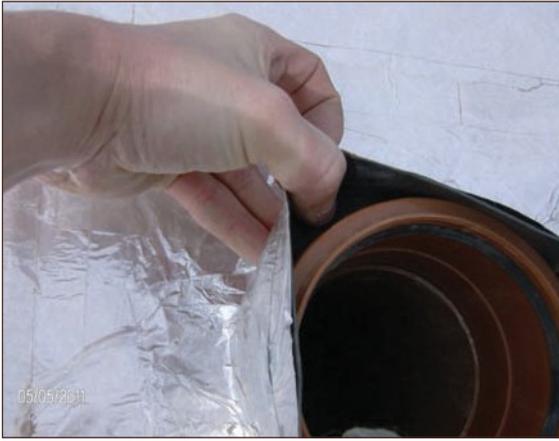
**Figure A4.73** No bead of double sided butyl tape provided between interfaces of ID top hat and OD service pipe: cannot be compressed enough to form seal (courtesy Smith Grant)

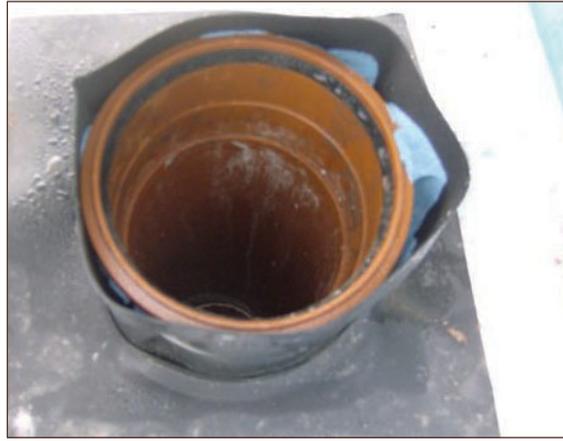
**Figure A4.74** Gap between OD of service pipe and ID of top hat too large: cannot be compressed enough to form seal, even with the application of additional tape (courtesy Smith Grant)

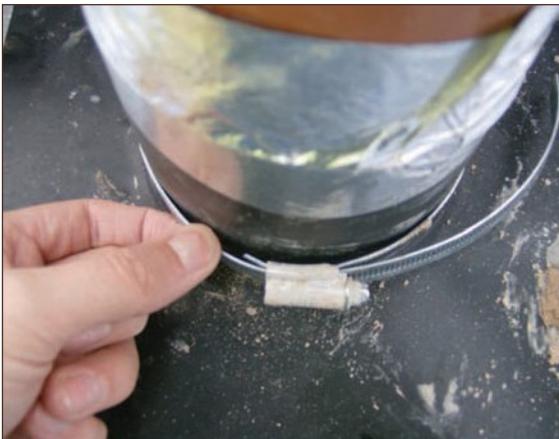
**Figure A4.75** Jubilee clip on service entry insufficiently tightened so joint is uncompressed (courtesy Smith Grant)

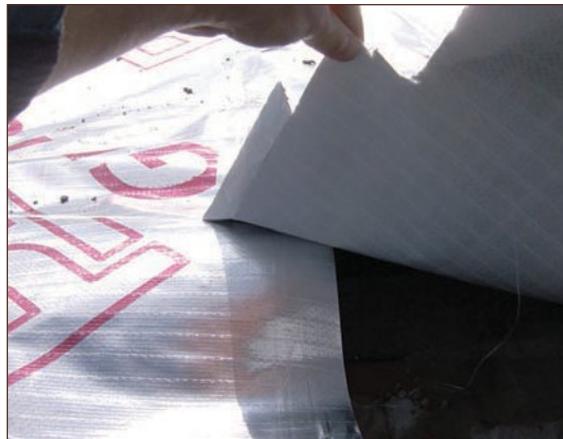
**Figure A4.76** No double sided tape used in joints (courtesy Smith Grant)

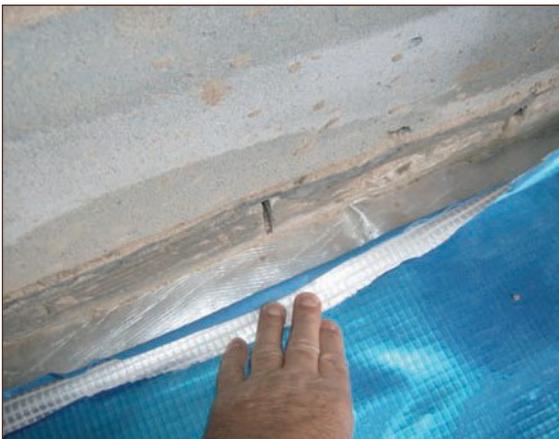
**Figure A4.77** Small lap and no single sided tape used to achieve secondary seal (courtesy Smith Grant)

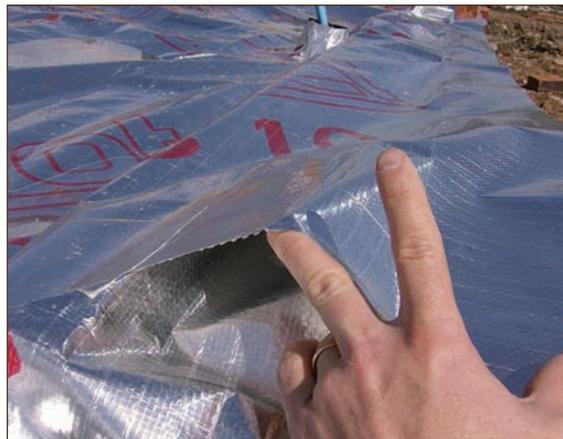
**Figure A4.78** Gap in jointing over wall cavity big enough to insert fist (courtesy Smith Grant)

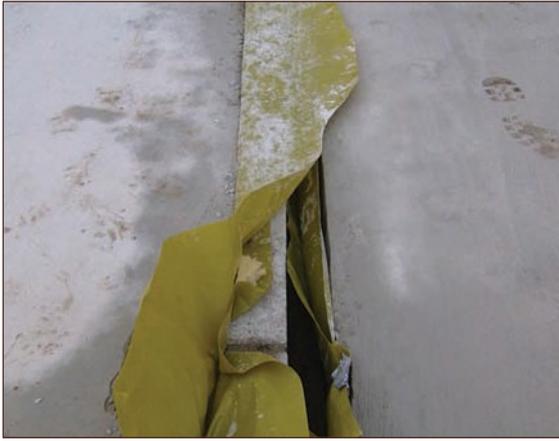
**Figure A4.79** Gas membrane not continuous over internal wall. It had been deliberately cut open for unknown purpose (courtesy Smith Grant)

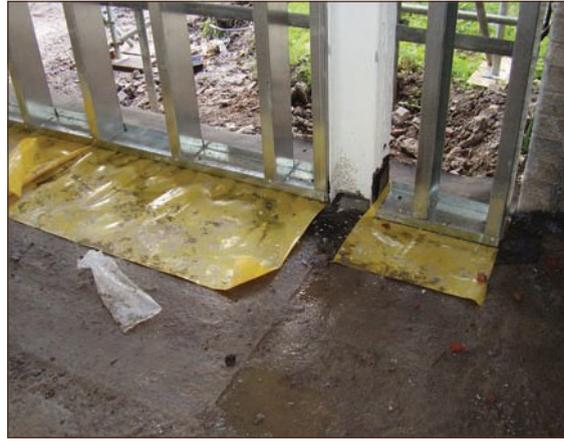
**Figure A4.80** Column left unsealed (courtesy PAGEotechnical Ltd)
