**Remediation and Verification Strategy for Ground Gases**

**FORMER GREENSIDE MILLS  
SKELMANTHORPE**

**Lovell Partnerships Limited**

Report Number 4494

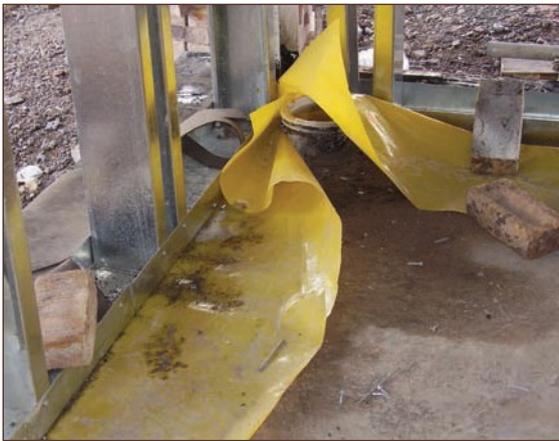
**Figure A4.81** No seal to perimeter pipe (courtesy PAGEotechnical Ltd)

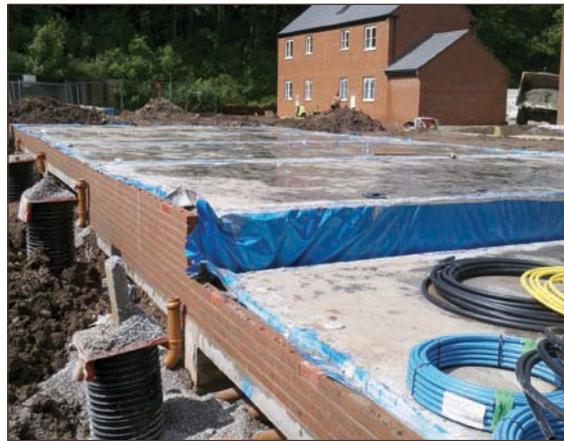
**Figure A4.82** Gas membrane used to bridge cavity wall instead of DPC, leaving it exposed to damage by follow-on trades (courtesy Smith Grant)

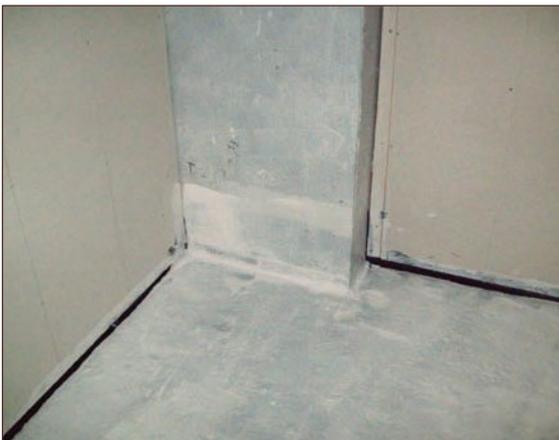
**Figure A4.83** Poor quality installation of liquid gas membrane. Liquid gas membranes come in two colours (black and white) allowing coverage of each coat to be easily assessed. Here the gas membrane has been spread too thinly and inconsistently. In addition, it appears to have been applied to a damp surface, causing blistering (courtesy Card Geotechnics Limited)

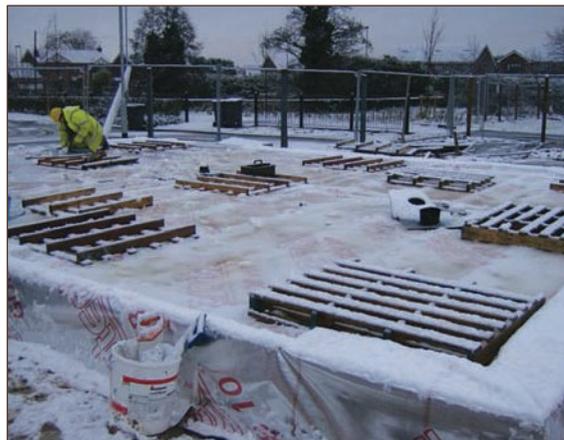
**Figure A4.84** Taped joints are difficult to construct in adverse weather. Also difficult to inspect if covered with snow (courtesy Smith Grant)

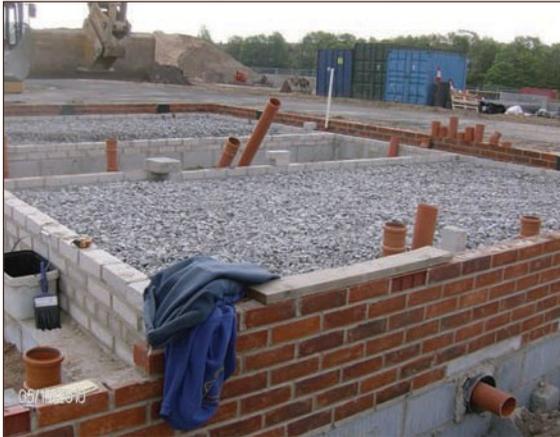
**Figure A4.85** Clean single sized stones with no fines acting as venting media, however no ventilation gaps in internal sleeper walls (courtesy Smith Grant)

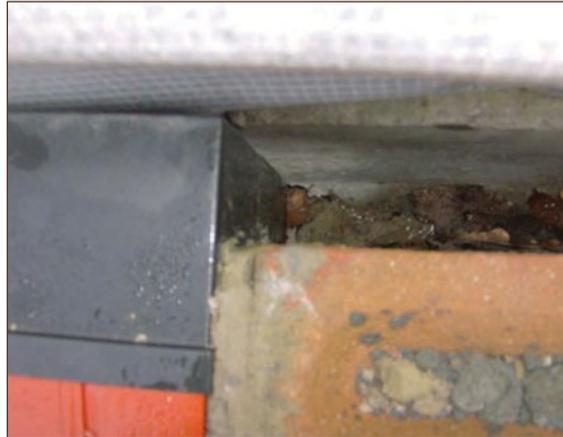
**Figure A4.86** Cavity is becoming blocked with detritus. The vent holes in the beam are no longer visible (courtesy Smith Grant)

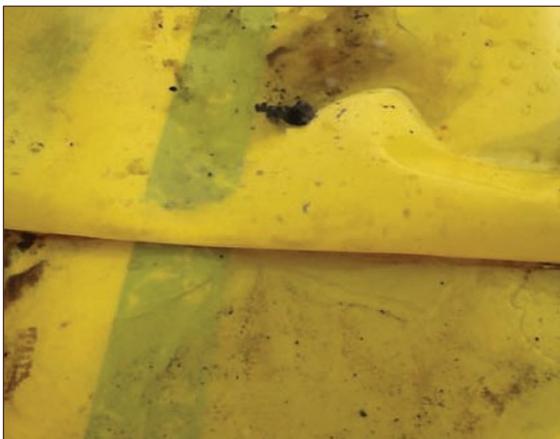
**Figure A4.87** Tape joint with crease running through and air bubbles where gas membrane not in complete contact with tape. Rollers should have been used to produce a consistent seal (courtesy MEC Environmental Ltd)

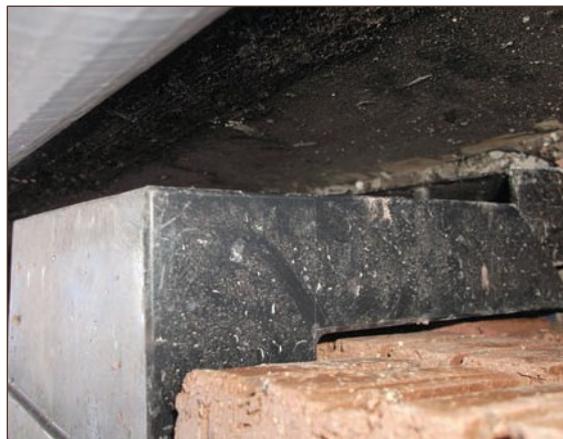
**Figure A4.88** Ventilator becoming detached to fit to external block work. This is due to builders requiring increased cavity widths to achieve thermal properties expected by Building Regulations (courtesy NHBC)

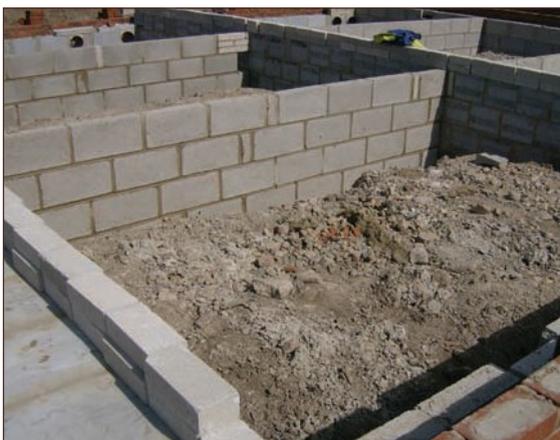
**Figure A4.89** No ventilation in internal sleeper wall (courtesy Smith Grant)

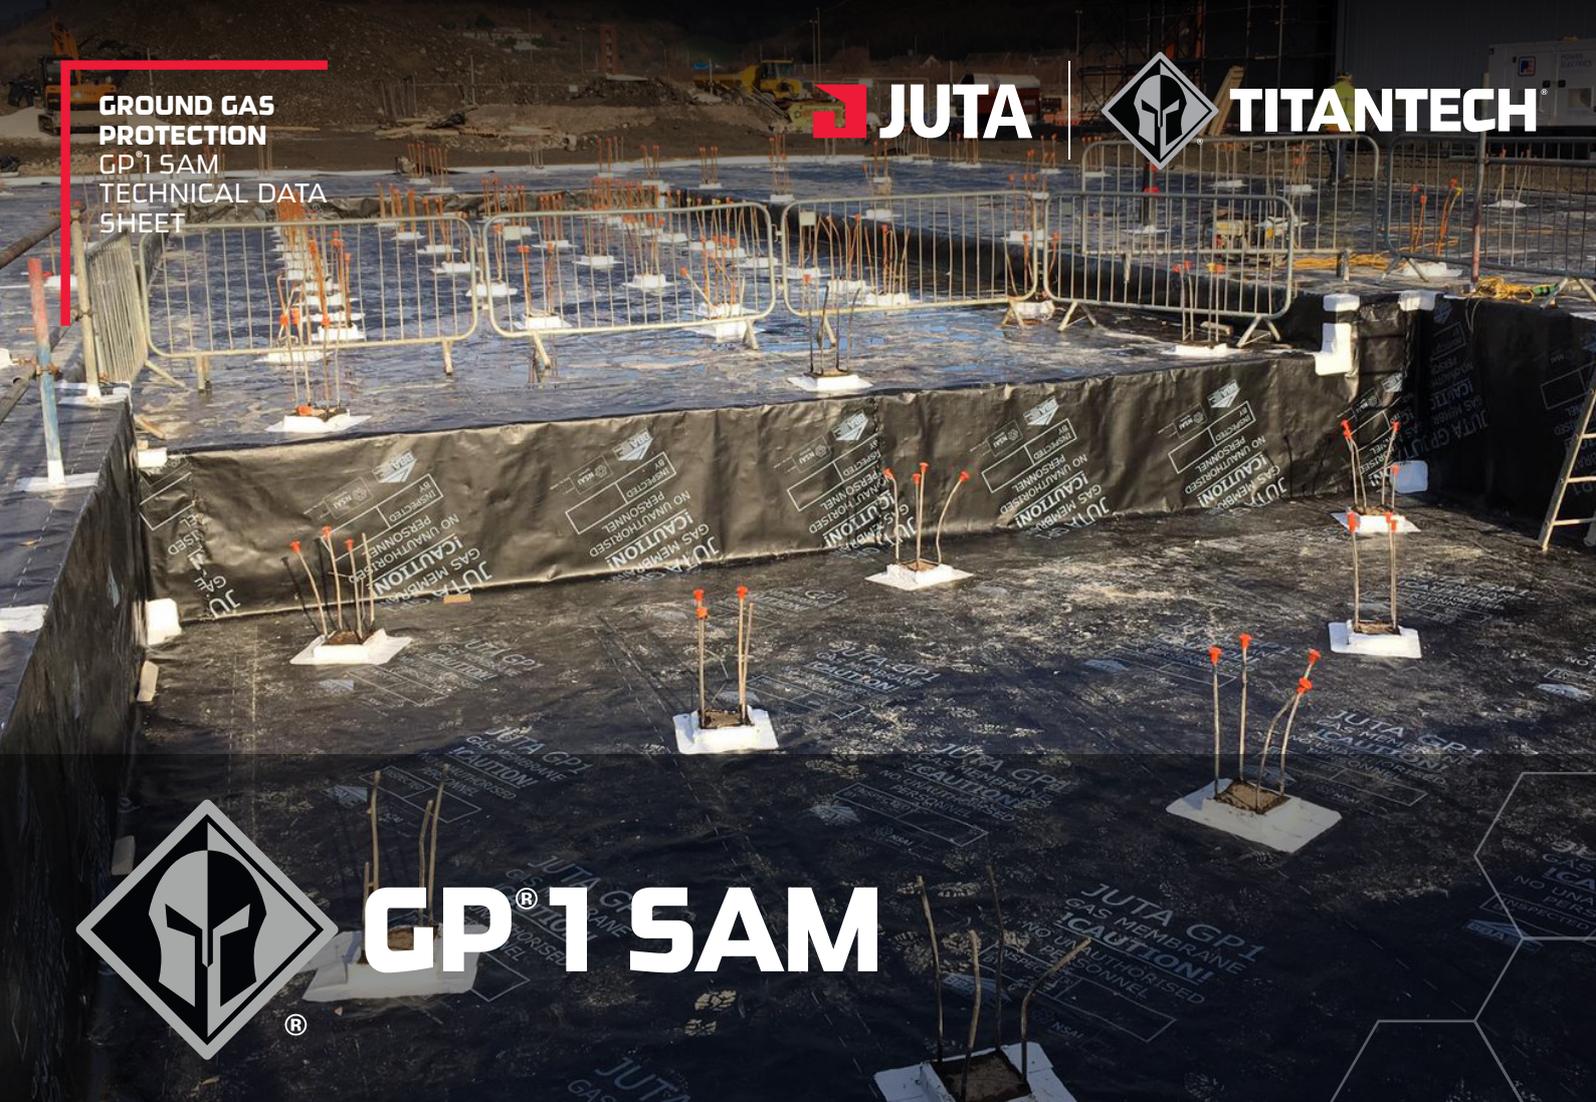
Juta GP1 Technical Datasheet

GP<sup>®</sup>1 SAM, gas protection self adhesive membrane, is a bituminous gas proof and water proof sheet, composed of self-adhesive SBS polymer modified bitumen incorporating GP<sup>®</sup>1 with an upper surface finish of black reinforced LDPE, and a lower surface finish of siliconized release film. GP<sup>®</sup>1 SAM is used for the gas/waterproofing of underground structures where harmful ground gasses are anticipated, and as a self adhesive accessory to GP<sup>®</sup>1.

Rolls of GP<sup>®</sup>1 SAM should be stored on in a cool, dry place, and be protected from exposure to rain, sun, heat and cold temperatures prior to installation. Exposure to sunlight for extended period of time could cause difficulty with removal of the release film.

It is recommended that GP<sup>®</sup>1 SAM is not applied in temperatures below 10°C, in colder weather the material can be warmed slightly to aid adhesion.

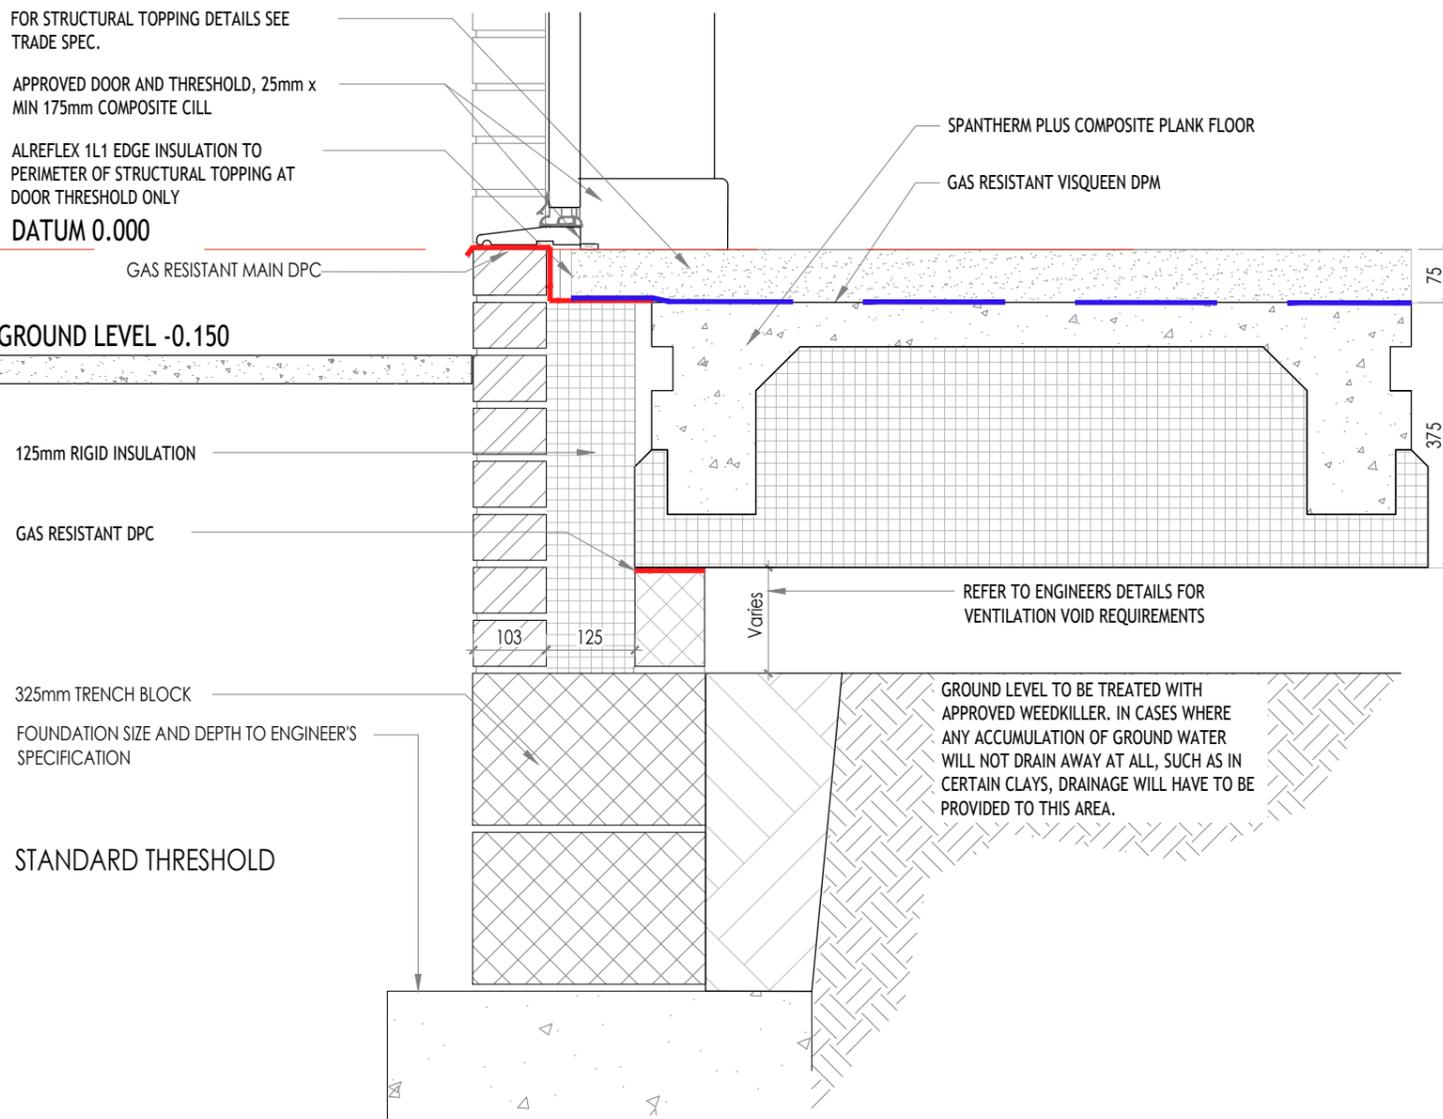
### Insulated Plank Ground Floor Detail - Gas Membrane

Insulated added to sub floor wall cavity and chipboard finish removed.
