Ref: Mining Stability – 27 Moor Lane, Gomersal

Further to the additional site investigation works completed by Haigh Huddlestone, we have reviewed the reports and can now recommend appropriate and specific remedial works for the proposed development at Moor Lane, Gomersal. It should be noted that the following recommendations are in line Drawing No.2539-D-20-002 which is appended to this letter.

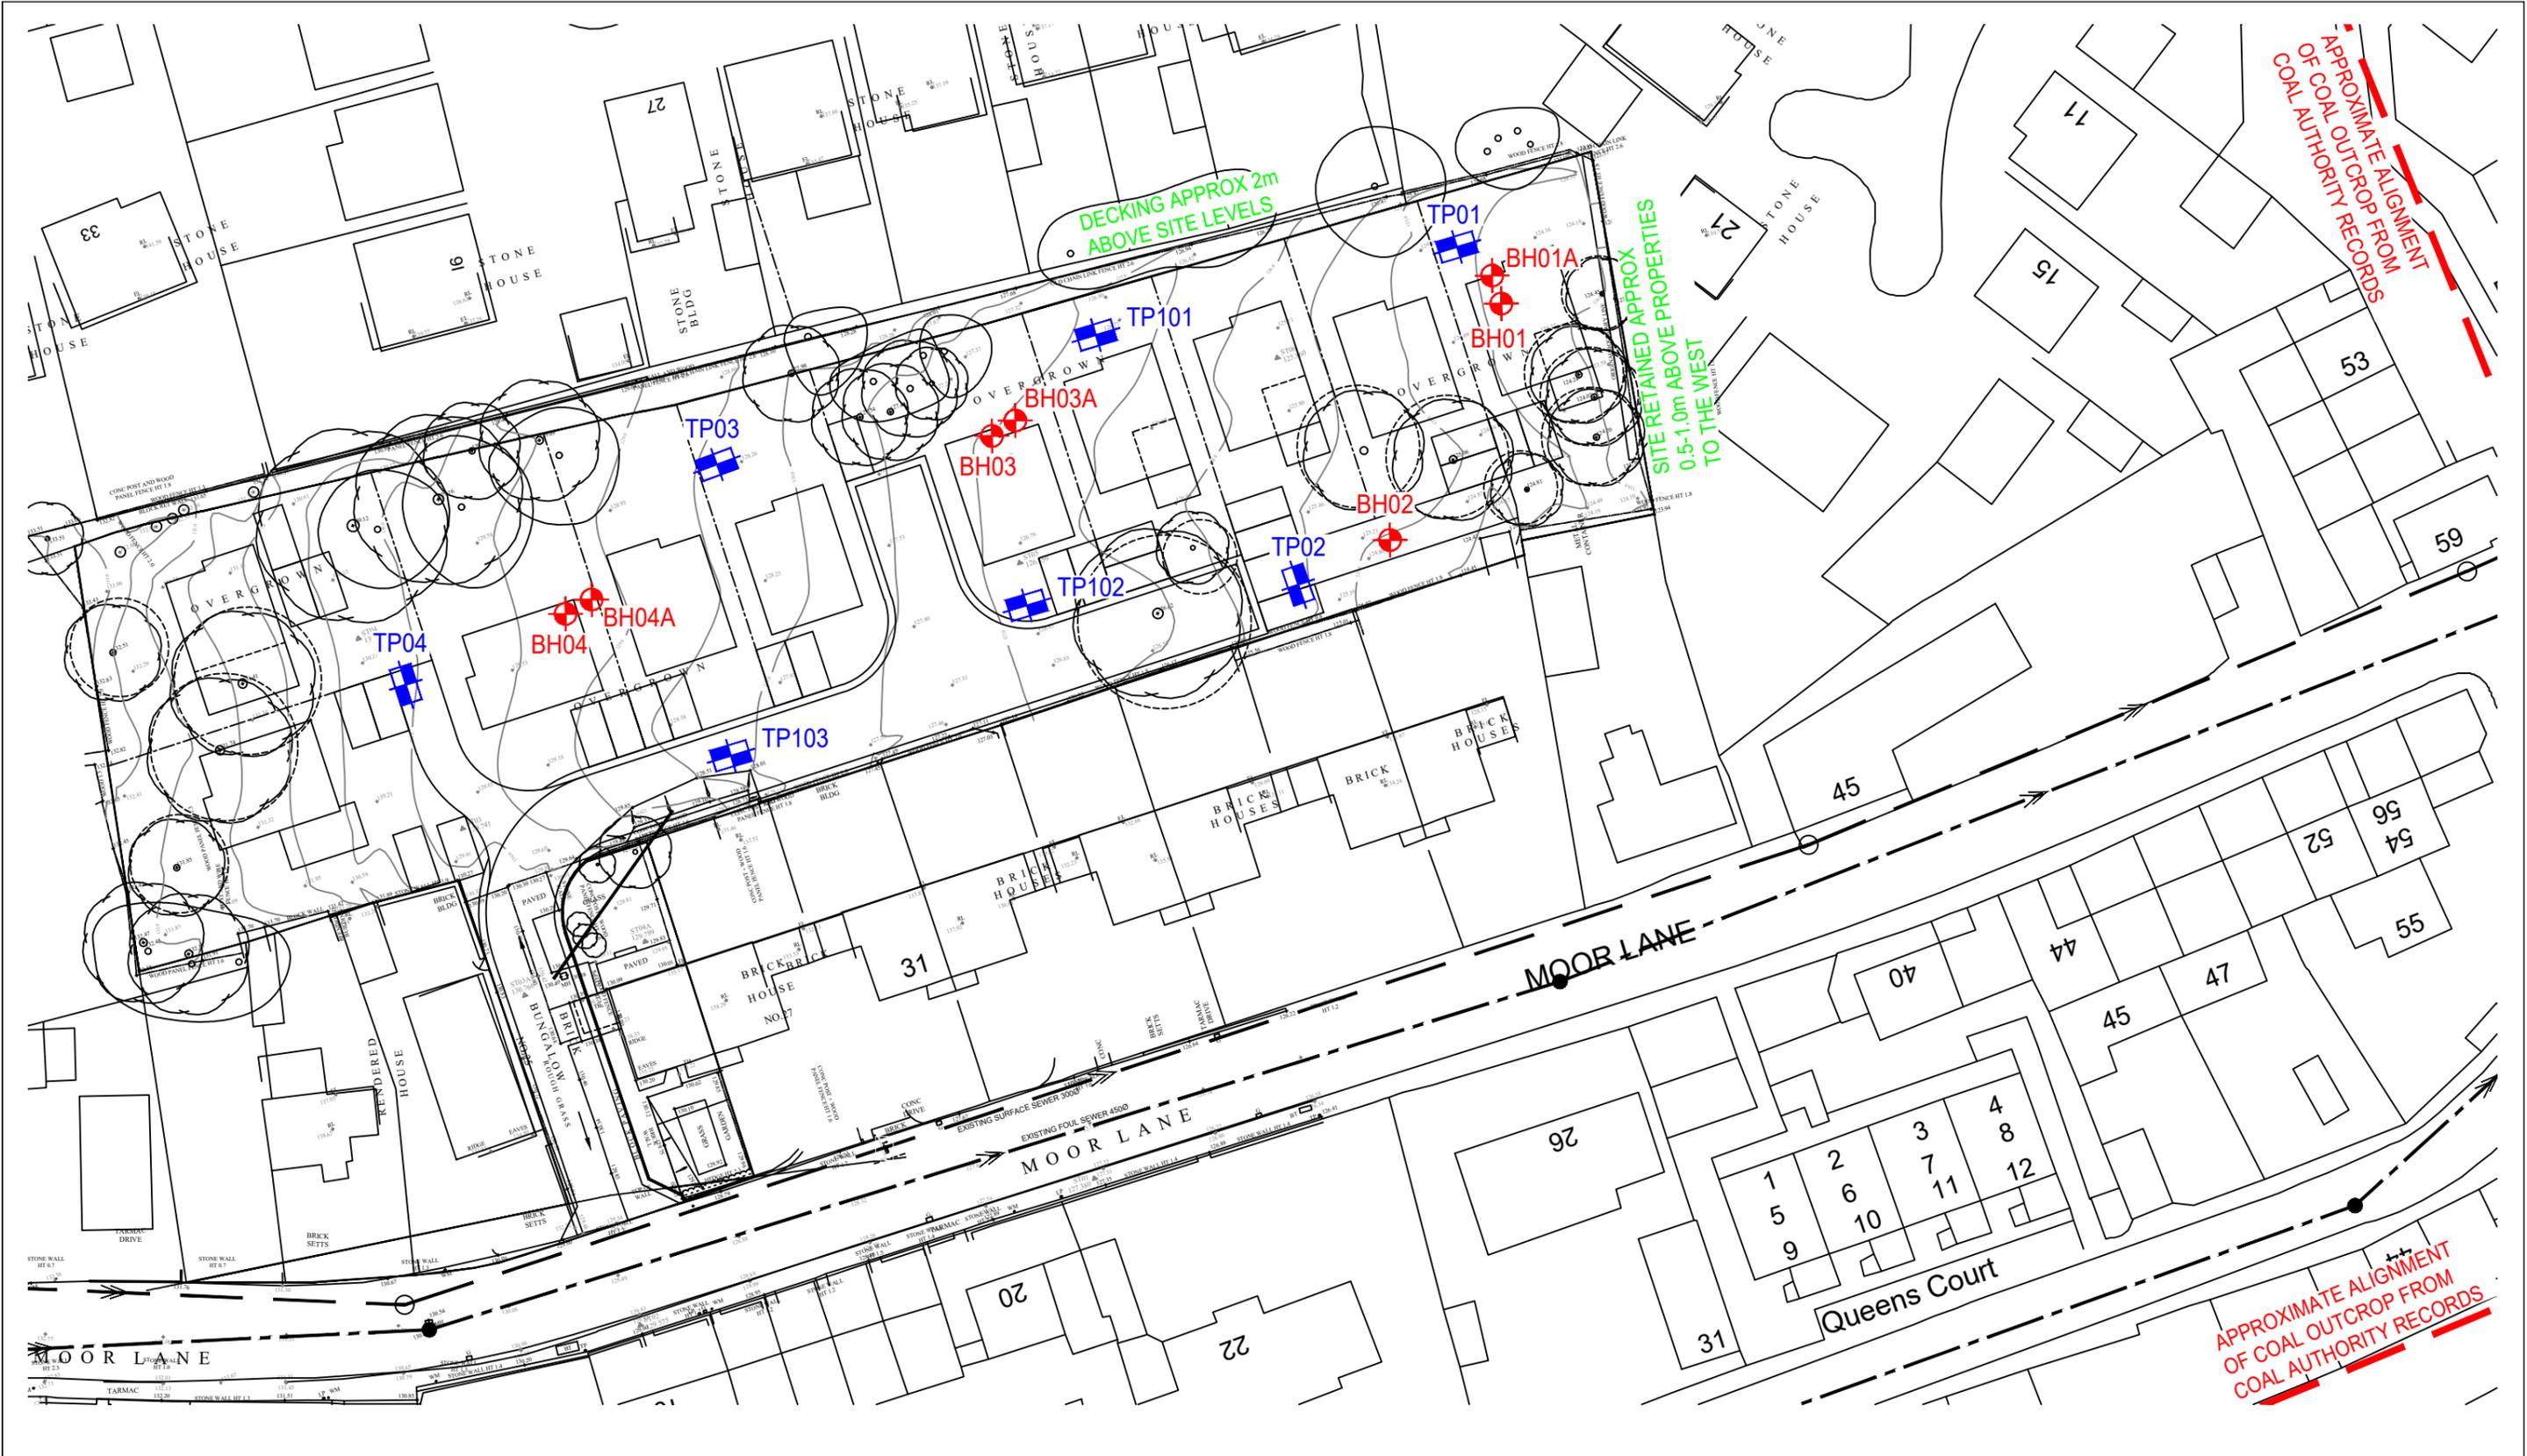
- SOAKAWAY LOCATION
- TRIAL PIT LOCATION
- PROPOSED BOREHOLE LOCATION

BOREHOLE LOCATIONS SUBJECT TO CHANGE DEPENDENT ON ACCESS AROUND SITE AND FINDINGS WITHIN BOREHOLES.

The appropriate borehole plans are appended.

- BH01/BH01A – Coal encountered at 21.0m, 2.0m thickness.
- BHB1 – Broken ground encountered at 25.5m, 3.2m thickness.
- BH02 – Broken ground encountered at 25.8m, 3.1m thickness.
- BHB2 – Broken ground encountered at 26.4m, 2.6m thickness.
- BH03/03A – No coal identified, but only drilled to 10m.
- BHB3 – Broken ground encountered at 26.7m, 3.1m thickness.
- BH04 – No deeper coal identified, borehole drilled to 30m.
