Coal Mining Risk Assessment

Millys Mini Mart, 29 Ravenshouse Road, Dewsbury, WH13 3QP

Amendments and extension to shop and flat

Assessment result	MEDIUM RISK
Recommended further work	INTRUSIVE GROUND INVESTIGATION / CONSULT A FOUNDATION DESIGN ENGINEER

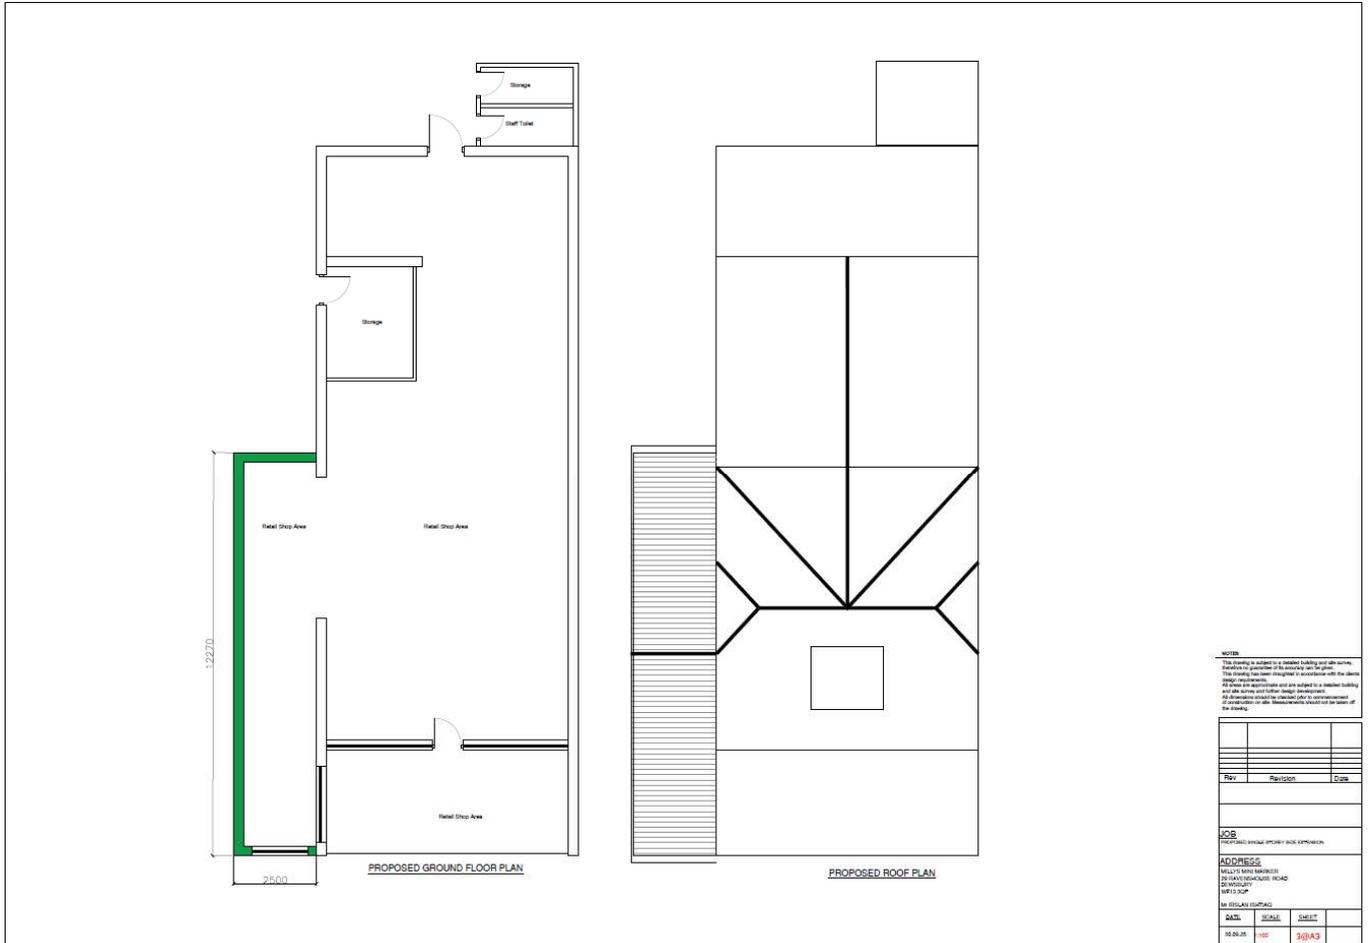
Appendix A – Plan showing proposed development layout

The Mining Remediation Authority understands that the developer plans to amend and extend shop and flat (see appendix A).
