Miller Homes

Woodhead Road, Honley

Arboricultural Method Statement
& Tree Protection Plan

October 2025

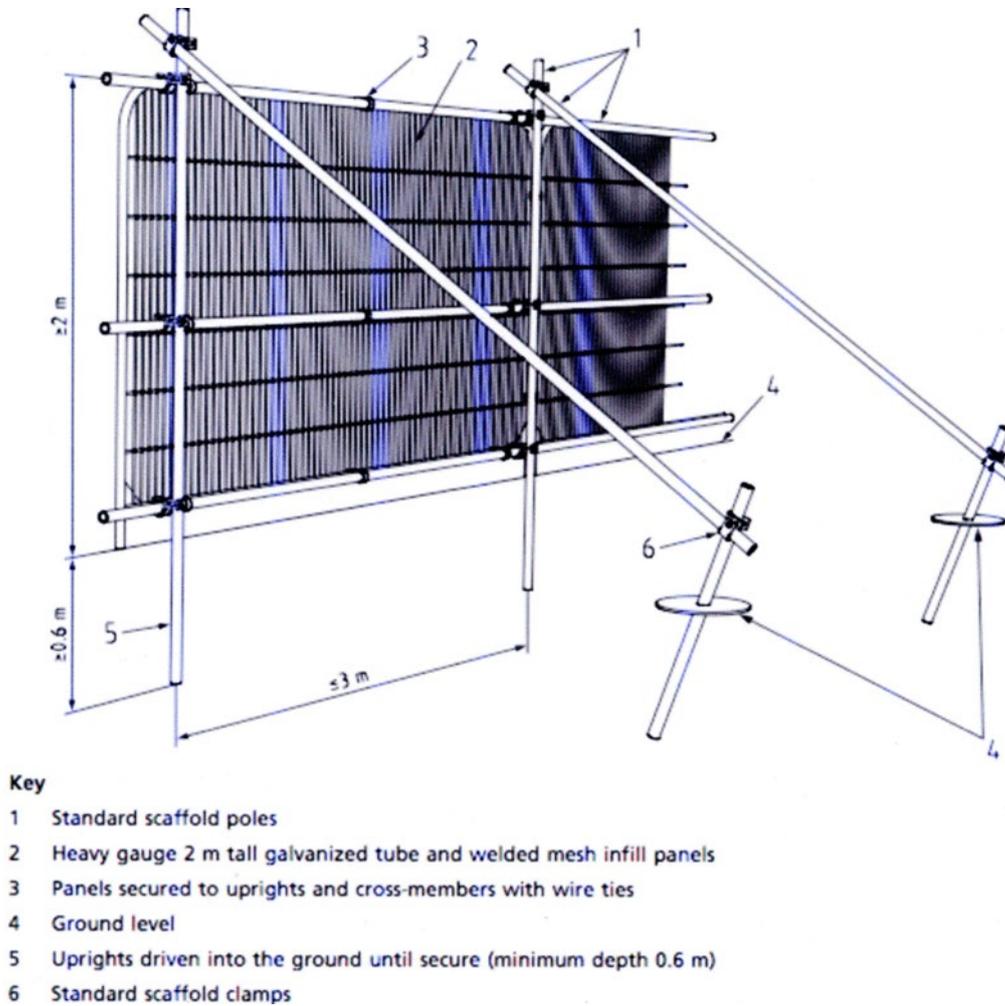
Figure 1. Default Specification for Protective Barrier (Tree Protection Fencing – TPF) (Taken from Figure 2 of Section 6 BS5837:2012)

- 2.12 Protection barriers will comprise a scaffold framework in accordance with Figure 2 of BS 5837:2012. The framework will consist of vertical and horizontal scaffolds with vertical tubes spaced at no more than 3m intervals and driven into the ground. Weld mesh (Heras or similar) panels will be securely fixed on to this framework with wire or scaffold clamps. Tubes will be firmed into holes in the ground made with post hole boring equipment. Post holes are to be no more than 30% larger than the scaffold tube. Supporting struts will be fixed to the inside of the barrier to ensure maximum rigidity.

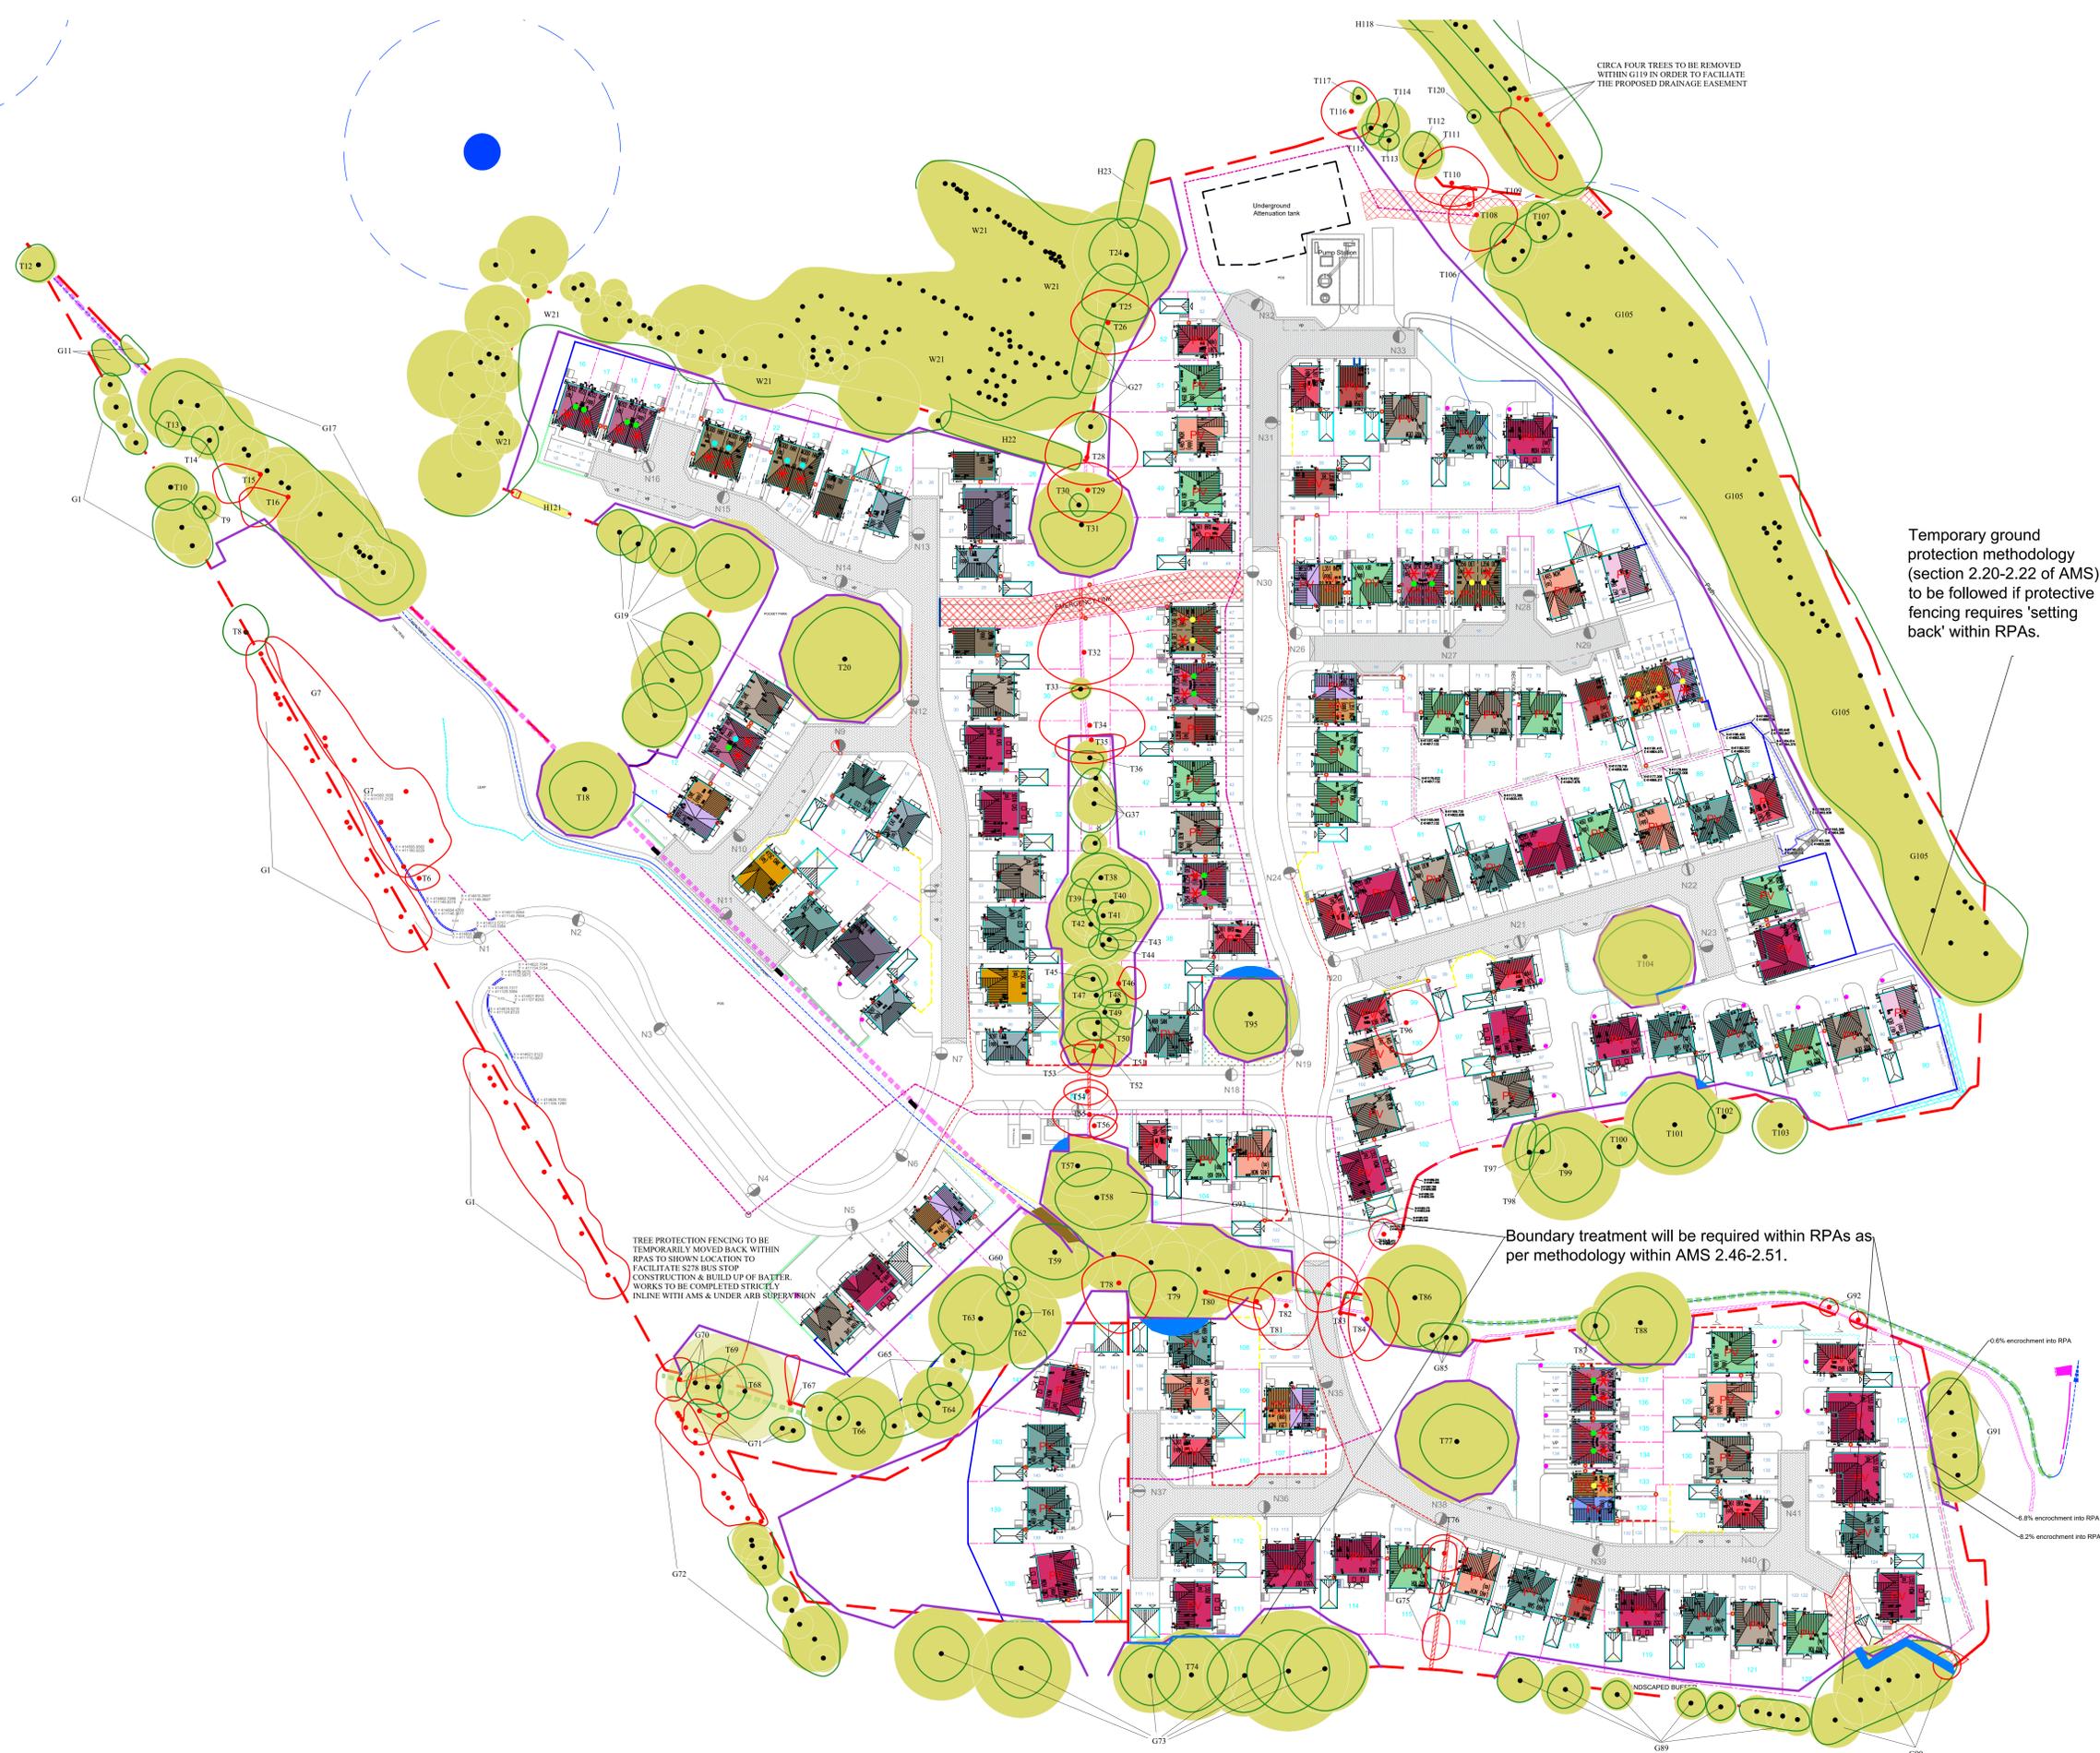
APPENDIX 4: Tree Protection Plan

Temporary ground protection methodology (section 2.20-2.22 of AMS) to be followed if protective fencing requires 'setting back' within RPAs.

Tree Protection Plan	
Client	Miller Homes Ltd
Site/Project	Woodhead Road, Honley
Scale/Sheet	1:500 - A0
Date	10/10/2025
Drawing No	4432_TPP
Rev	3
Drawn By	HM
Checked By	AL
Birmingham 0121 233 3522 Leeds 0113 233 8000 London 020 7234 9122 Manchester 0161 233 4260 Nottingham 0115 924 1100 www.bwbconsulting.com
