GEOLOGICAL AND MINING APPRAISAL

**FOR
188 DEIGHTON ROAD,
HUDDERSFIELD,
WEST YORKSHIRE,
HD2 1JJ,**

**REPORT NO. NE4118
NOVEMBER 2021**

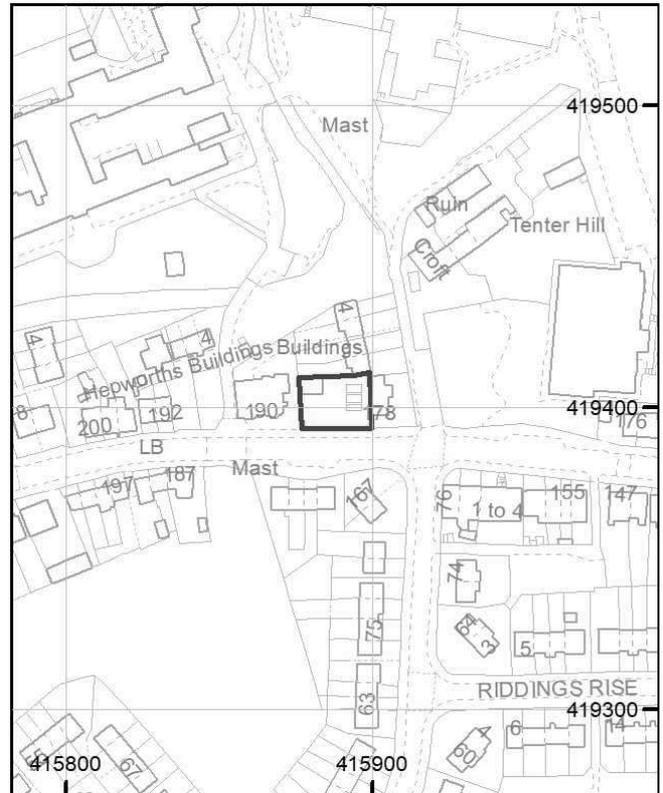
Approximate position of enquiry boundary shown

We can confirm that the location is **on the coalfield**

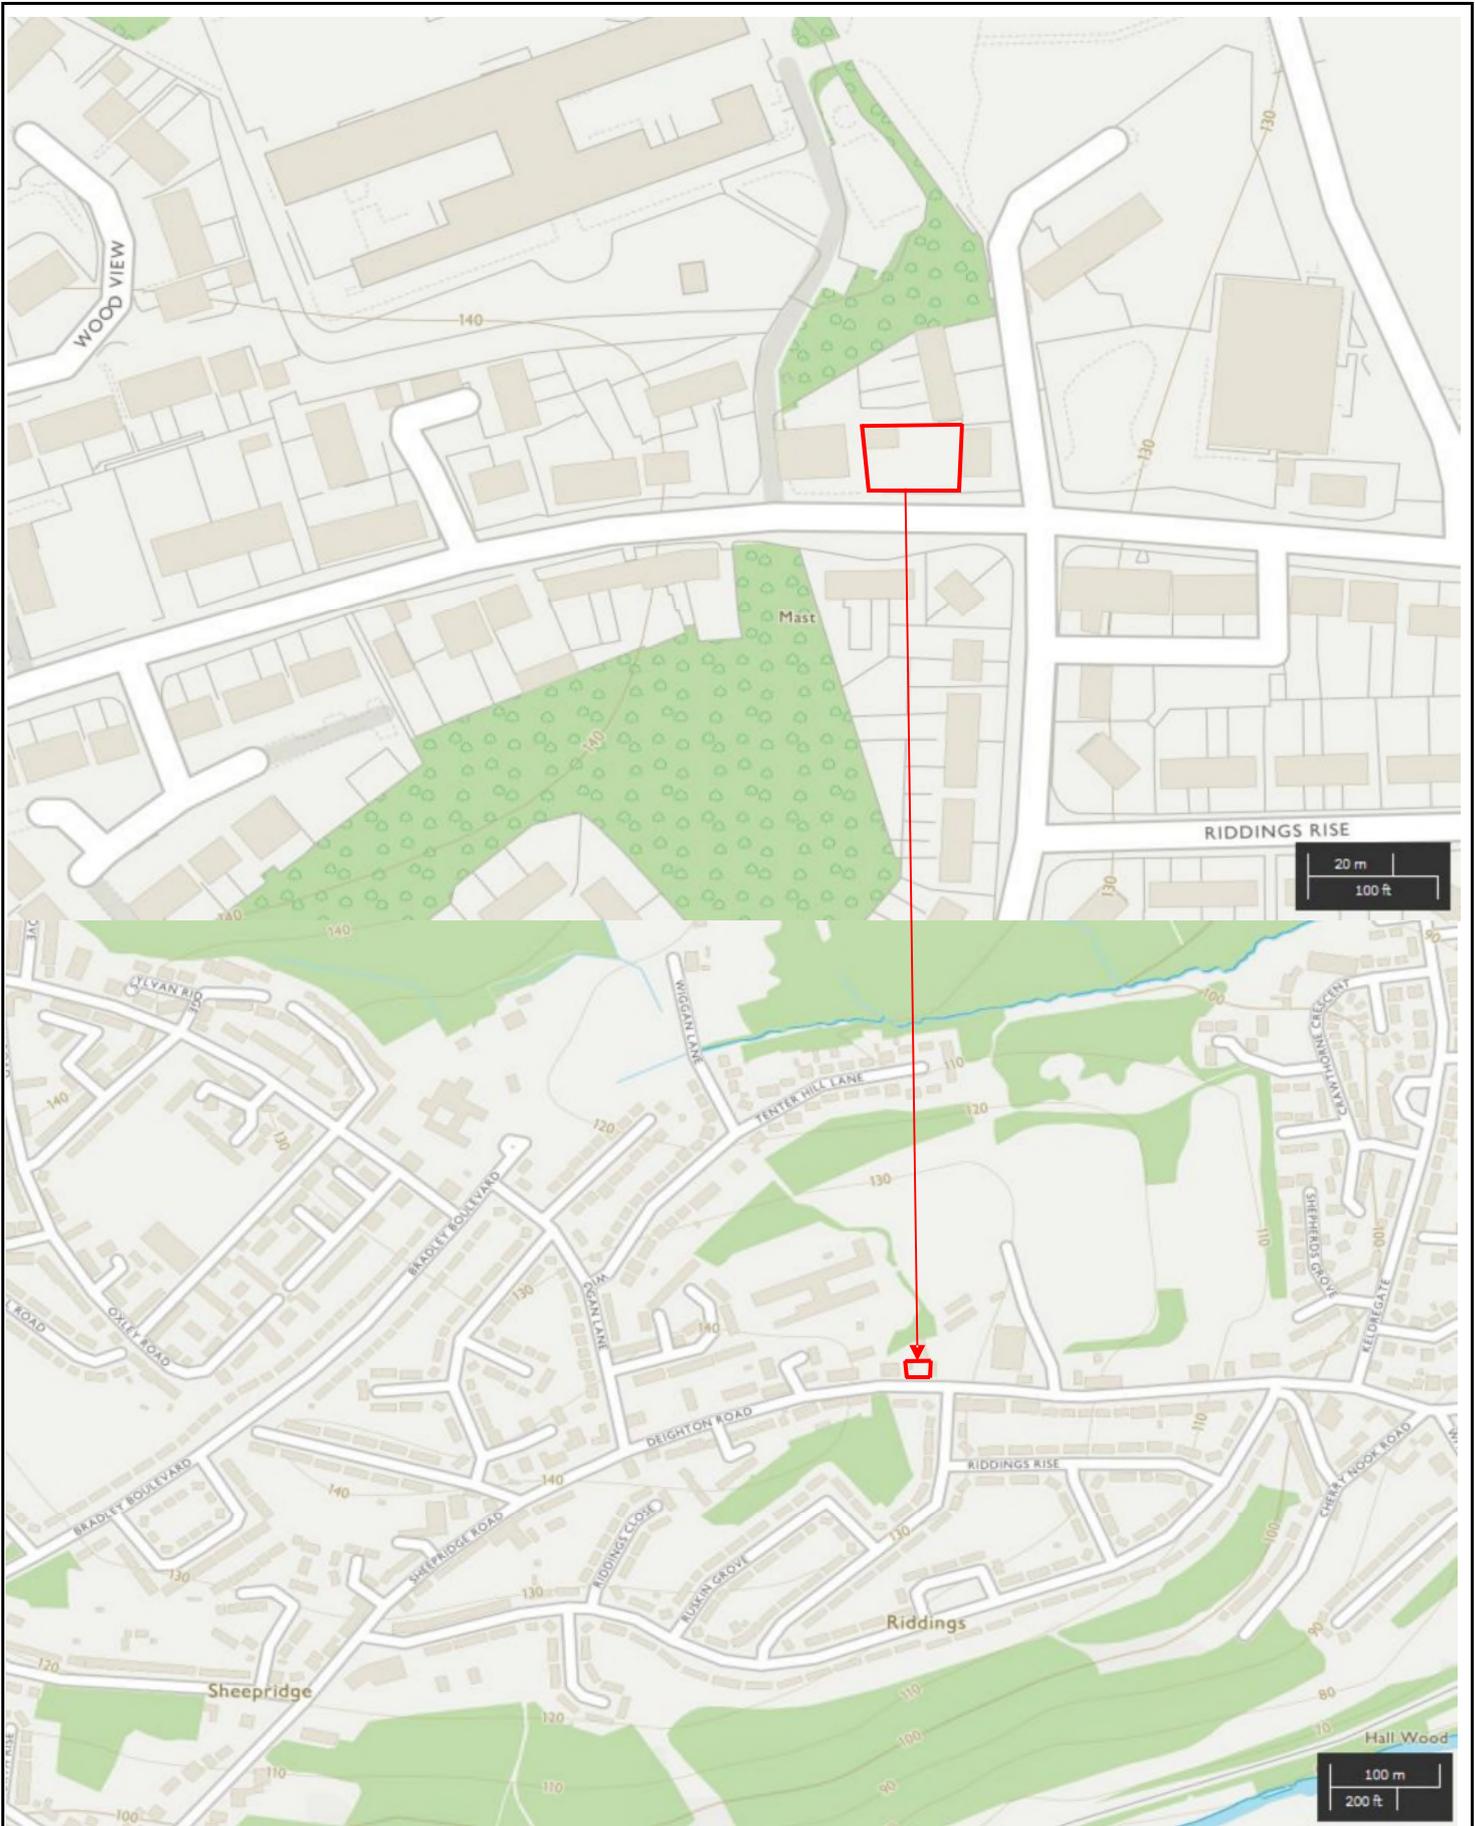
Job Number: NE4118
Site: 188 DEIGHTON ROAD, HUDDERSFIELD, WEST YORKSHIRE, HD2 1JJ	Drawn By: LAWM	Checked By:	Scale: -	Figure Number: 1
Client: JAMIE TULLY

SUB SURFACE SITE INVESTIGATION SPECIALISTS, GEOTECHNICAL & ENVIRONMENTAL CONSULTANTS 3 Peel Street, Preston, Lancashire, PR2 2QS. Tel: (01772) 561135 Fax: (01772) 204907	Site Location Plan			
	Date Drawn: 08-Nov-21	Date Checked:	Orientation:

The site is located at 188 Deighton Road, Huddersfield, West Yorkshire, HD2 1JJ, as indicated on Figure 1. The approximate National Grid Reference of the centre of the site is E415887m,N419405m.

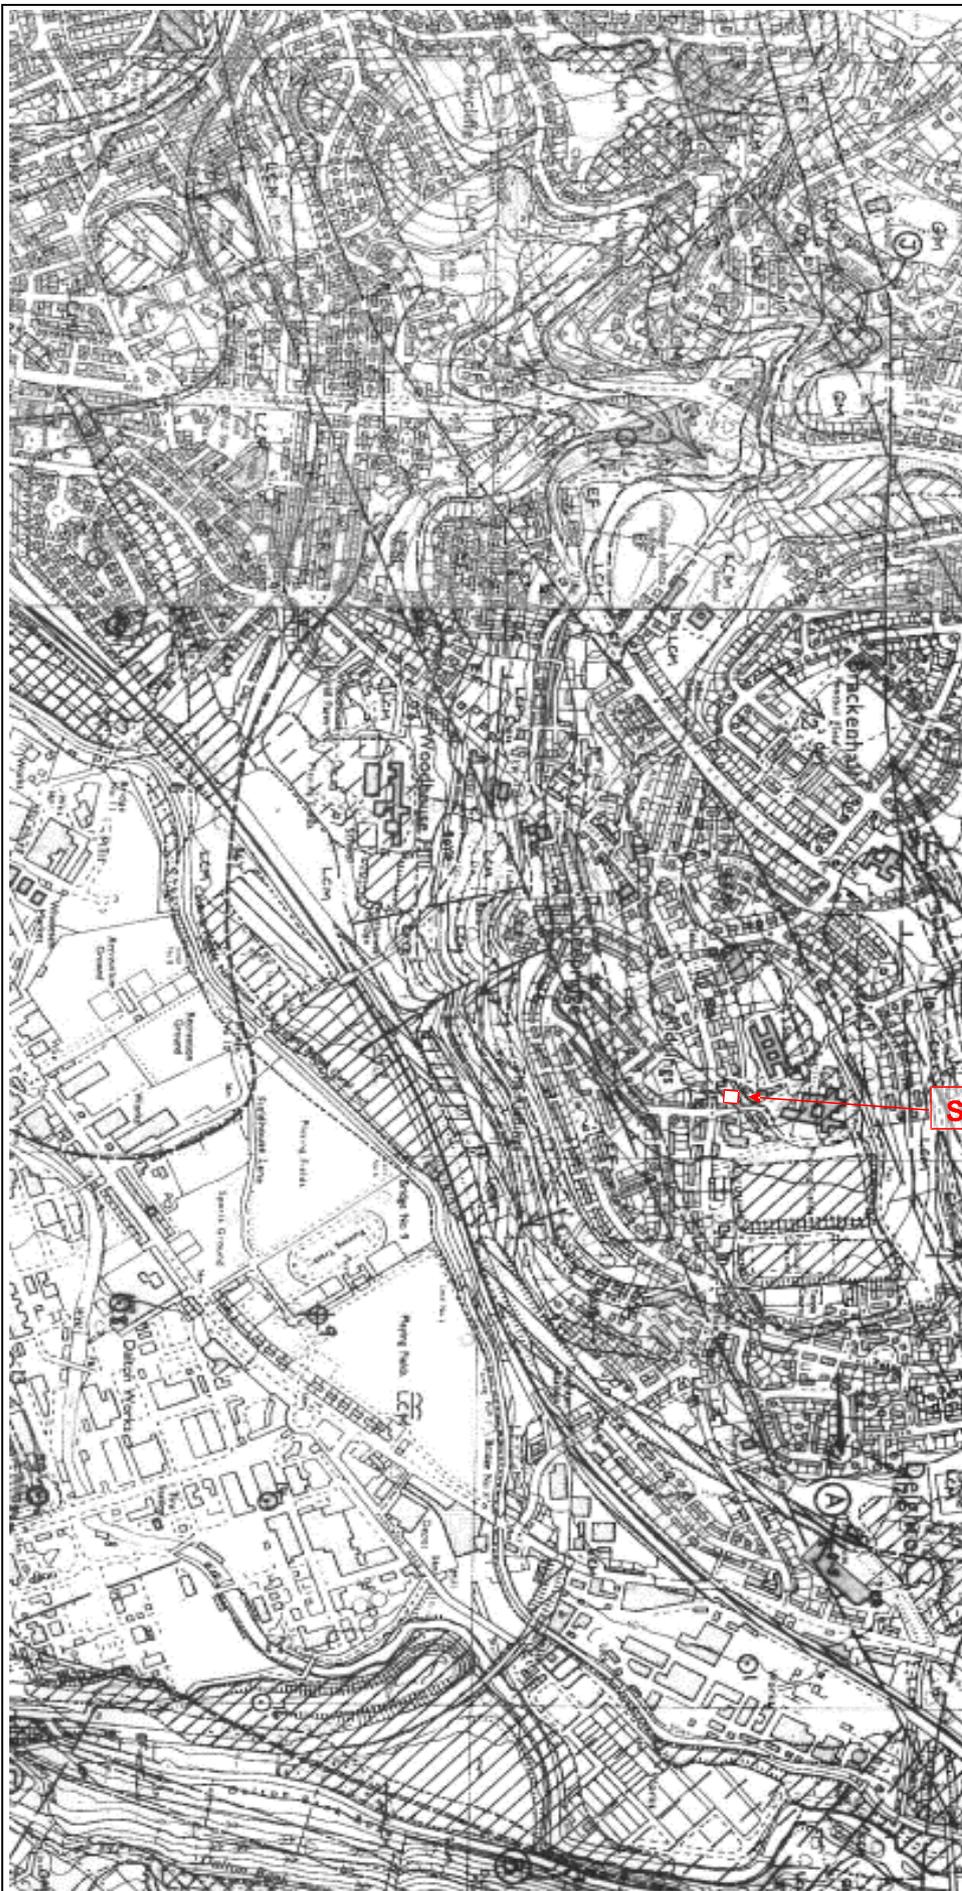
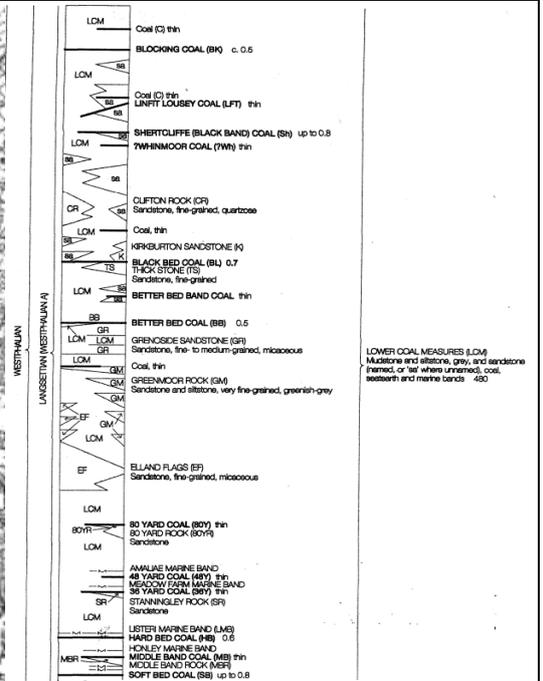
LOWER COAL MEASURES LCM
Mudstone and siltstone, grey, and sandstone
framed, or set where unframed, coal
southern and marine bands 480

DRIFT

The geological survey indicates that the site is underlain by Lower Coal Measures and an unnamed sandstone strata in the north west corner of the site. Coal Measures strata in this area normally comprise interbedded mudstones, grey siltstones and sandstones with occasional economically important mineral seams of coal, seat-earth and marine bands. It should be noted that where found at near surface level Coal Measures strata are normally completely weathered to a soil.
