REMEDIATION STATEMENT

**AT
188 DEIGHTON ROAD,
HUDDERSFIELD,
WEST YORKSHIRE,
HD2 1JJ**

**REPORT NO. NE4118C
MAY 2023**

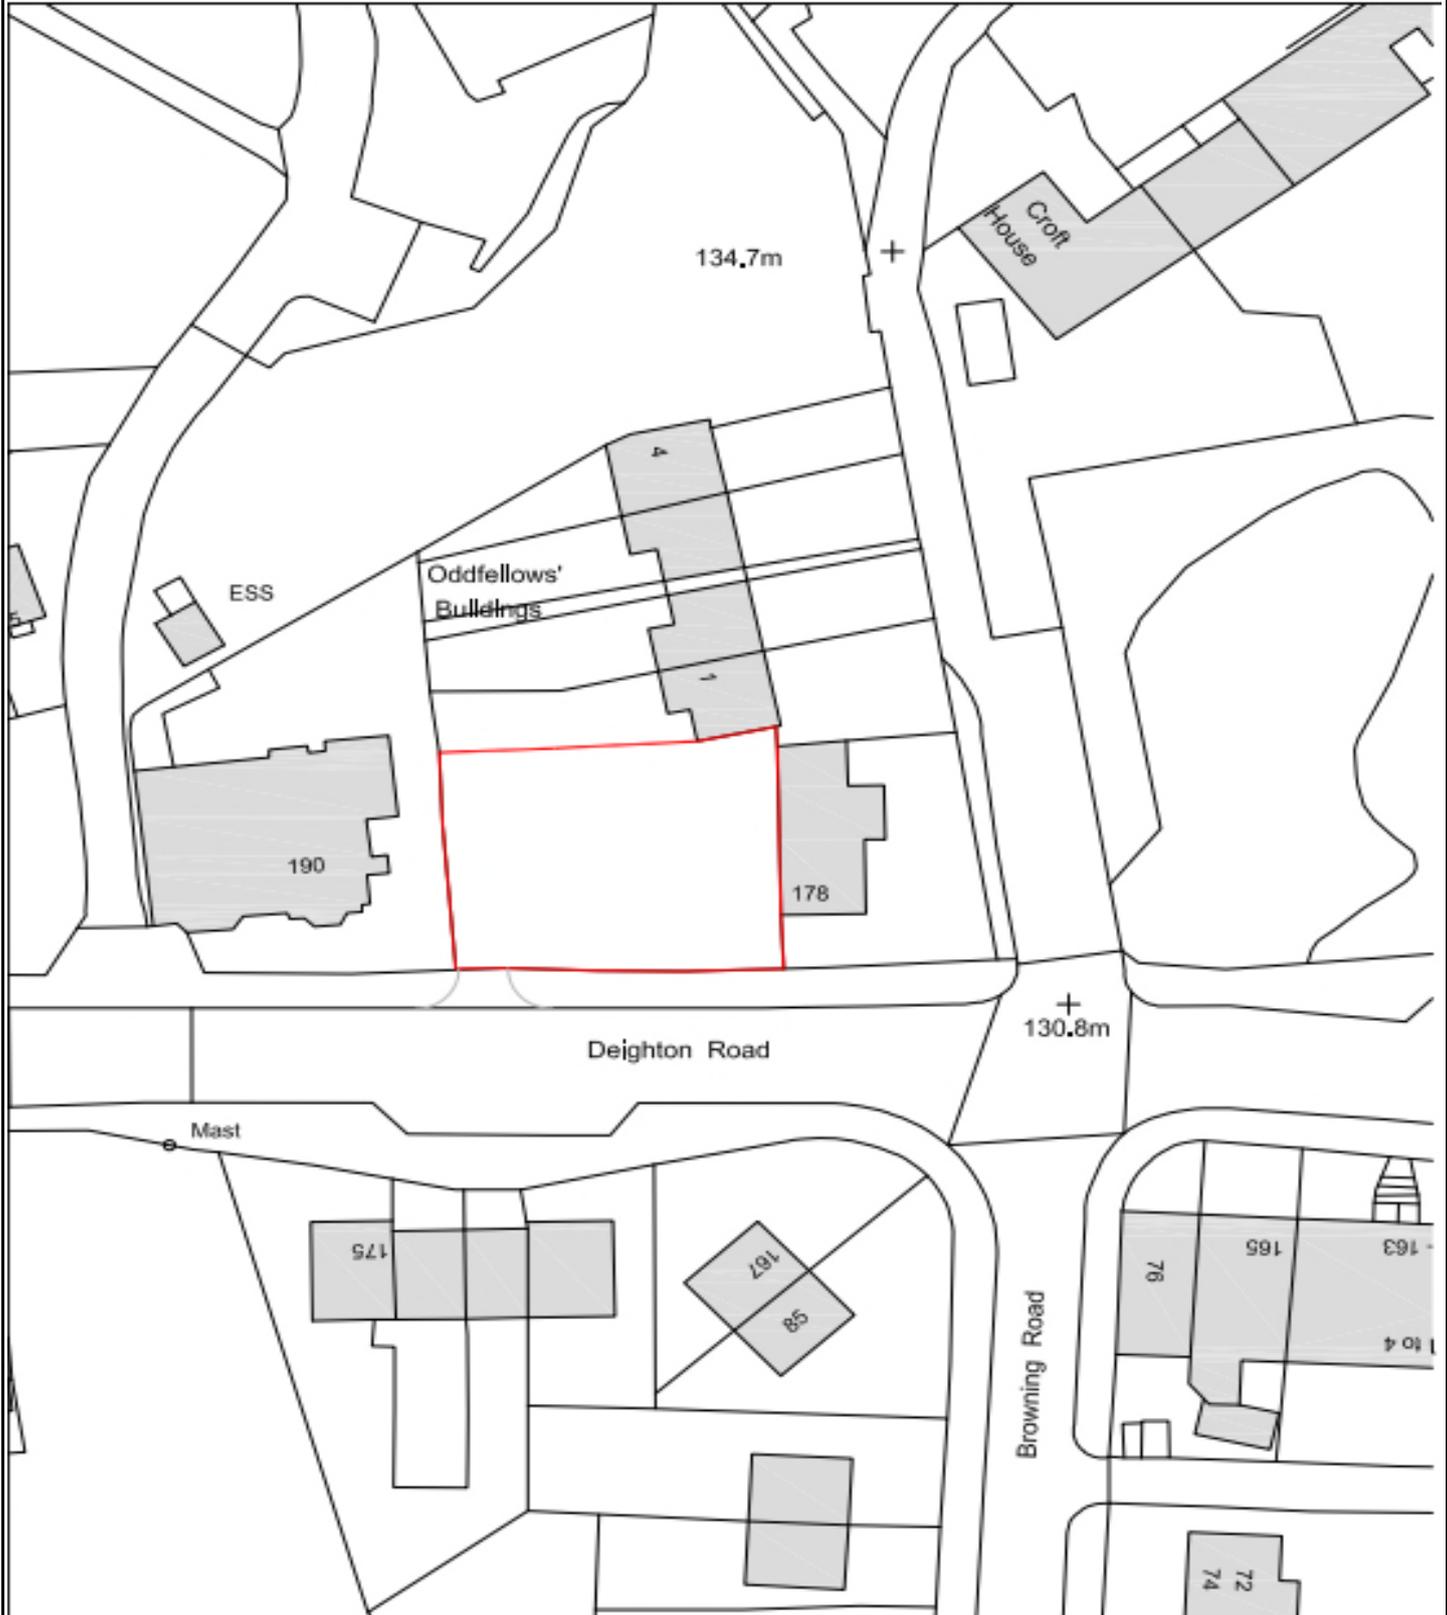
Location Plan (1:500 @ A3)

As shown on Figure 2, the about 0.04 hectare roughly rectangular shaped site is bounded to the east by No. 178 Deighton Road, to the north by the grounds of No. 1 Oddfellows Buildings, to the west by No. 190 Deighton Road, and to the south by Deighton Road.

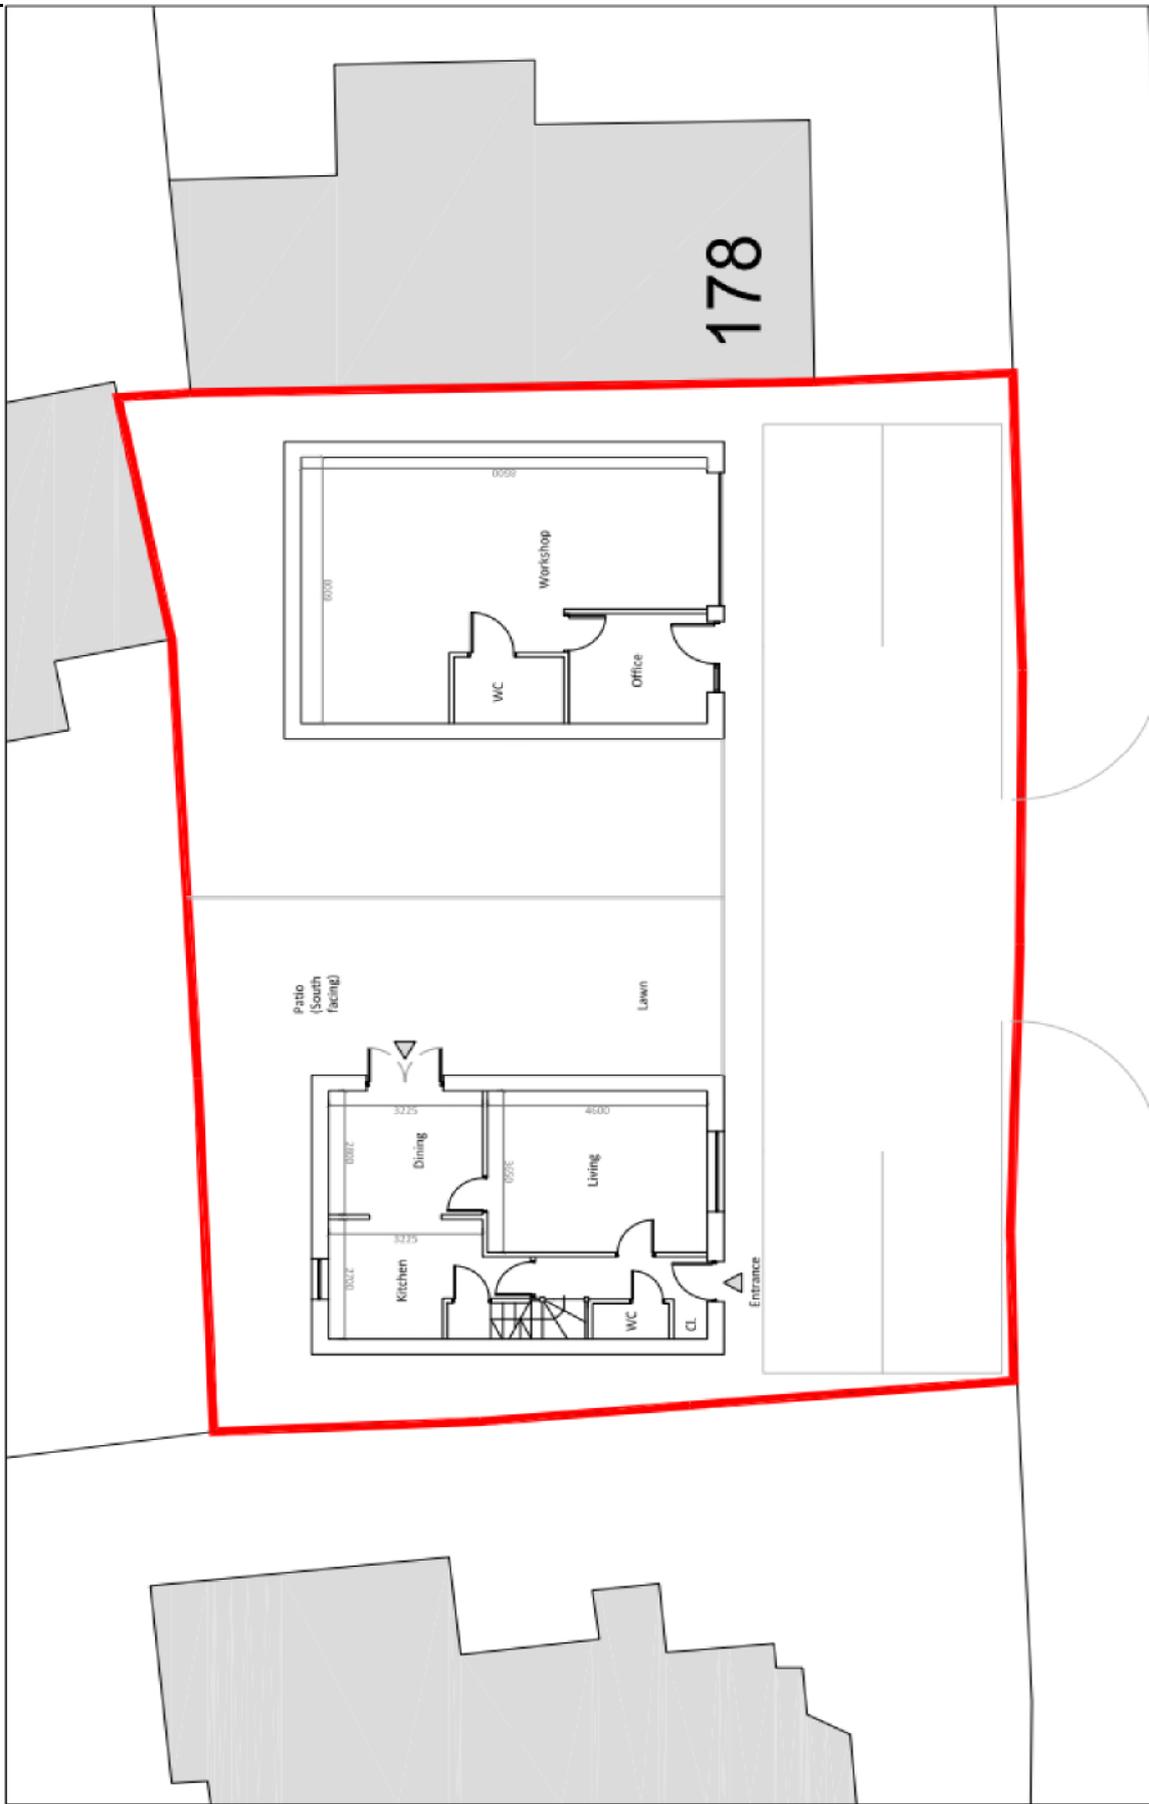
Job No. NE4118C
Site 188 DEIGHTON ROAD, HUDDERSFIELD, WEST YORKSHIRE, HD2 1JJ	Drawn By LMB	Checked By	Scale -	Figure No. 3
Client JAMIE TULLY

We understand that it is proposed to construct a residential property and a detached workshop, as shown on Figure 3.

SUB SURFACE SITE INVESTIGATION AND SPECIALIST GEOTECHNICAL CONSULTANTS 3 Peel Street, Preston, PR2 2QS. Tel. (01772) 561135 Fax (01772) 204907	Proposed Development Plan			
	Date Drawn 25-May-23	Date Checked	Orientation
