PROJECT:  
Proposed Replacement Stonework, Repair Works @  
Bridford  
Bridford 3PN

DRAWING TITLE:  
Proposed Front Elevations - STEPPED ENTRANCE  
Repair & Replacement Stonework Details

DRAWING NO.  
CJ/25/002  
SCALE:  
1:50/1:10  
DATE:  
17/9/25

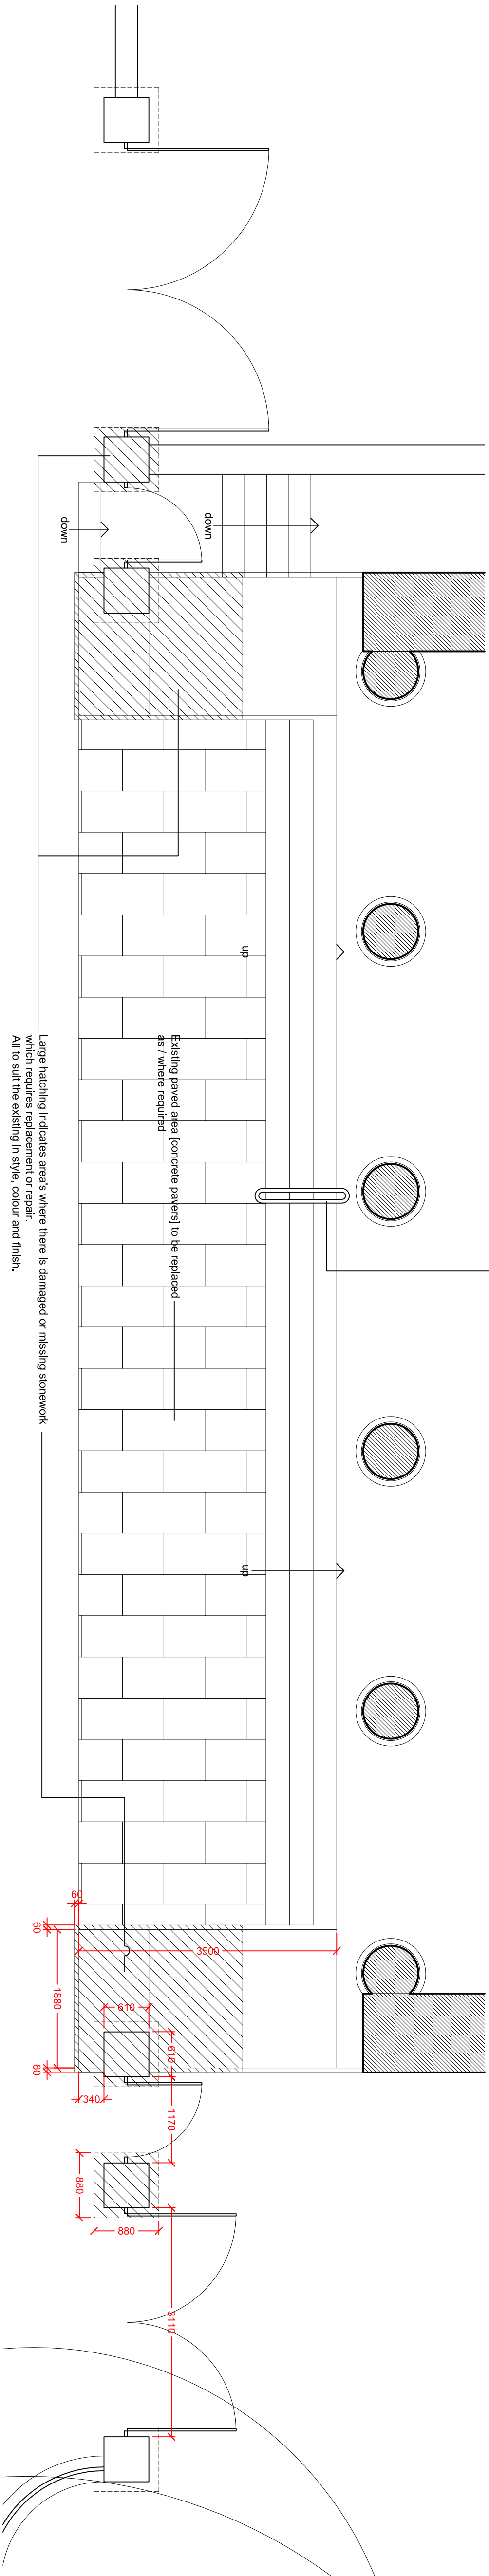
PLAN OF STEPPED FRONTAGE [ENTRANCE] @ 1 : 50

Existing decorative metal handrail to stepped entrance is to be replaced with 2No. matching handrails. This was submitted under the Planning Application 2025 / 90113 and granted approval

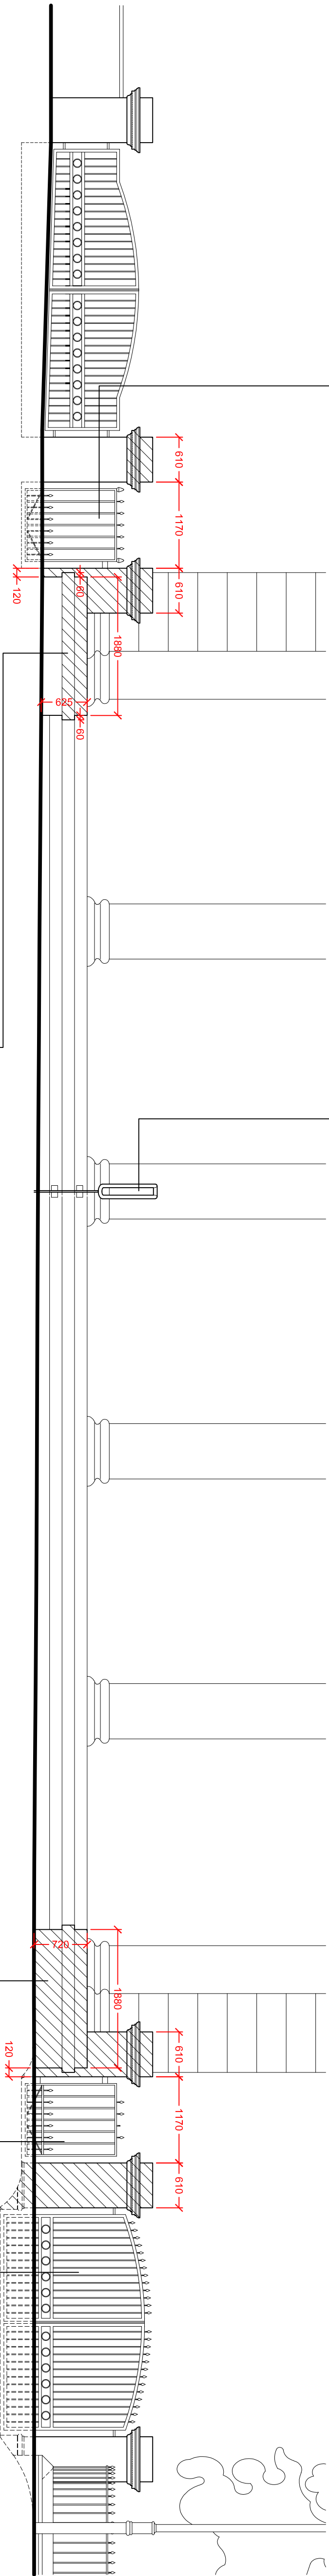
FRONT ELEVATION OF STEPPED FRONTAGE [ENTRANCE] @ 1 : 50

Existing decorative metal gates to be replaced or repaired as / where required. If possible, all to match the existing throughout in style, colour and finish.

Large hatching indicates areas where there is damaged or missing stonework which requires replacement or repair. All to suit the existing in style, colour and finish.

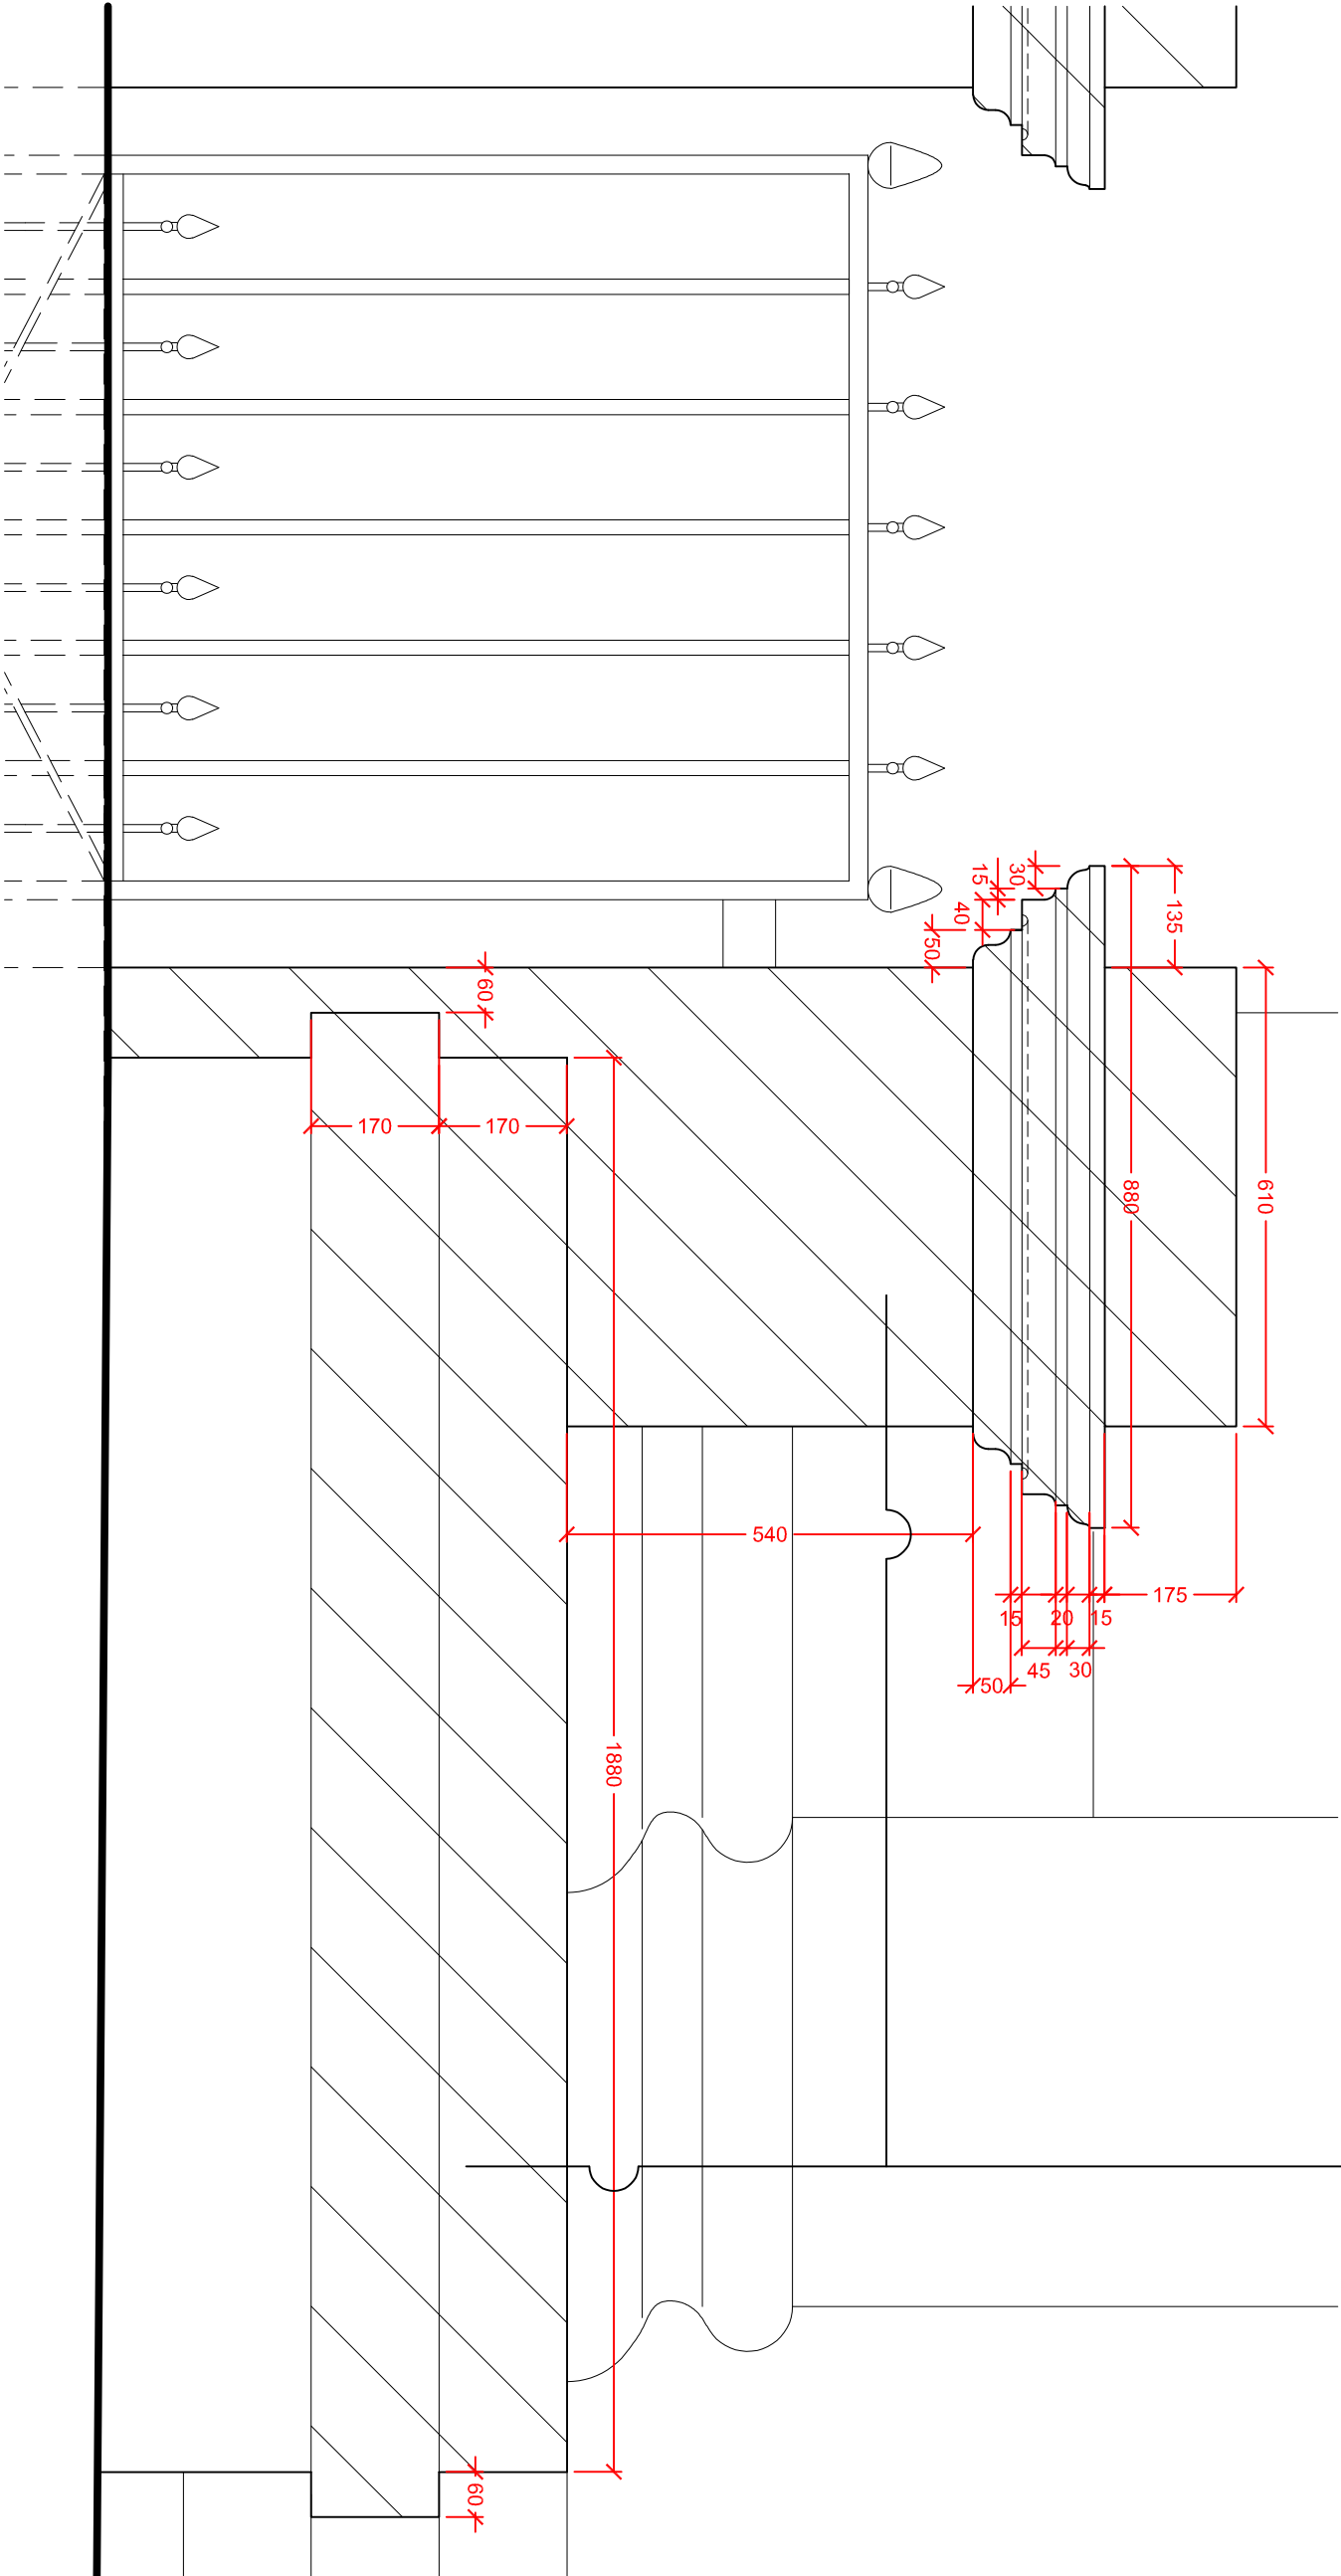
ELEVATION OF L/H SIDE STONE PLINTH BLOCK - [ENLARGED] @ 1 : 10

ALL NEW / REPLACEMENT JOINTS ETC... ARE TO BE MORTARED AS / WHERE REQUIRED. STONE MASON TO CONFIRM WHETHER STAINLESS STEEL TIE RODS ARE REQUIRED TO BE INSERTED WITHIN CERTAIN SECTIONS FOR STABILITY - SUBJECT TO PATCH REPAIRS.

## REPLACEMENT STONEMARK DETAILS - STEPPED ENTRANCE
