## COAL MINING RISK ASSESSMENT REPORT

| Location: | Land at Leak Hall Road<br>Denby Dale, Huddersfield, West Yorkshire, HD8 8RY | |
| For: | Castlehill Damage Restoration Ltd | |

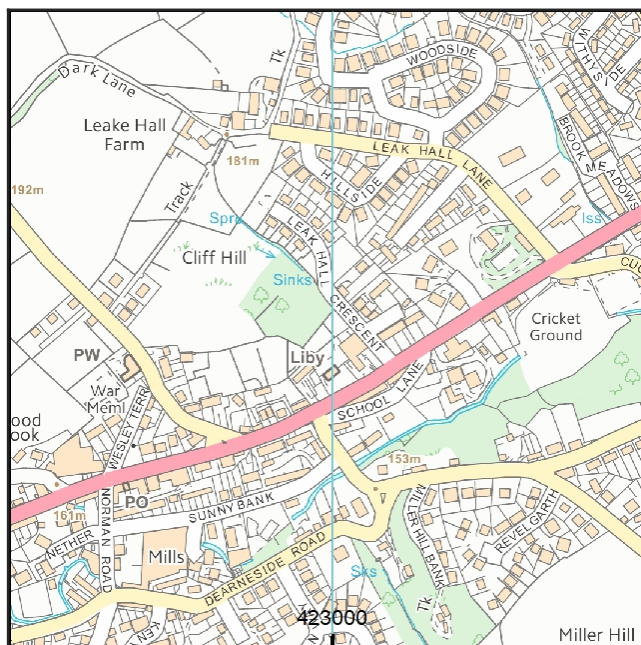
Approximate position of property

| 4 | Mine Entries | Yes | Eight mine entries are indicated to be present in close proximity to the, northwest, west and southwest of the site. All except one of these are indicated to be adits travelling in between the directions of west and north. The mine shaft and four of the adits have been investigated, located and found to be treated. No details are given for the remaining adits. |
