Oakwell Hall – Building Fabric Repair Works

Heritage Impact Assessment

2024.00049.010

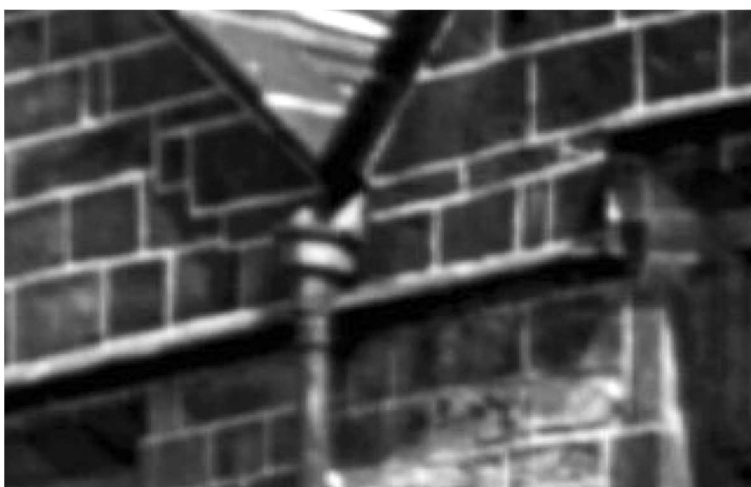
It is proposed to introduce a hopper and spitter to the valley over the porch on the front elevation. This is required as any blockage to the outlet in this location results in water ingress inside. In photographs c.1900 the hall had a much larger outlet forming a chute into the hopper, it is proposed to reintroduce this

Outlet with lead chute above.

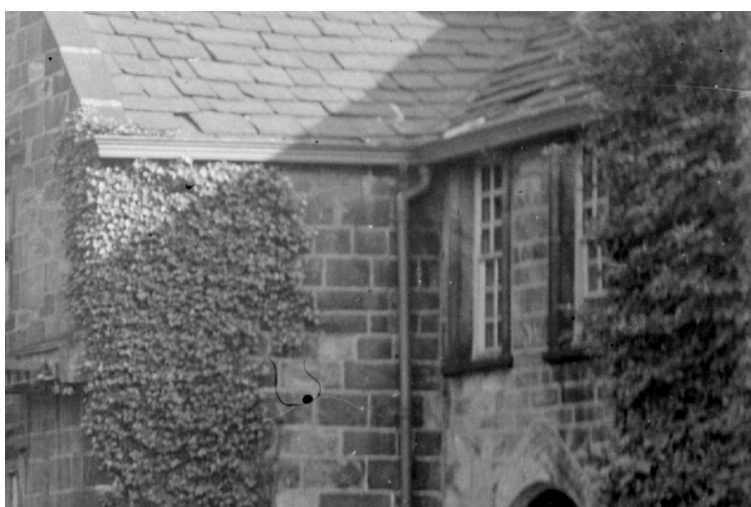
The lead lined timber gutters are in poor condition as the gutters have leaked into the timber enclosures leading to rot. The gutters require replacement. Use of cast iron will be more durable and of increased capacity, leading to greater climate change robustness. In photographs c.1900 the hall had cast iron gutters

Photo c. 1900. Cast iron gutters and pipes with cast iron swan necks.

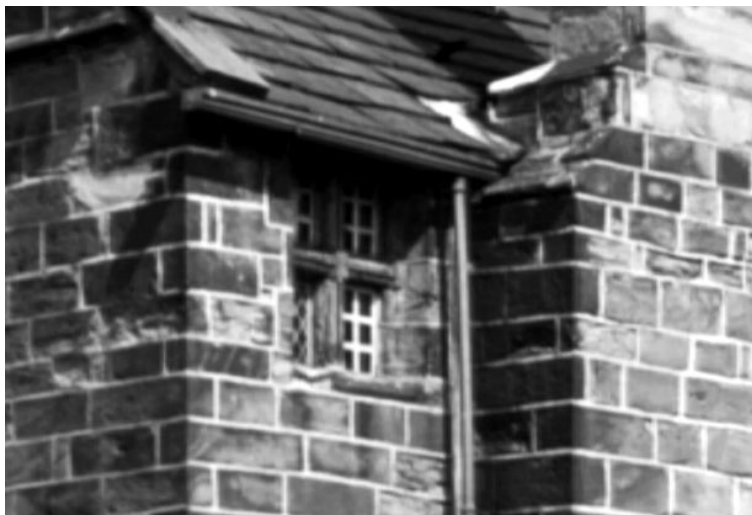
It is proposed to change to cast iron swan necks to link to cast iron rainwater pipes. In photographs c.1900 the hall had cast iron swan necks to some pipes whilst those to the east were offset from the building. It is proposed to introduce swan necks to allow all pipes to be fitted tight to the masonry as they are pre-existing in these locations and as this is a more discrete solution.

Photo c. 1900. Cast iron gutters and pipes set proud of the wall without cast iron swan necks.
