REMEDIATION STATEMENT

STONE PIT HALL, HORN LANE
NEW MILL, HOLMFIRTH, HD9 7DH

REPORT REF: MSS 3522REM

FEBRUARY 2024

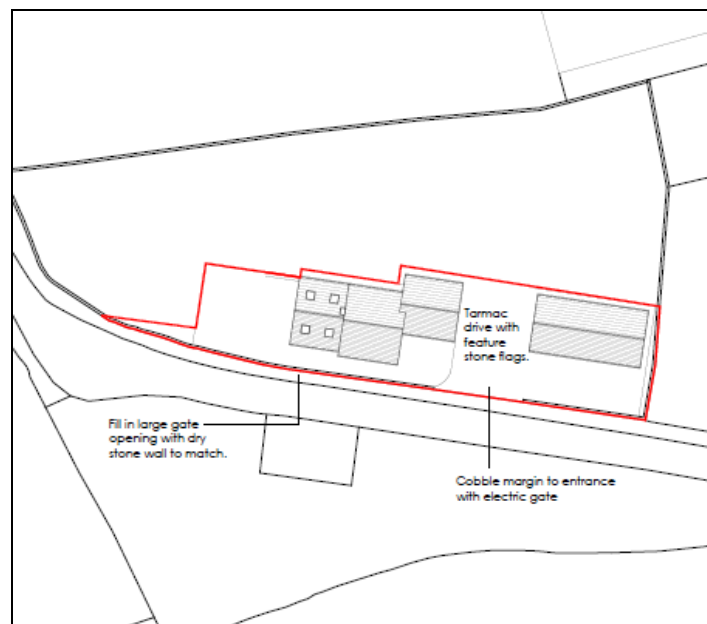
Figure 3 Proposed Development Plan

The proposals are to add an extension to the house and to demolish existing sheds and replace with a garage and hard standing in the area to the east of, and separate to the house.

A Site Location Plan is presented as Figure 1 and a Detailed Site Location Plan as Figure 2. A Proposed Development Plan is presented as Figure 3. Waste and Landfill Sites as Figure 4 and Made Ground as Figure 5. A Geological Faults and Bedrock Geology Plan is presented as Figure 6. Figure 7 illustrates a Venting material and Figure 8 presents an Installation of gas membrane and services entry.

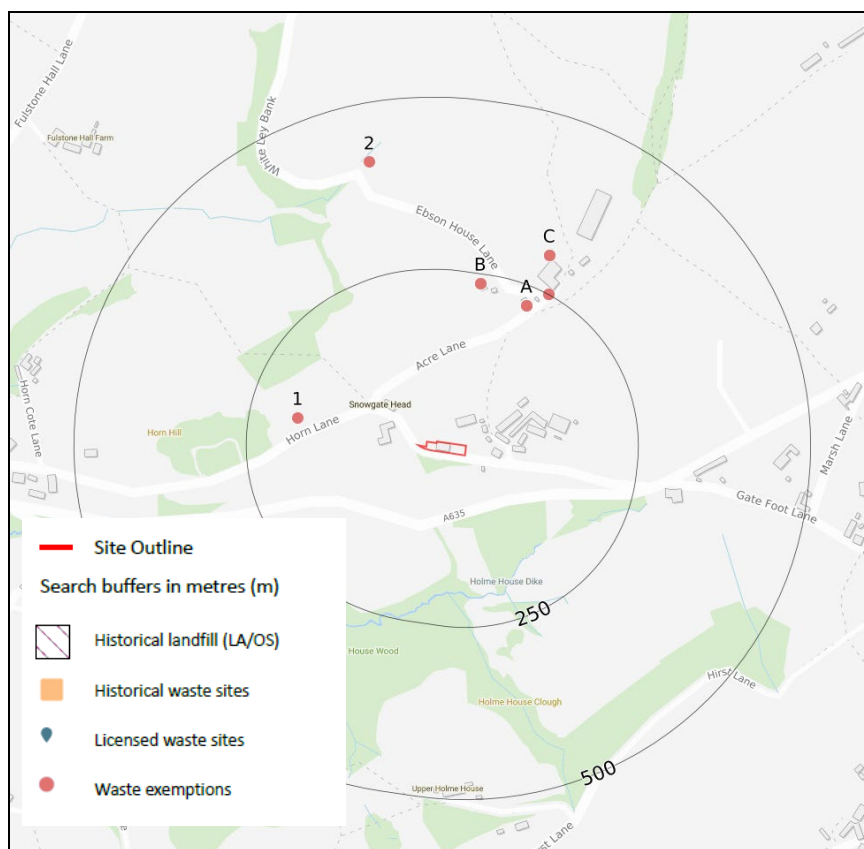
Figure 4 Waste and Landfill Sites

There are no active or recent landfill sites within 500m of the site. The BGS records and the LA/mapping indicate no historical landfill within 500m of the site. There are no historical EA/NRW landfills or historical or recently closed waste sites within 500m of site.

Waste exemption licences exist within 250m of the site area as shown in Figure 4. The closest is located 180m to the west of site at Ebson House Farm for storage of sludge. All exemptions within 250m are located at Ebson House Farm 221m and 236m distant to the north east construction,

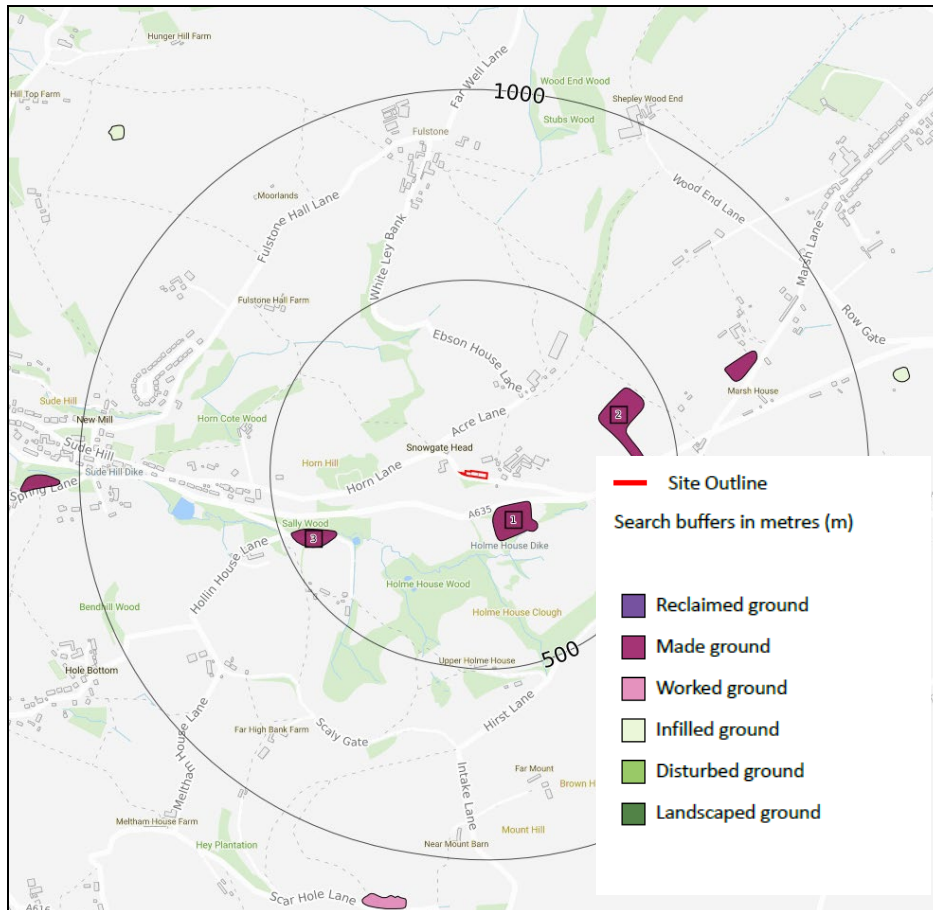
Figure 5 Made Ground

Made ground is evident 83m to the south east and represents the former colliery spoil tip as shown on Figure 5. Further worked ground is shown 400m to the south west and to the north east. Made ground is not shown to be within the site area.

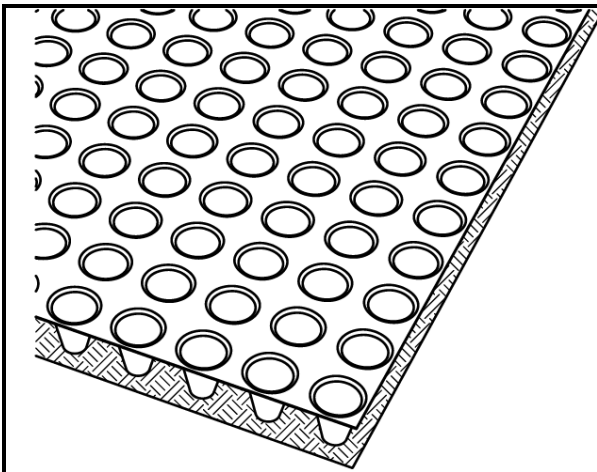
Figure 7 Venting material

The venting area could be installed with a cusped high density polyethylene (HDPE) sheet with a geotextile fabric bonded to the end of the cusps as detailed in Figure 7. Aggregate can be used instead, but it must not be MOT Grade 1 or 2. It should be clean washed aggregate with particles no smaller than 20mm and with no fines. Aggregate would need to be 300mm depth.

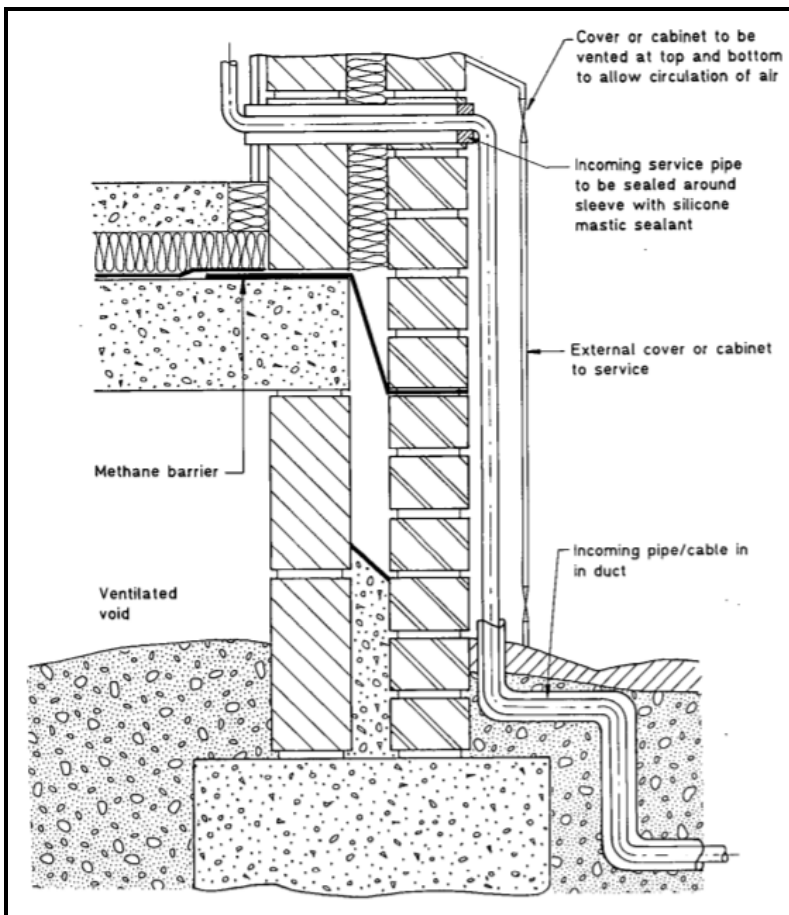
Figure 8 Installation of membrane and service entries

The membrane should be pulled taut across the plot and lapped and sealed to the gas resistant damp proof course which should extend across the wall cavities. Gas proof products should be used to fully seal the membrane at overlaps and around service entries. The products used and installation should be in accordance with the manufacturer's recommendations.

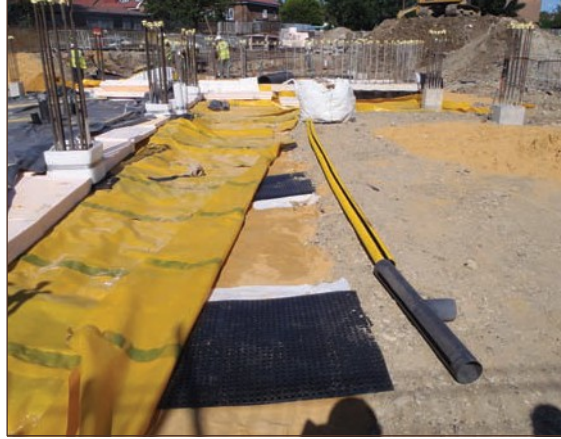
Figure A4.8 Geovent beneath the 2000g taped gas membrane lined up with collector pipes (courtesy Alderburgh Group)

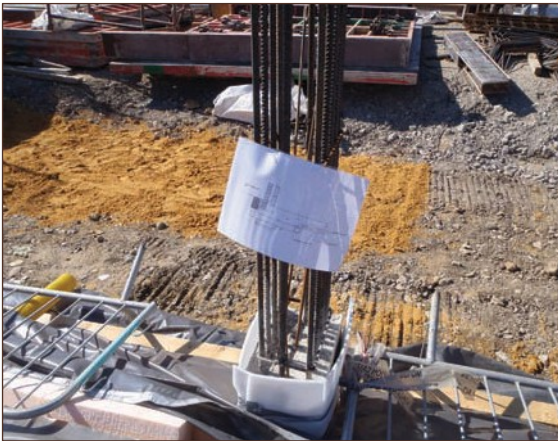
Figure A4.9 On site schematics to aid construction workers build the gas protection system (courtesy Alderburgh Group)

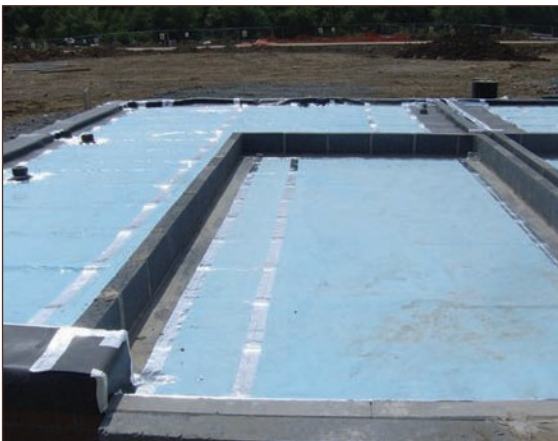
Figure A4.11 Gas membrane continued through cavity wall and above air bricks (courtesy Hydrock)

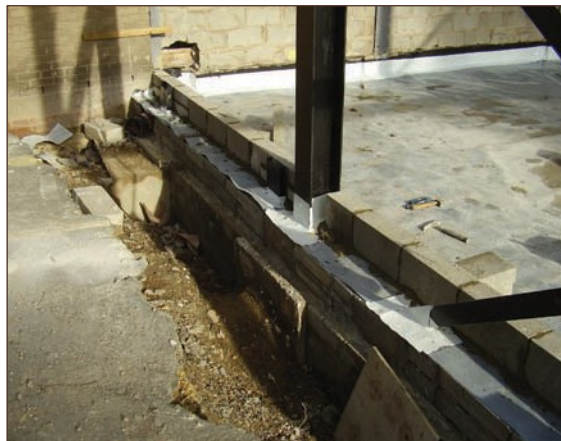
Figure A4.12 Good edge detail across cavity (courtesy PAGEotechnical Ltd)

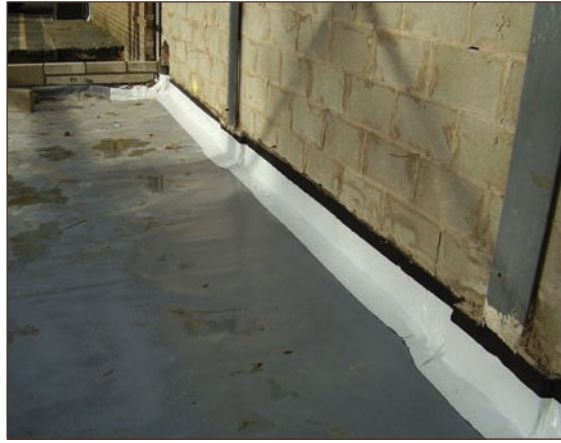
Figure A4.14 Good perimeter seal (courtesy PAGEotechnical Ltd)

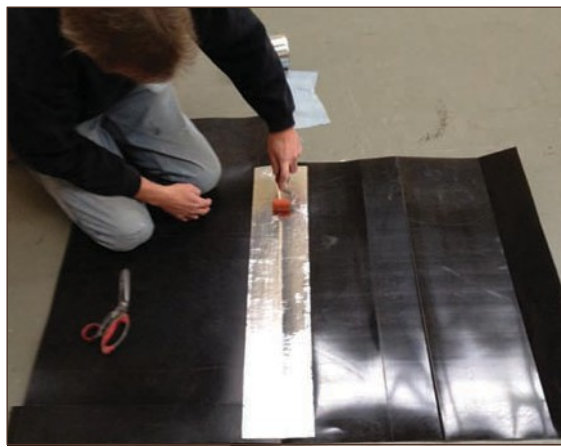
Figure A4.16 Example HDPE type gas membrane and steam roller used to ensure self-adhesive tape is correctly installed (courtesy A Proctor Group)

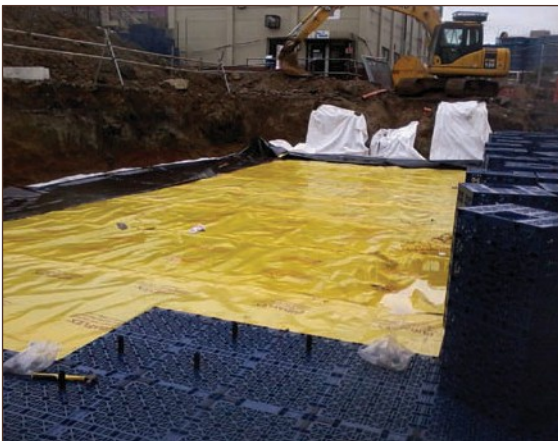
Figure A4.17 Gas membrane installed in attenuation tank (courtesy Industrial Textiles & Plastics Ltd)

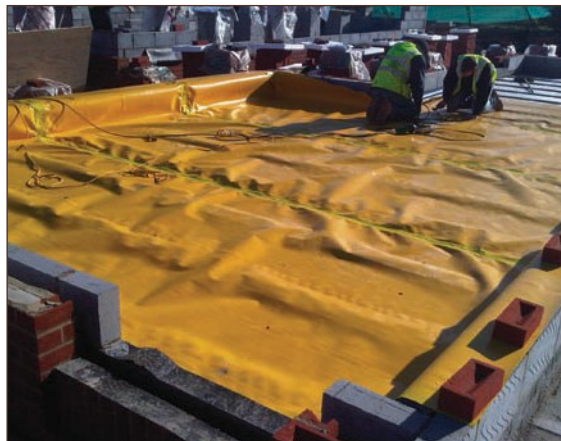
Figure A4.18 Gas membrane installed as part of foundation barrier (courtesy Industrial Textiles & Plastics Ltd)

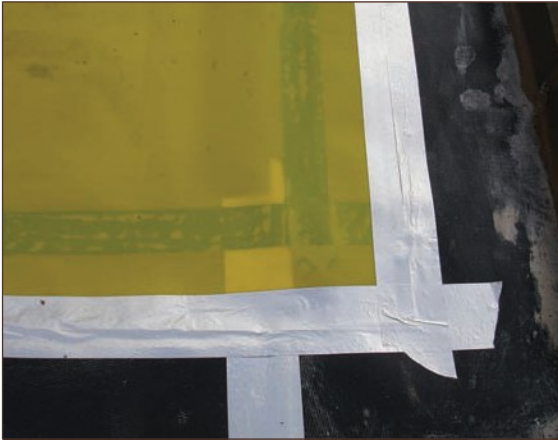
Figure A4.19 Well-constructed joints with gas resistant DPC, lap and double sided butyl joints visible beneath semi-transparent gas membrane, secondary seal with proprietary single sided tape (courtesy Smith Grant)

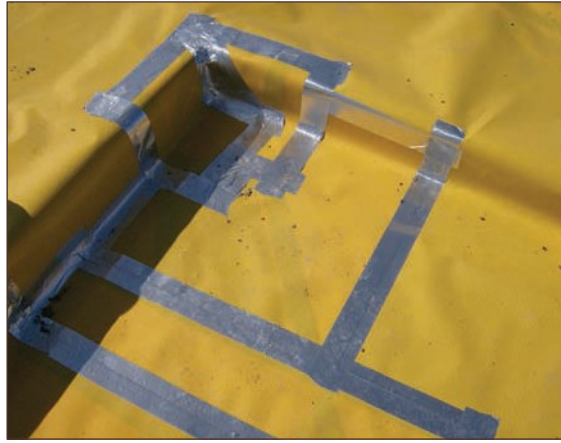
Figure A4.20 A pre-formed corner unit would have been preferable as fewer joints would have been formed, however the installer has achieved a good level of workmanship in this corner detail (courtesy Smith Grant)

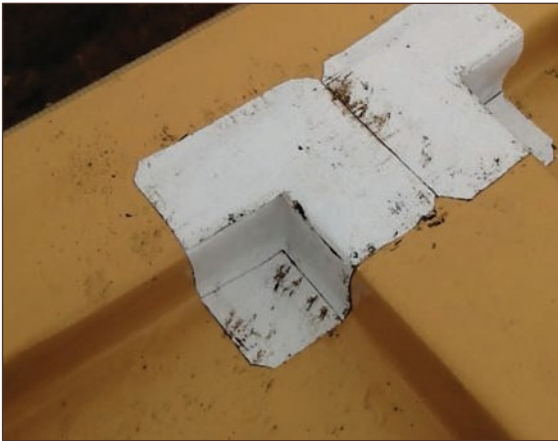
Figure A4.21 Good prefabricated corner detail (courtesy MEC Environmental Ltd)

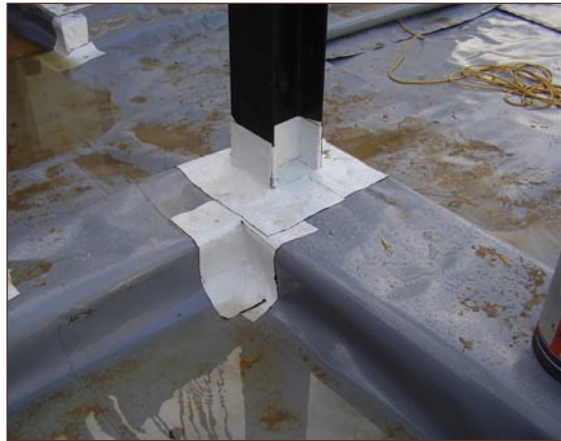
Figure A4.22 Good detail around stanchion and corner (courtesy PAGeotechnical Ltd)

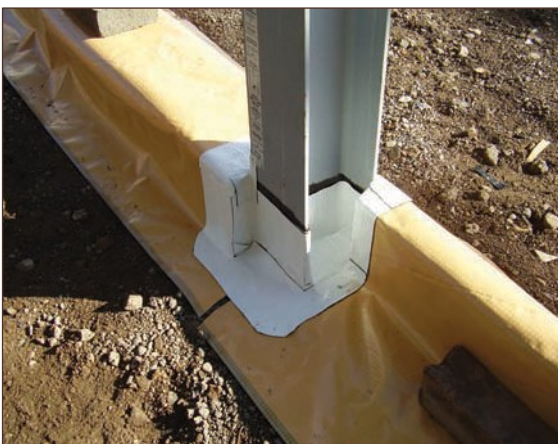
Figure A4.23 Complex column seal (courtesy PAGeotechnical Ltd)

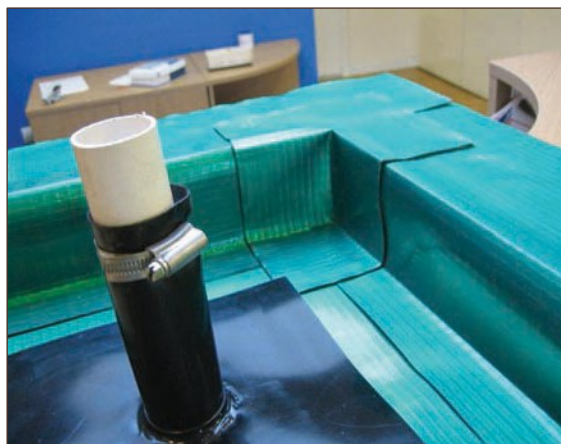
Figure A4.24 Prefabricated corner detail and top hat (courtesy A Proctor Group)

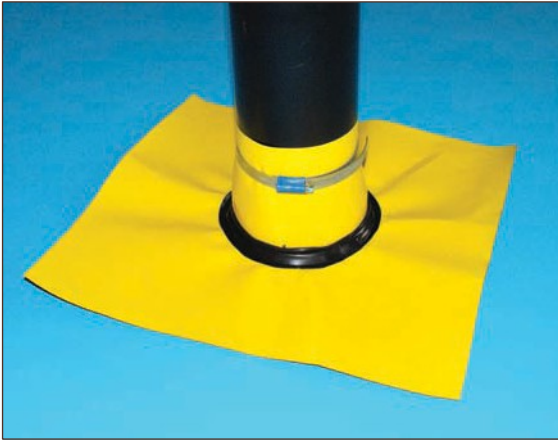
Figure A4.25 Top hat around service entry (courtesy Industrial Textiles & Plastics Ltd)

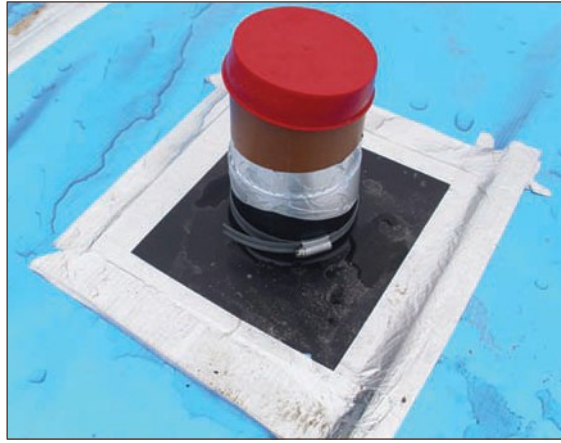
Figure A4.26 Well-constructed service entry: top hat fits well with service pipe and taped down to gas membrane, secondary seal with proprietary single sided tape (courtesy Smith Grant)

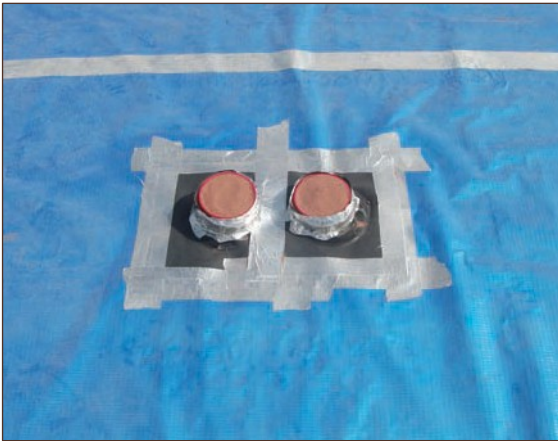
Figure A4.27 Top hats placed around service entries secured with jubilee clip seals. Top hats secured to gas membrane with double sided butyl tape (courtesy Hydrock)

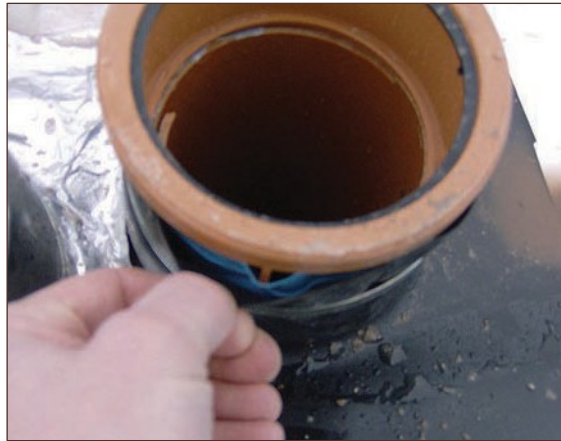
Figure A4.28 Bead of double sided butyl tape provided between interfaces of ID top hat and OD service pipe. When compressed with jubilee clip, forms an effective seal (courtesy Smith Grant)

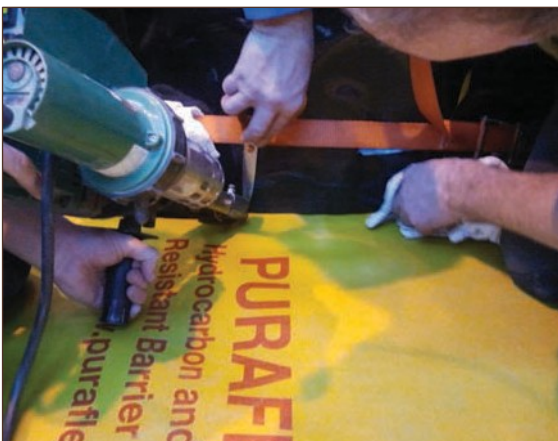
Figure A4.29 Extrusion welding technique (courtesy Industrial Textiles & Plastics Ltd)

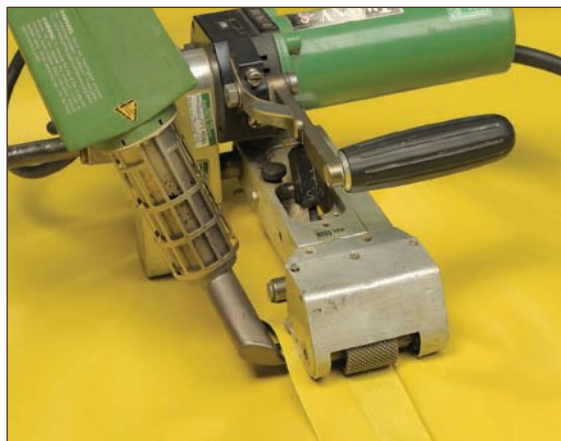
Figure A4.30 Thermal welding technique (courtesy Industrial Textiles & Plastics Ltd)

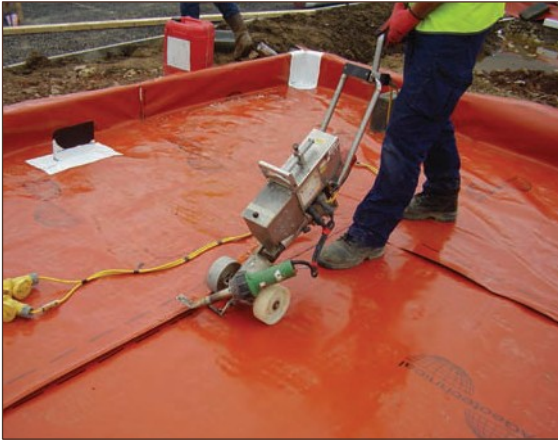
Figure A4.31 *Extrusion welding (courtesy PAGeotechnical Ltd)*

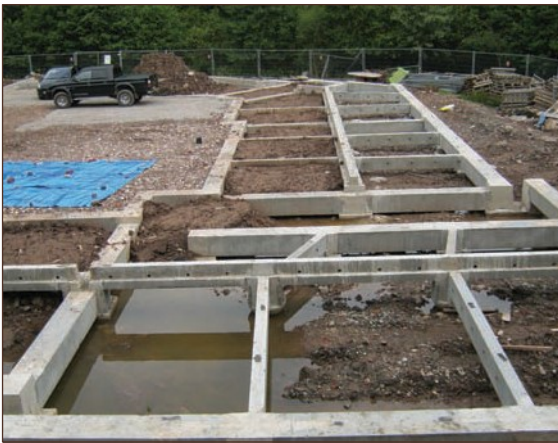
Figure A4.33 *Good ventilation in internal sleeper walls, cast into prefabricated beams (courtesy Smith Grant)*

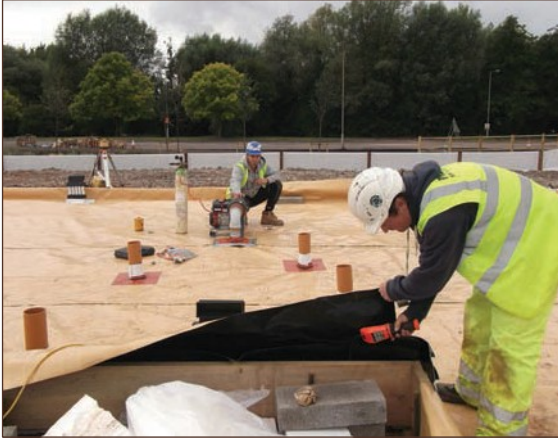
Figure A4.37 Tracer gas testing, whereby gas or smoke is applied under pressure beneath the installed gas membrane and detectors are used to screen for leaks above (courtesy NHBC)

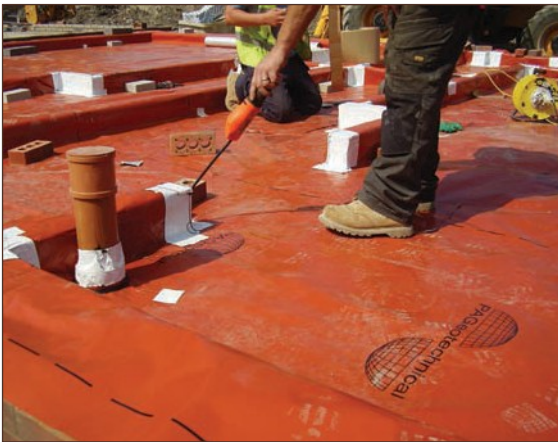
Figure A4.39 Scanning for leaks (courtesy PAGeotechnical Ltd)

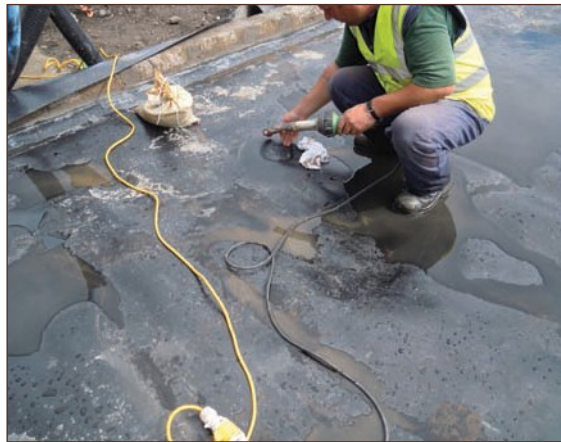
Figure A4.40 CO₂ injection integrity testing (courtesy Landline Ltd)

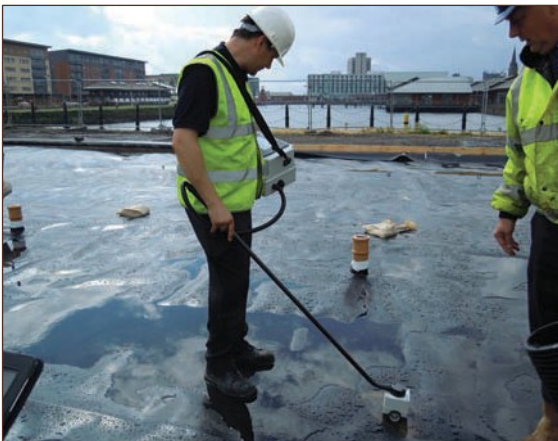
Figure A4.41 Small sand bags are marking holes made in the gas membrane used to check whether injected CO₂ has worked its way beneath whole area (courtesy Landline Ltd)

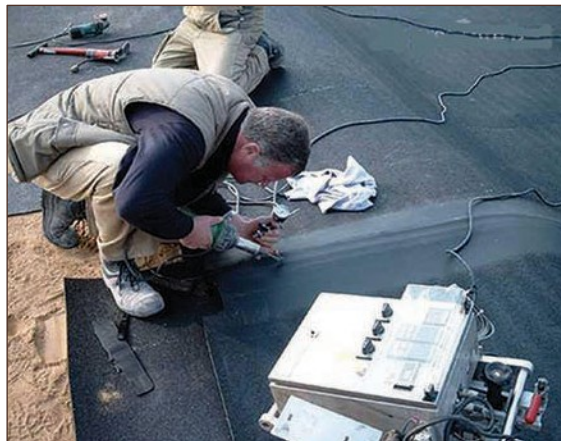
Figure A4.42 Air pressure testing (courtesy GSE Environmental)

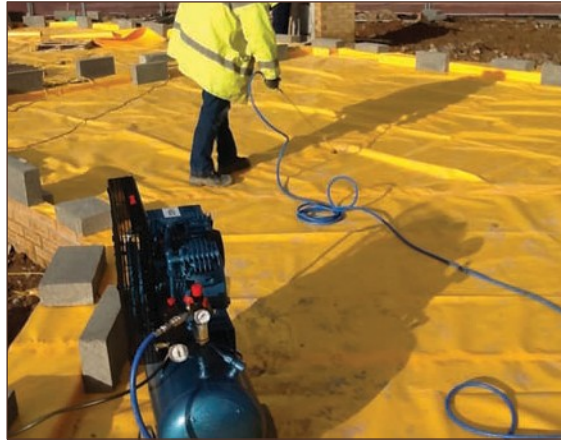
Figure A4.44 Air lance test, used to test the quality of welded seams along gas membrane joints (courtesy MEC Environmental Ltd)

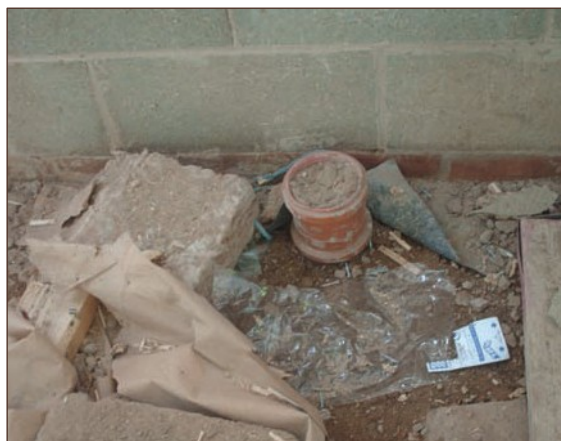
Figure A4.48 Loose nails and over construction debris likely to be left in place beneath gas membrane – poor preparation of gas membrane prior to sealing service penetration (courtesy Card Geotechnics Limited)

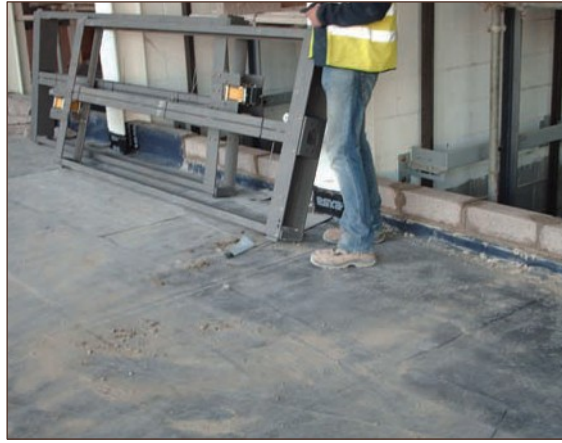
Figure A4.50 *Large/heavy/sharp objects being moved over unprotected gas membrane (courtesy Card Geotechnics Limited)*

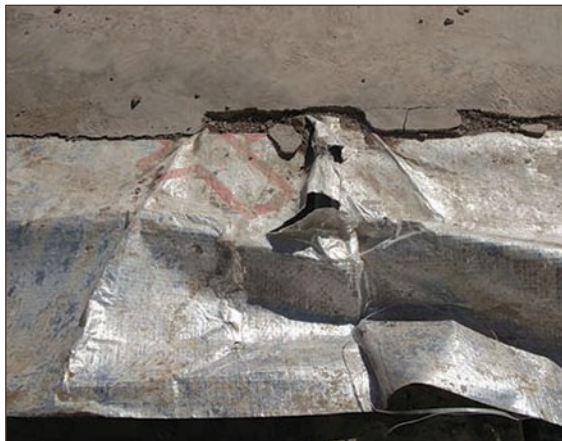
Figure A4.54 *Gas membrane damage/tearing at edge of ground floor slab screed layer where it was left exposed to elements for period of time (courtesy NHBC)*

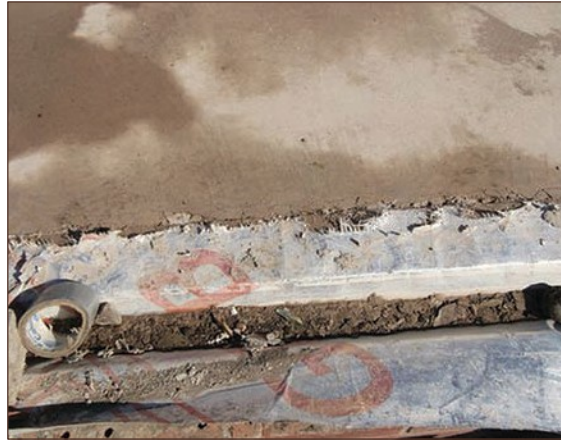
Figure A4.56 Gas membrane at edge of concrete screed. Screed has been grinded to achieve desired levels, gas membrane shows extreme wear and damage as a result (courtesy NHBC)

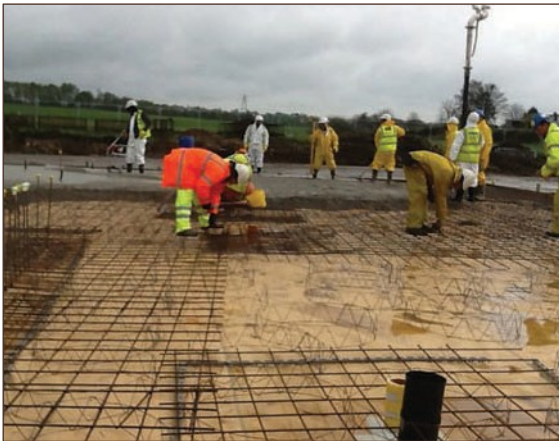
Figure A4.57 Unprotected gas membrane damaged by heavy traffic (courtesy MEC Environmental Ltd)

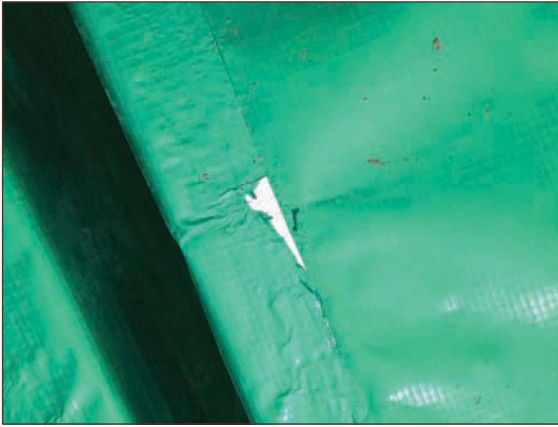
Figure A4.61 'Stripping' occurs on gas membranes that contain aluminium foil. The foil gets too hot under the outer layer of LDPE or PP and the top layer of the gas membrane sticks to the roller which strips it off, leaving the aluminium completely exposed (courtesy MEC Environmental Ltd)

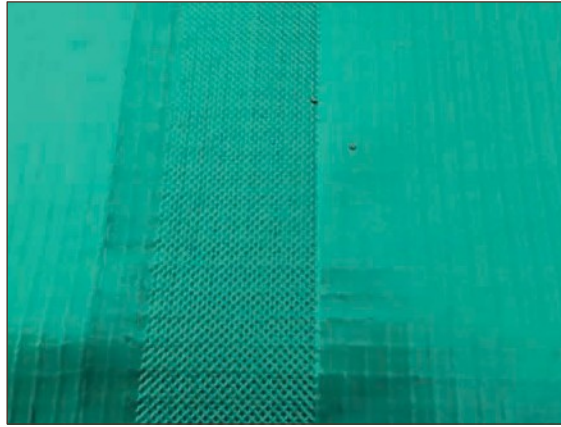
Figure A4.62 Wedge weld on an LDPE aluminium gas membrane, where the installer used metal nip rollers. This destroyed the top layer and probably the bottom layer, leaving aluminium exposed between the weaves. This failed dielectric testing along all joints (courtesy MEC Environmental Ltd)

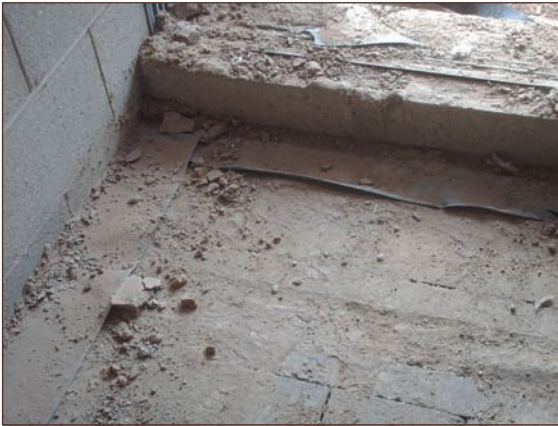
Figure A4.63 Absence of surface preparation prior to laying of gas membrane, debris likely to pierce gas membrane (courtesy Card Geotechnics Limited)

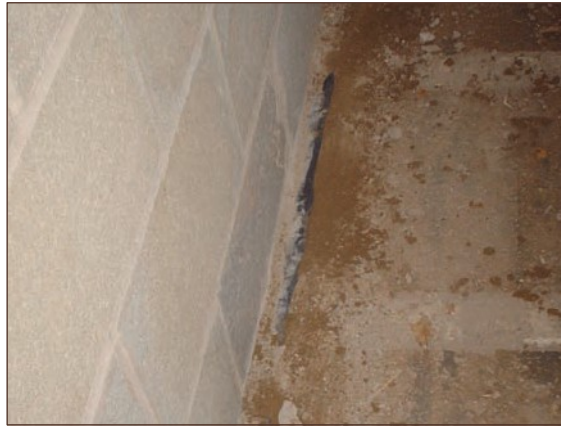
Figure A4.64 Insufficient length of gas membrane protruding through wall to overlap with gas membrane within building (courtesy Card Geotechnics Limited)

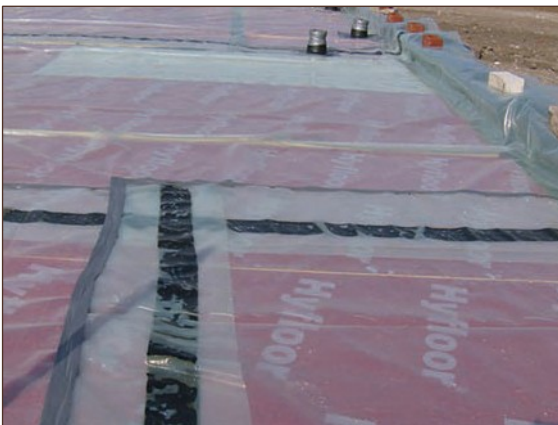
Figure A4.65 Wrinkling of gas membrane over joint has resulted in gaps (only visible due to the use of a transparent gas membrane) and the secondary seal uses ordinary gaffer tape rather than a proprietary product (courtesy Smith Grant)

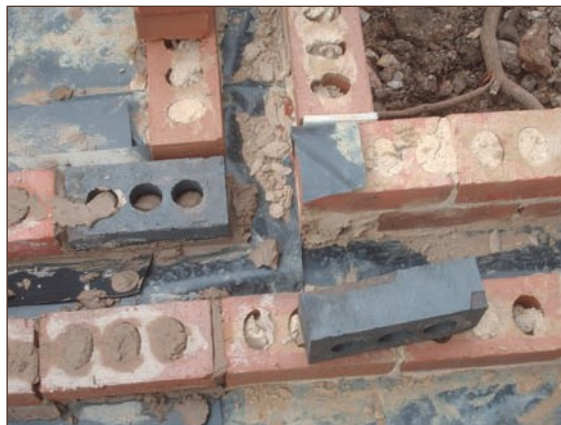
Figure A4.66 Follow-on trades proceeded work before gas membrane joints sealed (courtesy Card Geotechnics Limited)

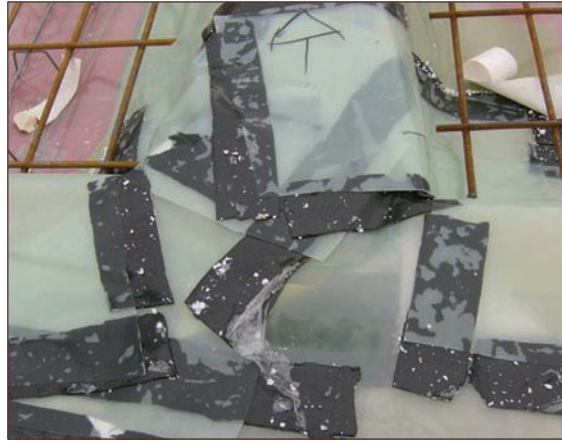
Figure A4.68 A pre-formed corner unit would have been preferable. The installer could not produce sufficient quality despite the amount of tape applied (courtesy Smith Grant)

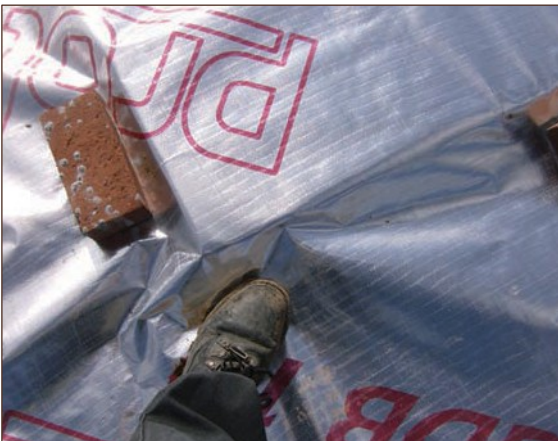
Figure A4.71 No corner detailing leading to stress point on gas membrane (courtesy Smith Grant)

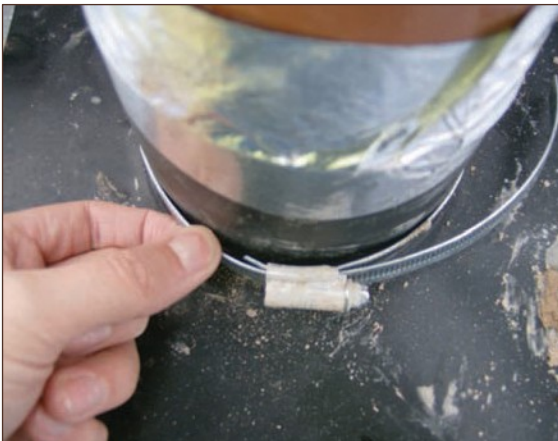
Figure A4.75 Jubilee clip on service entry insufficiently tightened so joint is uncompressed (courtesy Smith Grant)

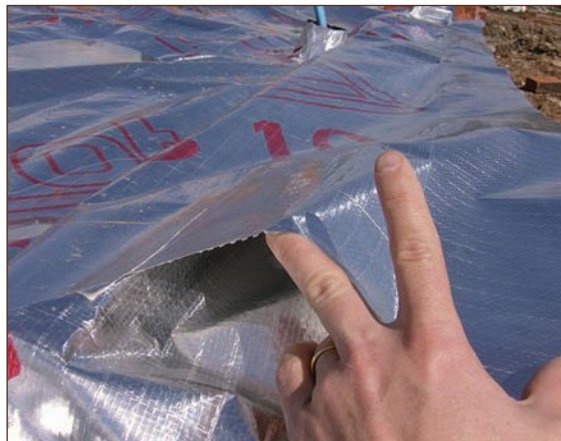
Figure A4.78 Gap in jointing over wall cavity big enough to insert fist (courtesy Smith Grant)

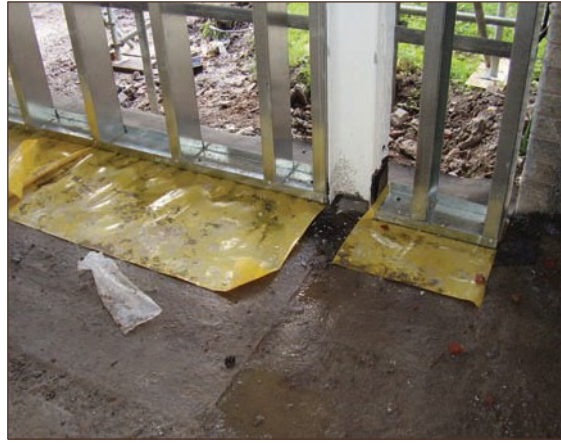
Figure A4.80 Column left unsealed (courtesy PAGEotechnical Ltd)

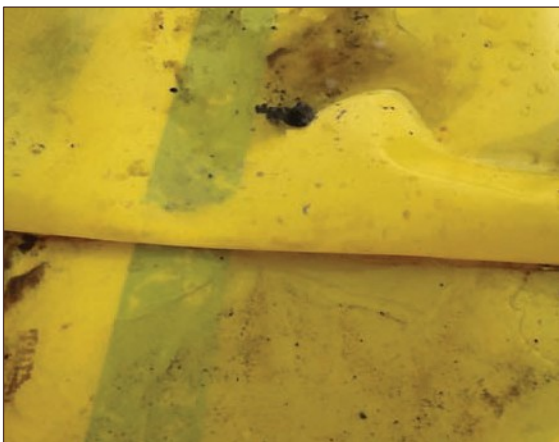
Figure A4.87 Tape joint with crease running through and air bubbles where gas membrane not in complete contact with tape. Rollers should have been used to produce a consistent seal (courtesy MEC Environmental Ltd)

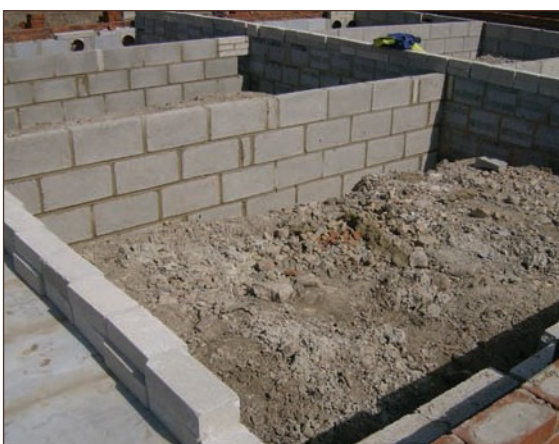
Figure A4.89 No ventilation in internal sleeper wall (courtesy Smith Grant)
