COAL MINING RISK ASSESSMENT REPORT

Report on a Coal Mining Risk Assessment

Location: **Busk Farm, Northfield Lane**
Highburton, Huddersfield, West Yorkshire, HD8 0QT

Report No. C3473/23/E/5263.REV1

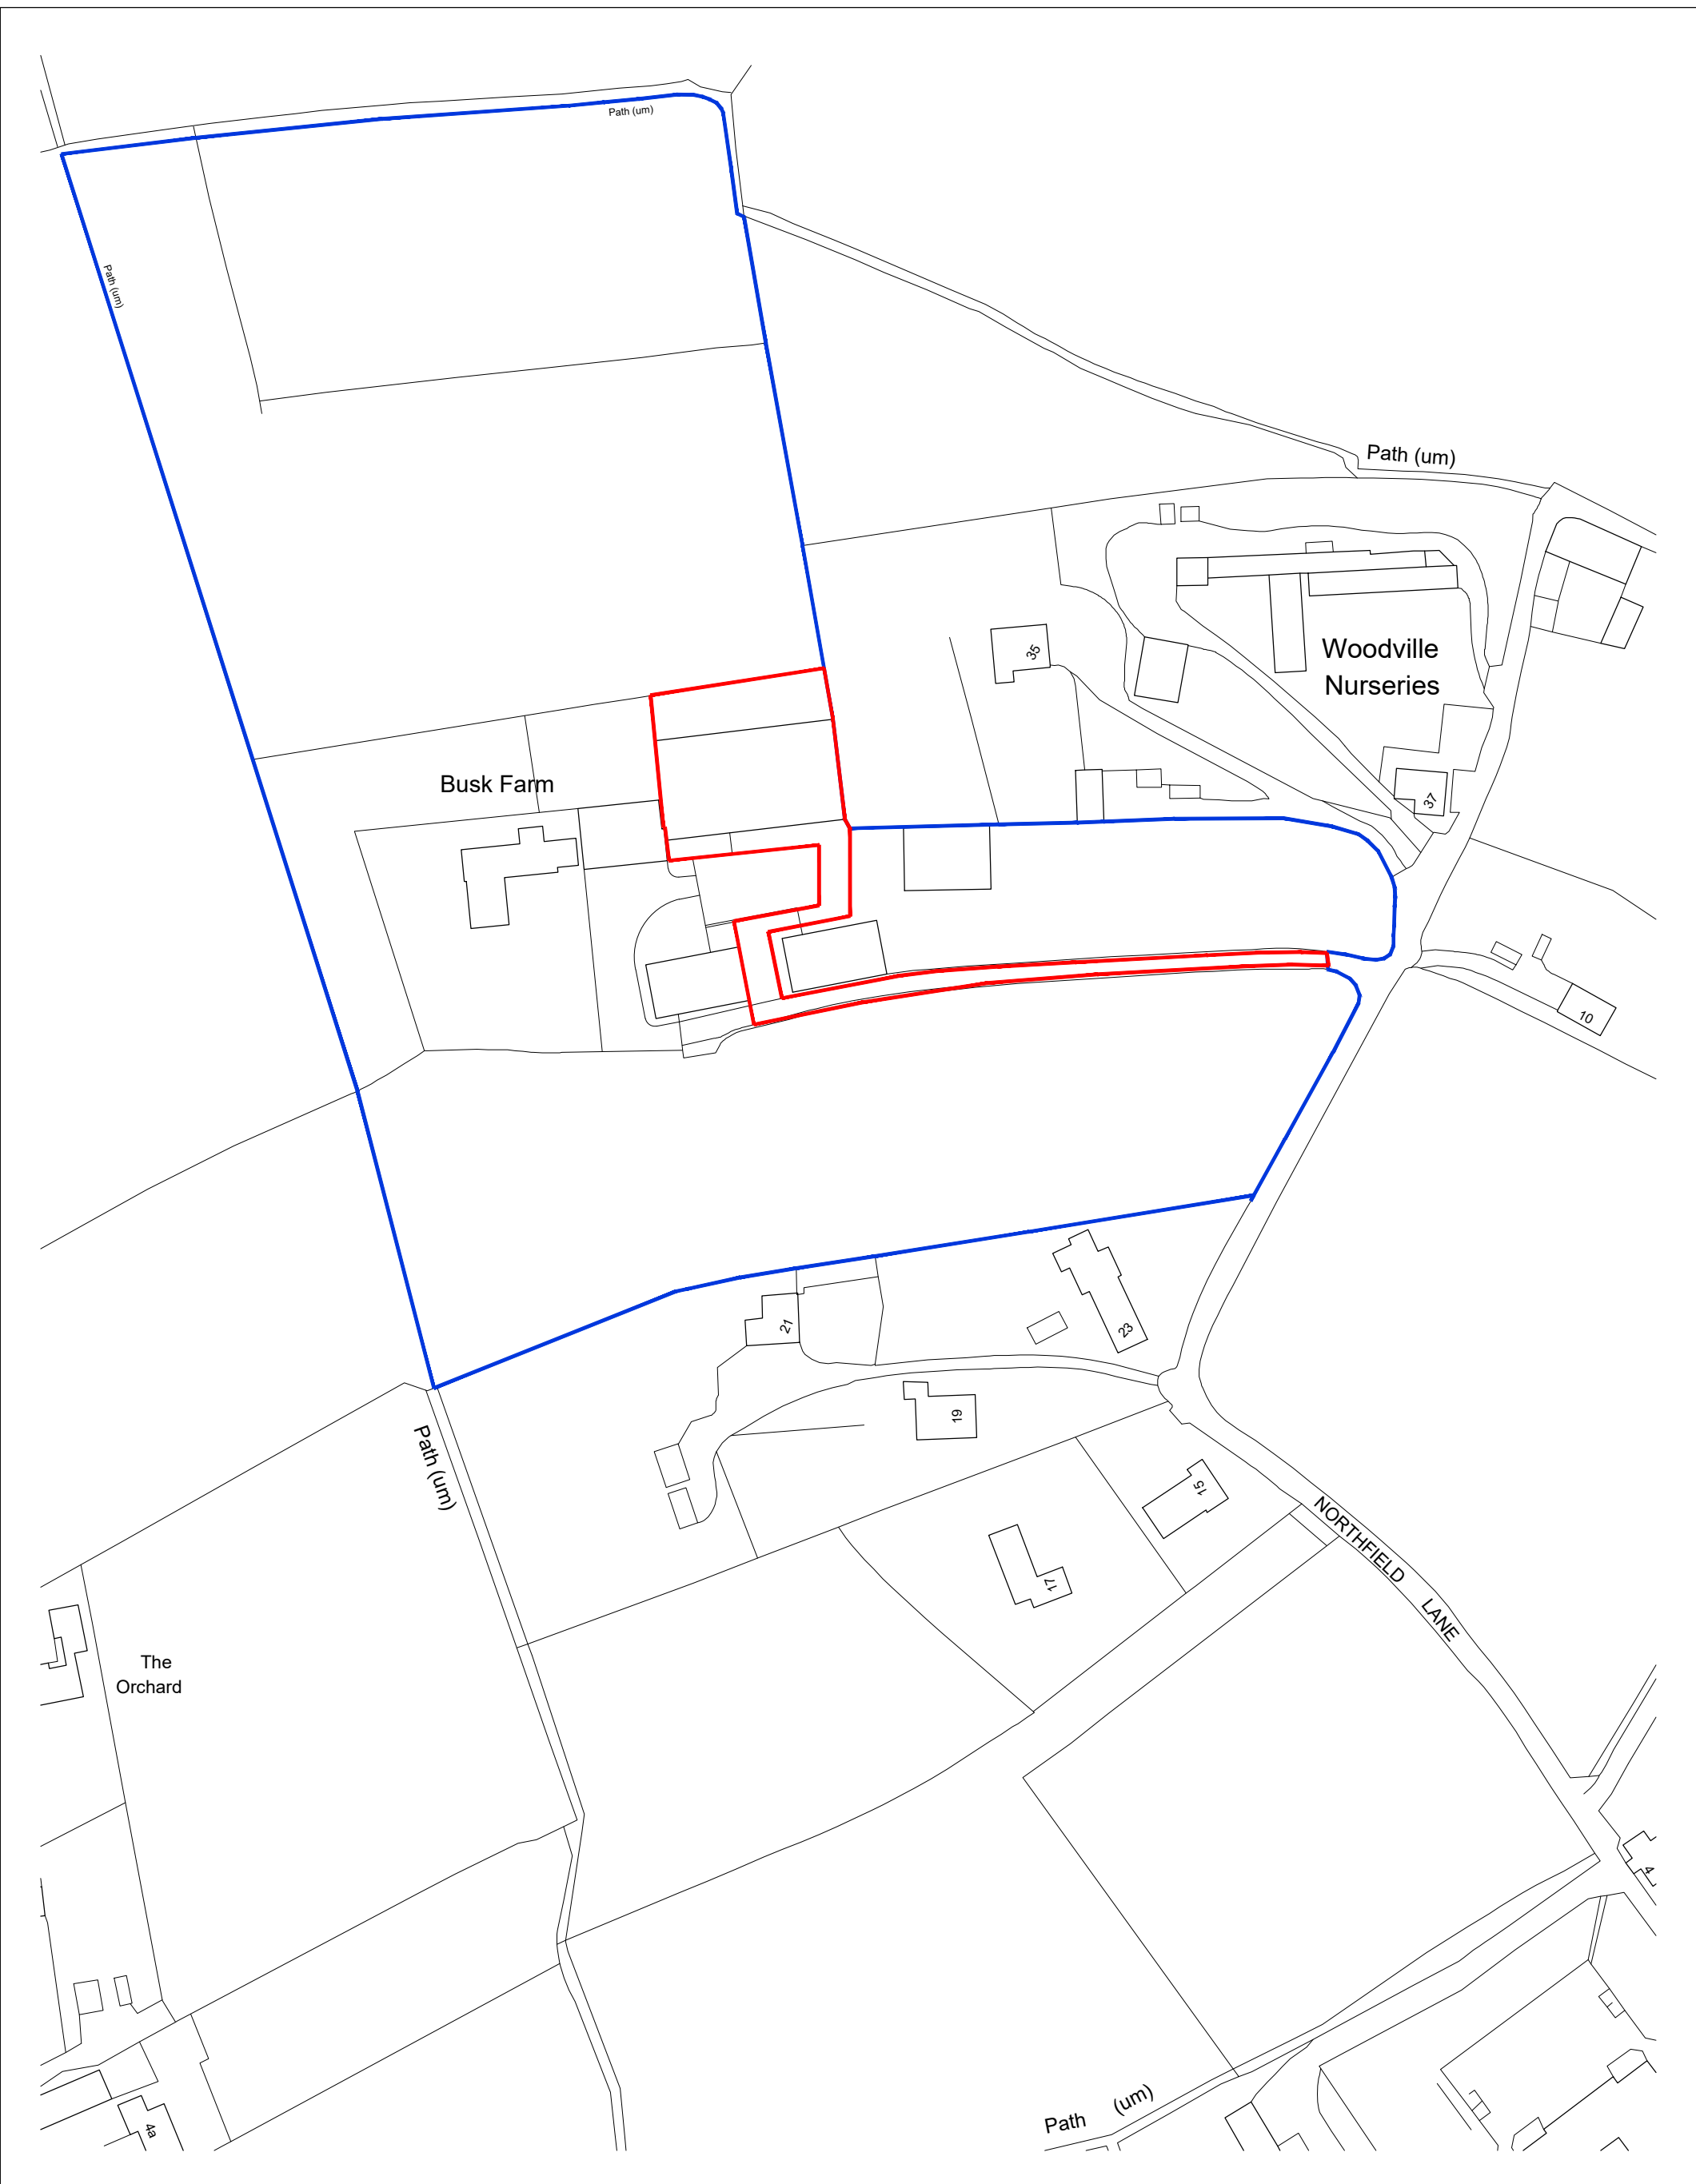
Site Plan

Project	Proposed replacement building at Busk Farm, Northfield Lane, Kirkburton
Client	Mr R Andrews, Busk Farm, Northfield Lane, Kirkburton HD8 0QT
Dwg Title	(25432)1_Location Plan
Scale	1: 1250 @ A3
Date	October 2023
