**The Arcade, Dewsbury  
& 18-20 Corporation Street / 17 Foundry Street**

Design and Heritage Statement Addendum

1705-BDP-AD-XX-RG-Z-00006

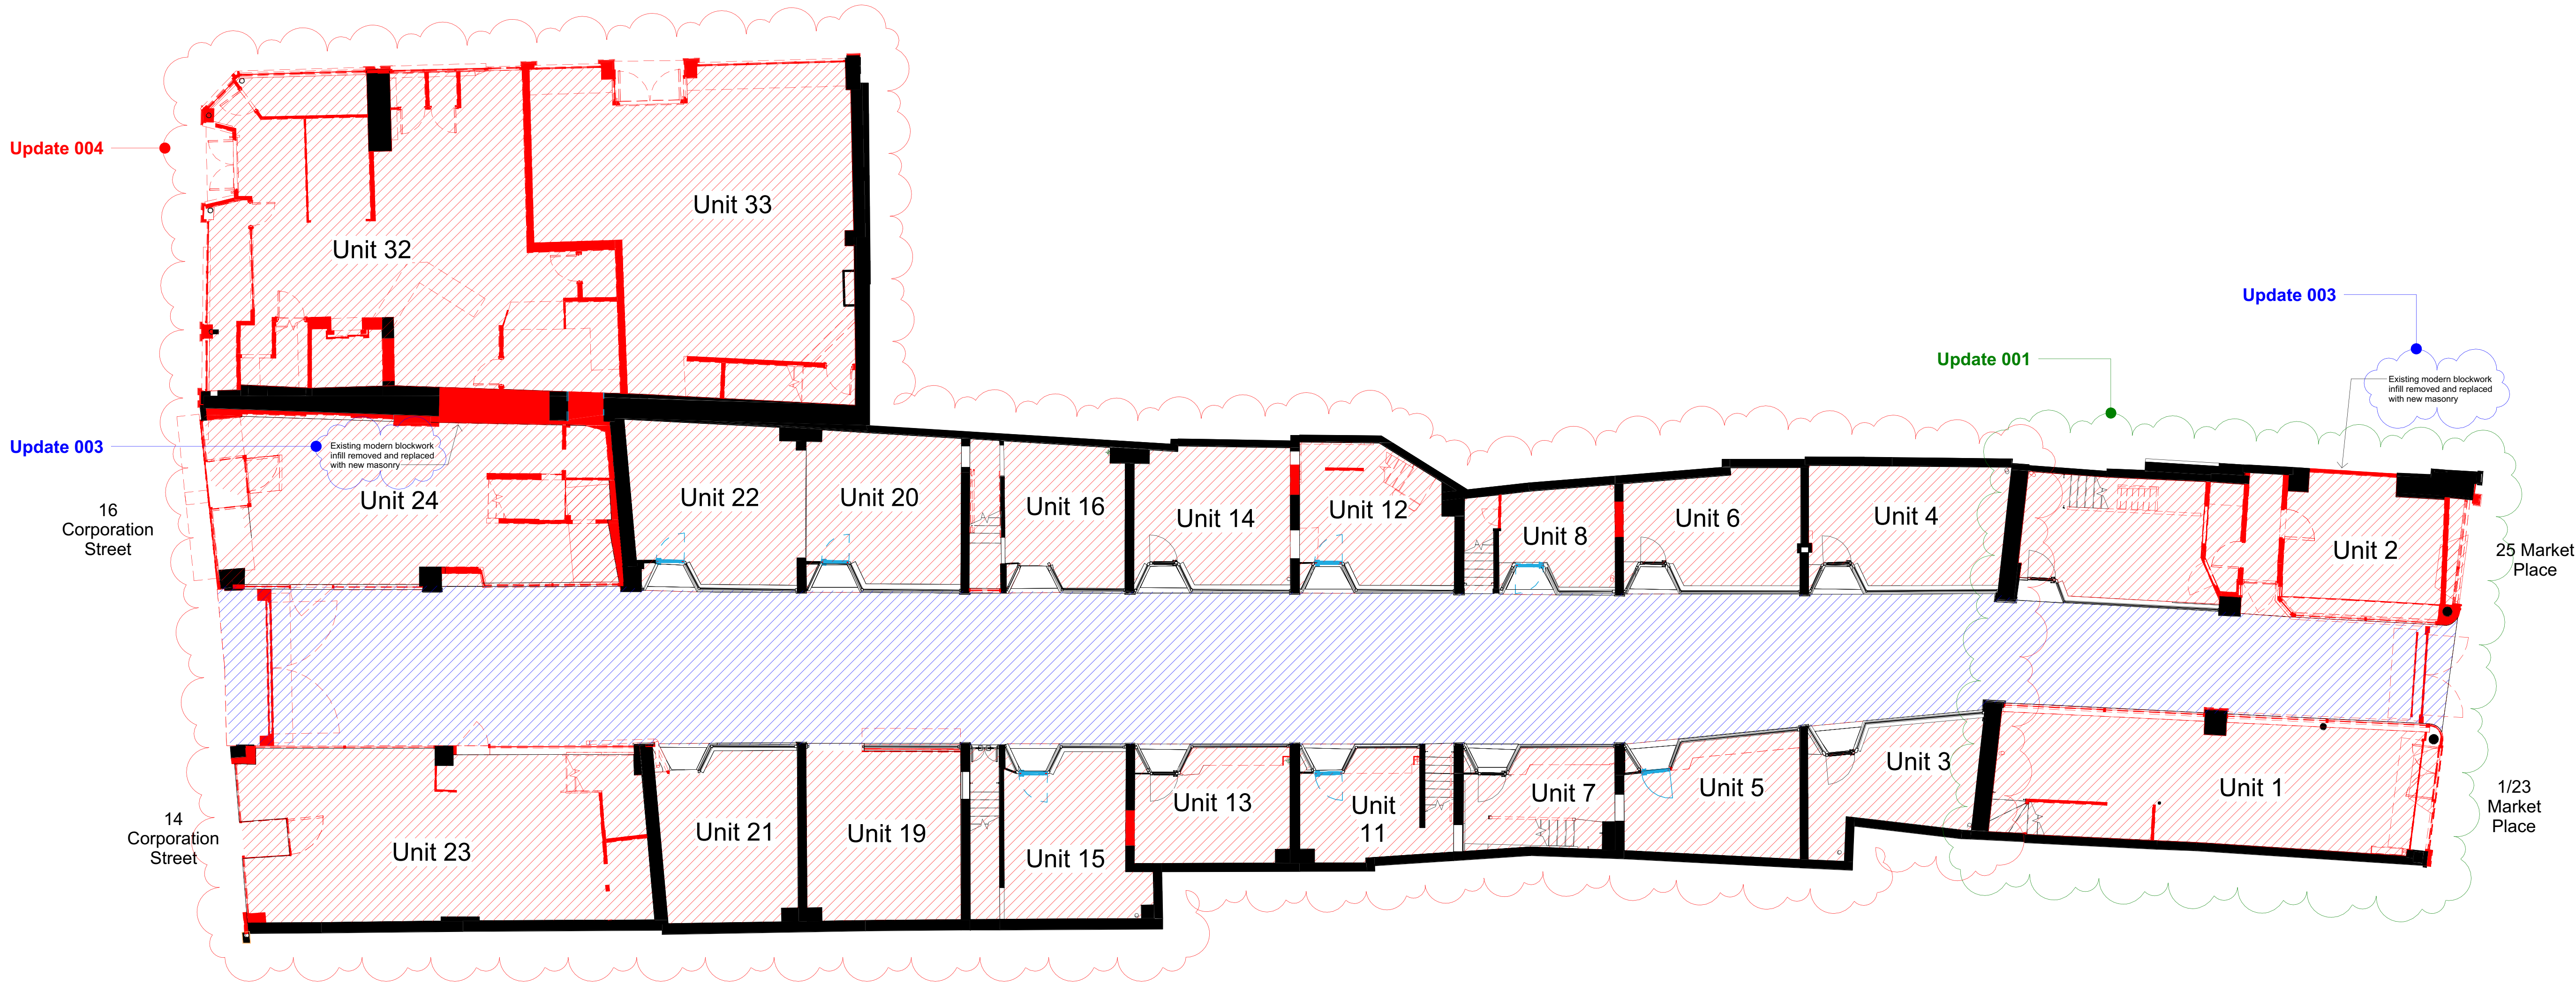
Please refer to Structural Engineers documentation for replacement of slabs in ground floor retail units

Where floor area has been removed as a result of wet and dry rot decay
-

| Ref | Location | Element | Original consented proposals | On-site discoveries (where applicable) | Issue caused / Opportunity for improvement | Proposed solution to address issue | Impact (see 1.2) | Relevant drawing(s) as consent | Updated proposed drawings |
|---|---|---|---|---|---|---|---|---|---|
| 001 | 23-25 Market Place<br>Units 1 and 2 | Floors | Existing later poorly-constructed steel post and beams within timber suspended floor to be removed. | Following on-site opening up the existing timber floor structure was found to be in poor condition and have wet rot, with numerous steel beams added. | <b>CONDITION + PERFORMANCE:</b> The structural engineer confirmed the existing structure was unsuitable for the proposed building use and could be subject to future decay preventing continued viable and flexible uses. | Replace the suspended timber floor. The location of the floor below the surrounding external ground levels would make the ends of any timber joists prone to rotting (as evidenced on the existing joists and extensive unsuccessful past repair attempts). It is therefore proposed that a concrete suspended floor is installed in these two units. | Minor Adverse | 1705-BDP-AD-00-PL-A-20002_T01 | 1705-BDP-AD-00-PL-A-20002_T02 |
| 004 | Central Arcade, 14-16 Corporation Street, 18-20 Corporation Street and 17 Foundry Street<br>Units 3-8, 11-15, 19-24, 32 and 33 | Floors | Existing floor slab to be locally removed for new building services and then reinstated. | The floor slabs in these units were found to be several thin layers of poor quality screed directly onto the soil, rather than actual slabs. The overall thickness of these layers was considerably thinner than expected for a proper slab. | <b>PERFORMANCE:</b> It would not be possible to dowel into the existing 'slabs' to reinstate areas of slab following the installation of new building services. It could lead to differential settlement between the existing areas of slab and the new infill areas preventing continued viable and flexible uses. | Remove more of the existing screed layers and install complete slabs to these units, to avoid future differential settlement. This strategy has already had consent in unit 16 and slabs are concealed under the consented floor finishes. | Negligible | 1705-BDP-AD-00-PL-A-20002_T01 | 1705-BDP-AD-00-PL-A-20002_T02 |

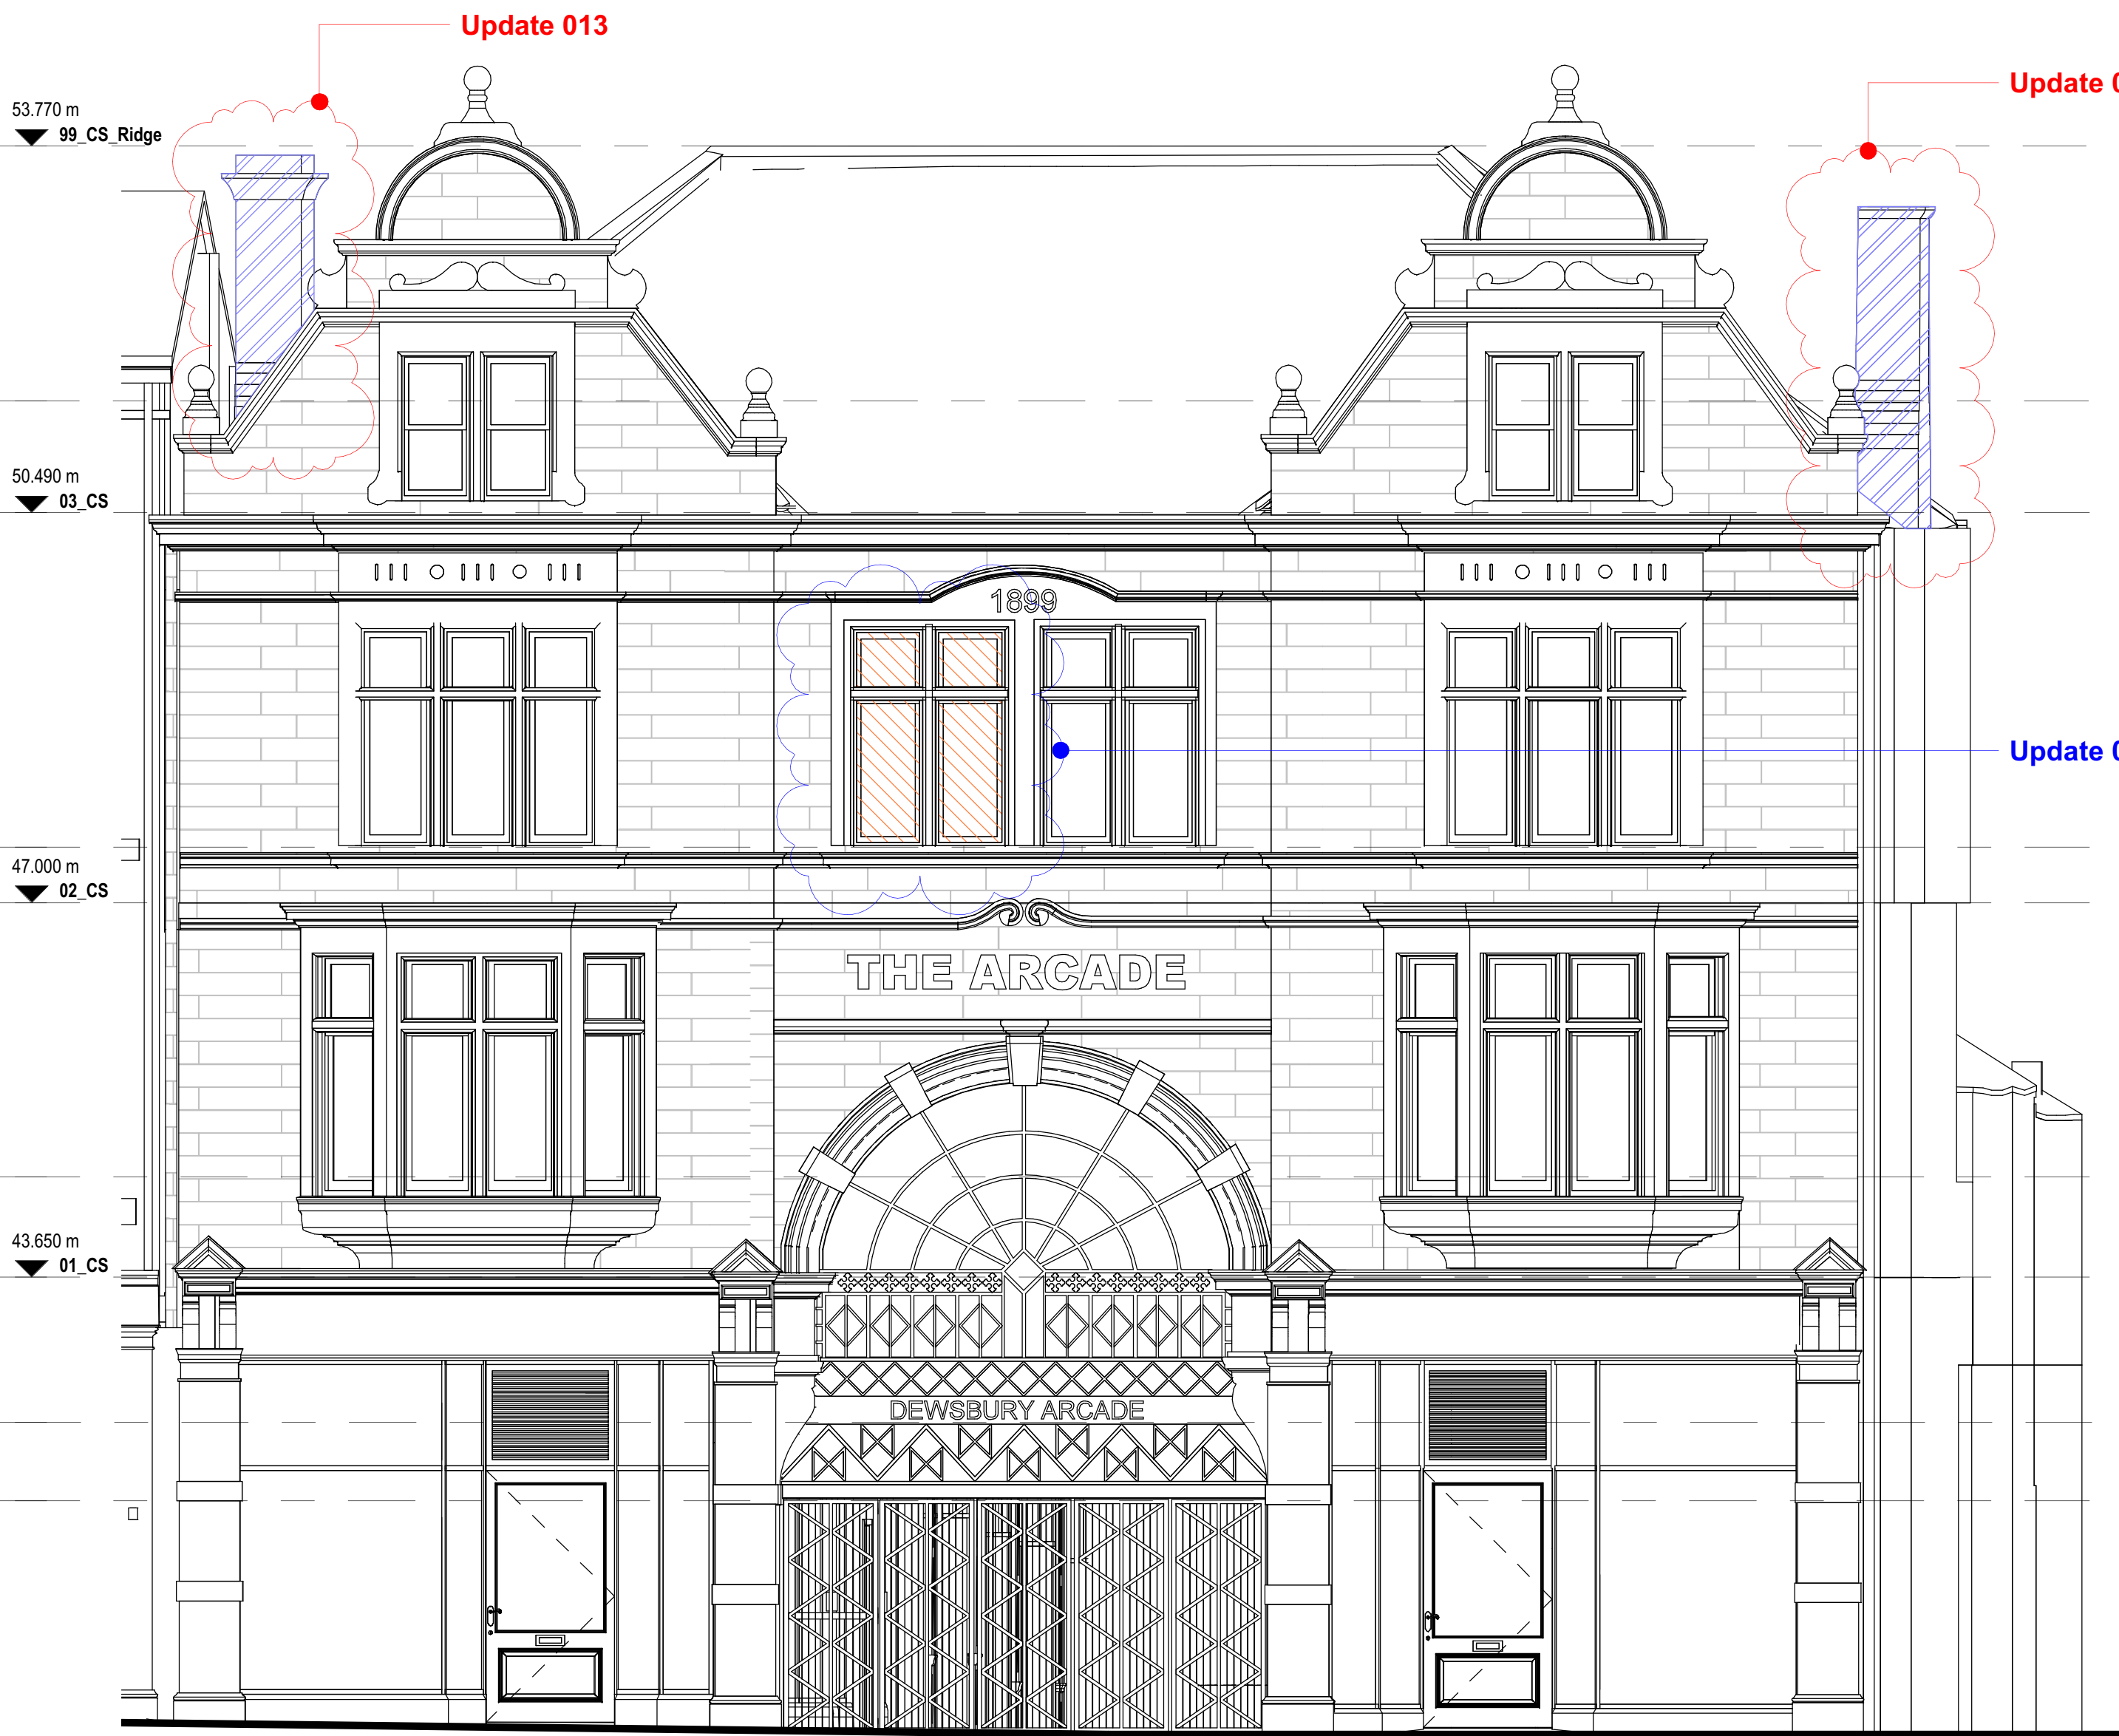
2 North Elevation\_Proposed  
1 : 50

RAINWATER GOODS

All rainwater pipes to be renewed in new cast iron
