# Coal Mining Risk Assessment ACCU Stadium Hotel

## Prepared for Town Sports & Entertainment Group Limited

**April 2026**

**KSTAD-CCL-XX-XX-RP-G  
02601\_Rev02**

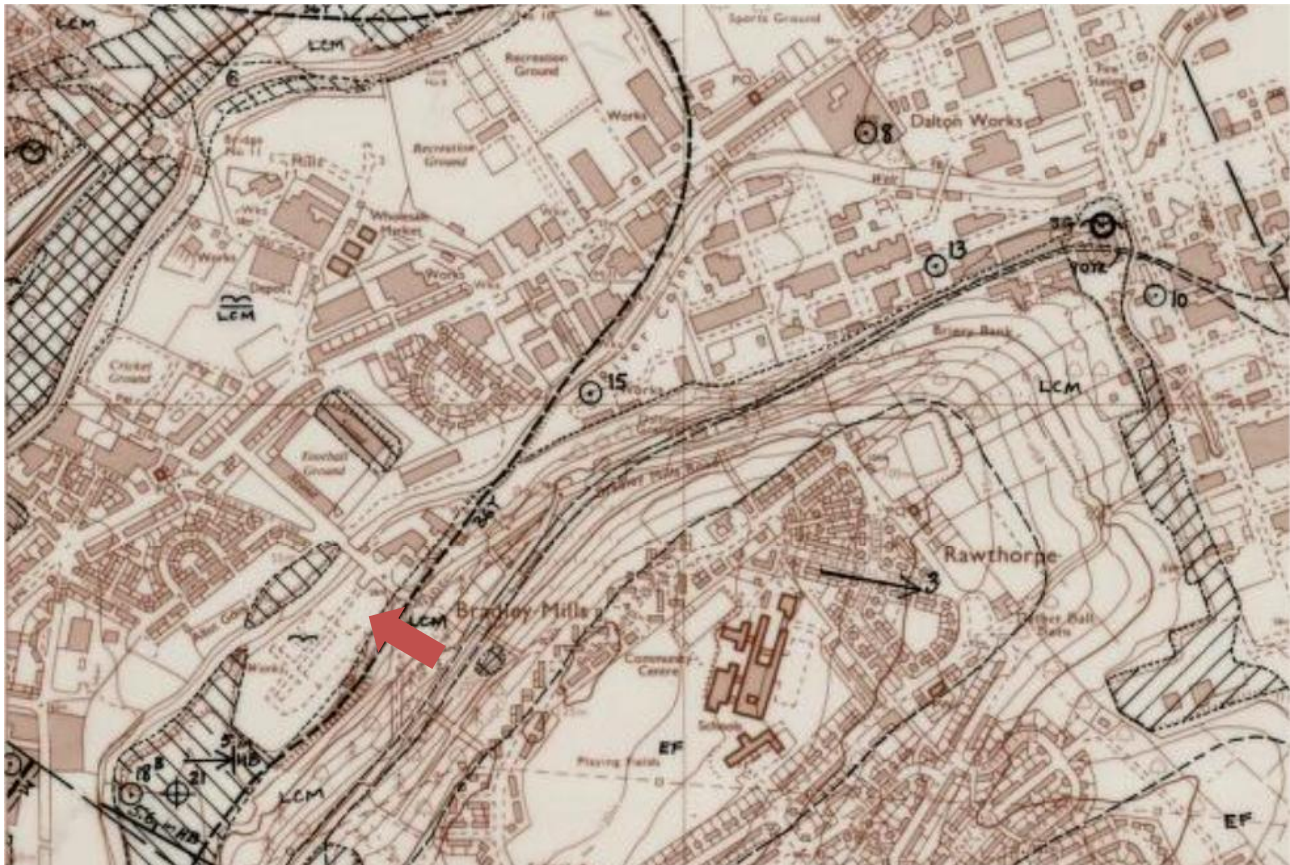
**Figure 3 – Excerpt from 1999 1:10,000 Scale Geological Mapping**

Several boreholes and shafts were indicated to be present within close proximity to the site on the BGS 1:10,000 and 1:10,560 maps of the area. Extracts of these are presented below as Figure 3 and Figure 4.

**Note:** Red Arrow = Site Location.

A borehole approximately 280m to the south west of the site (reference SE11NE21, also shown as '21' in Figure 3 and the Grove Pit shaft in Figure 4 above) indicates that the Hard Bed Coal seam was worked at a depth of 81ft (21.3m). The seam is indicated to be 2ft 2in (0.66m) in thickness.

Borehole reference SE11NE18/B, (also shown as '18B' in Figure 3 above) approximately 330m to the south west of the site indicates the Hard Bed Coal seam to be present at 98ft (29.9m). The seam is indicated to be 2ft (0.6m) in thickness. The borehole also intercepted a second coal seam at 277ft (84.4m), with a thickness of 6ft (1.8m) and was thought to be the Soft Bed Coal seam. The Middle Bed Coal was not recorded on the borehole log. A second log is present within the borehole record. This indicates a thin coal seam of 6in (0.15m) to be present at 55ft (16.7m) and a second coal seam of 1ft (0.3m) thickness at 61ft bgl (18.6m). The log however notes that the depths and lithology is estimated based on arisings returning to surface via water flush. The base of the estimated section was 103ft bgl (31.4m).
