BATLEY TOWN CENTRE AUDIT 2004

FACT SHEET 6: ENVIRONMENTAL QUALITY

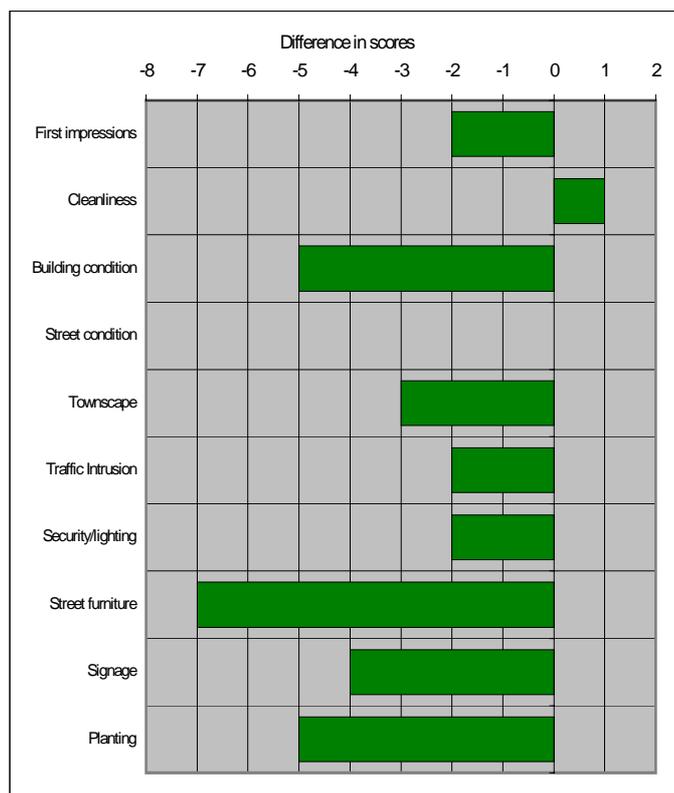
Figure 1: Changes in indicator scores 1999-2003

As a whole, the results of the 2003 survey have shown a decline in the environmental quality of the town centre during the last 4 years. All but two of the indicators have shown a reduced score. Cleanliness recorded a slight improvement, whilst the street condition indicator has remained the same. Figure 1 shows the general changes in the scores achieved for each environmental indicator between the 1999 and 2003 assessments.

Street furniture has recorded the greatest reduction in score followed by building condition and planting. The low scores in these 3 indicators suggests that the town has suffered a certain amount of neglect and lack of maintenance. Considerable resources were pumped into the town as part of the City Challenge Programme, which ended in 1999. However, since then, the town has experienced a decline in the quality of the environment in certain locations.

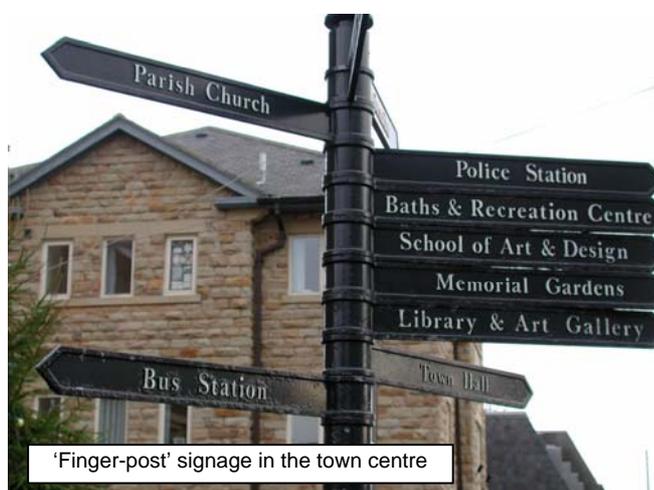
'Finger-post' signage in the town centre
