## Hudawi Centre - Asset Information Pack

## **Building Information**

The Hudawi Centre is located on Great Northern Street, Huddersfield, HD1 6BG and opened in 1997 on a site formerly occupied by Beaumont Street School. The building is a two storey, steel framed building with masonry and rendered walls covered by pitched tiled roofs.

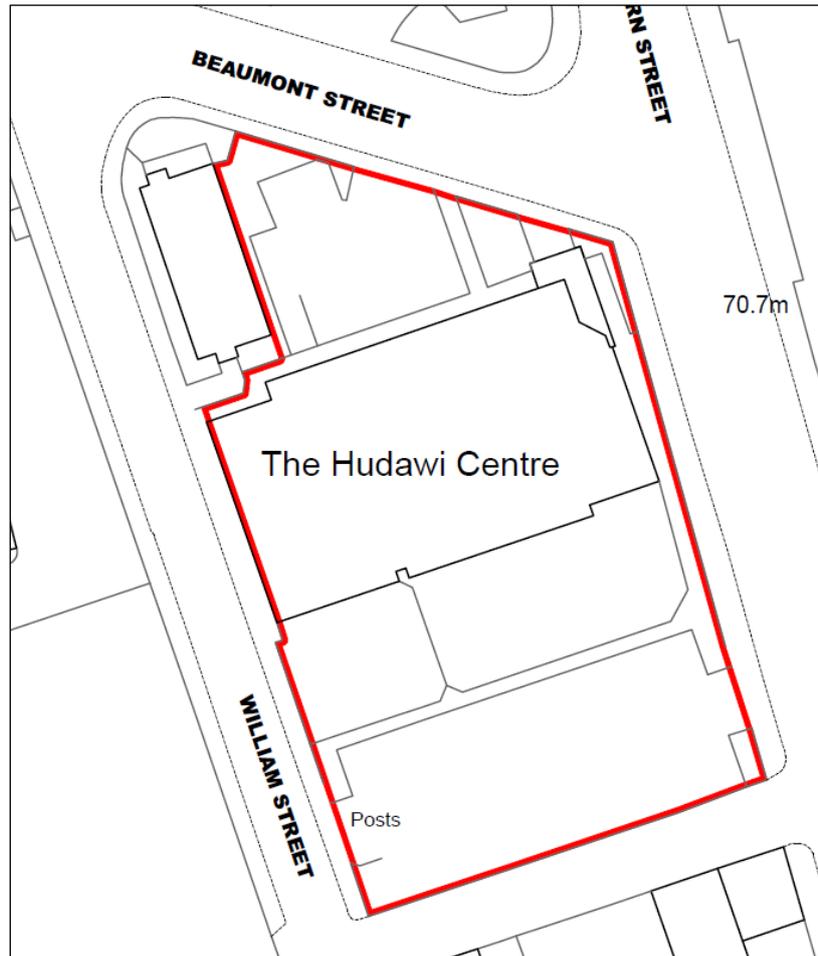
## Site Plans

**Red Line Boundary** - indicates the extent of the building and land.
