## **A REPORT ON A COAL MINING RISK ASSESSMENT**

**83 COMMON END LANE, LEPTON, HUDDERSFIELD, HD8 0AF**

**Report No J3542/16/EDS**

**June 2016**

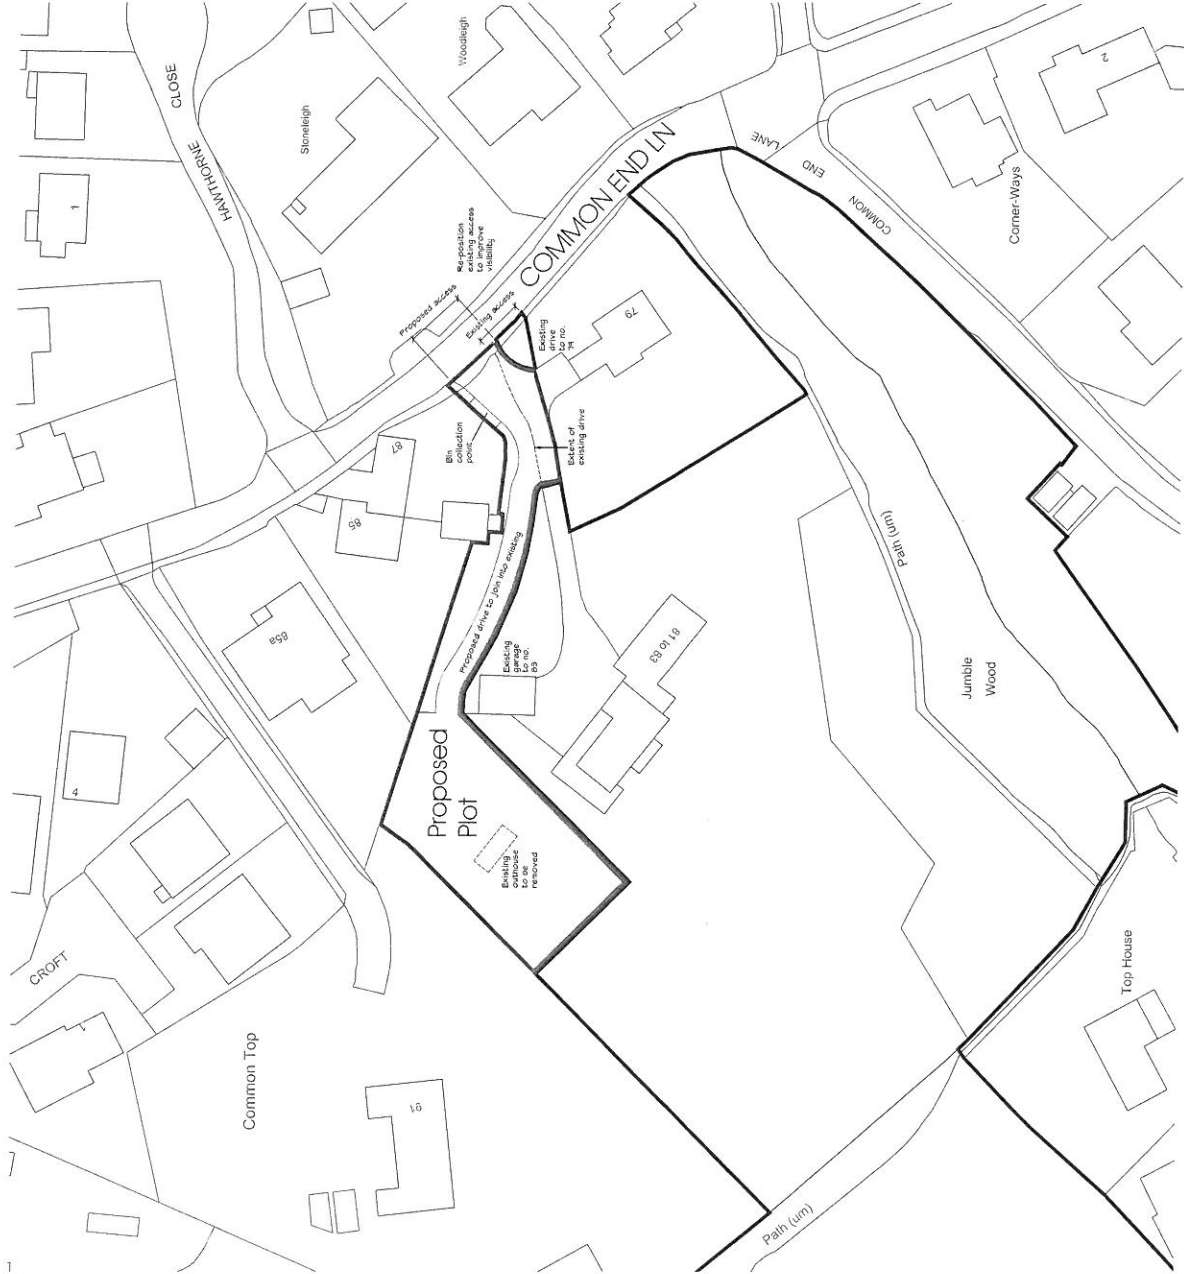
## SITE PLAN

Site Layout Plan

Proposed Site Layout
