Qualitative Assessment of Pedestrian Routes

Project: Dobroyd Mill, Jackson Bridge / Hepworth,
West Yorkshire

20 November 2017

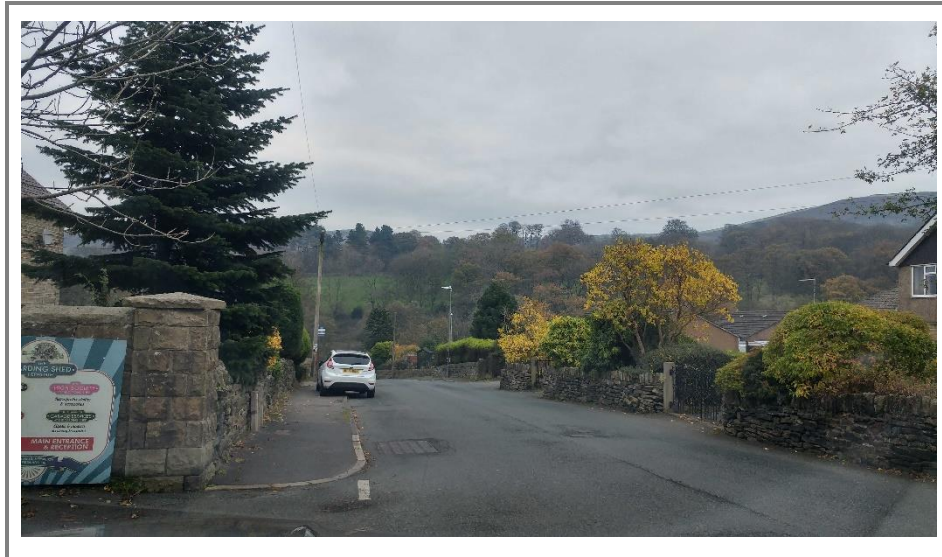
The present access to the upper level of Dobroyd Mill from Butt Lane will be retained for use by pedestrians and cyclists. This provides a convenient and relatively level route to and from the bus stops on Butt Lane located less than 50m from the access point. There is a footway with dropped kerbs along Butt Lane which links the site access to the bus stop locations.

Photograph 1 - View of footway linking to bus stops on Butt Lane

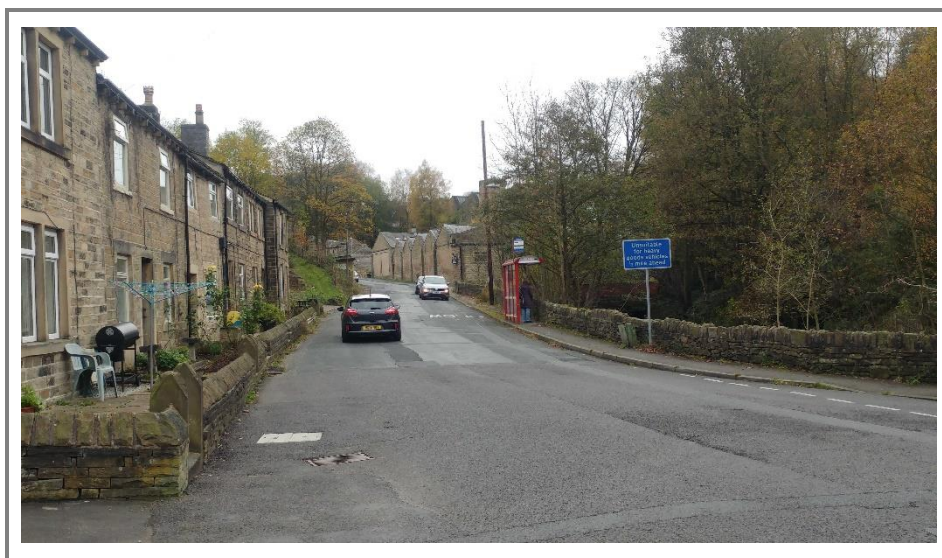
As part of the provision of the main site access on to Hepworth Road a new footway will be provided along the site frontage. This will link to the existing footway provision on the western side of Hepworth Road and to the bus stop and shelter located on that footway. 2

Photograph 2 - View of footway linking to bus stop on Hepworth Road

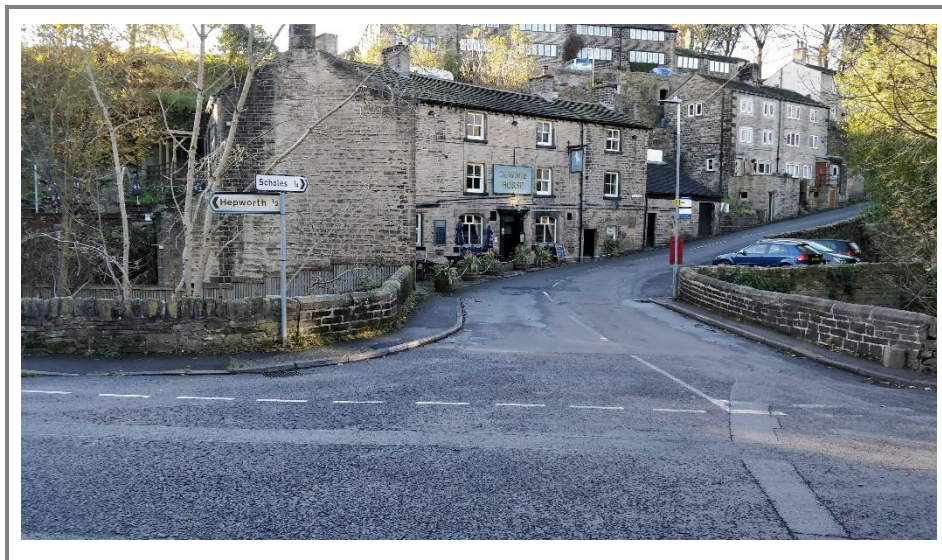
There are footways to both sides of East Street over the bridge over the beck. A footway then continues on the northernmost side up Scholes Road. There is a bus stop located on the northern footway adjacent to the bridge which can be seen in Photograph 3 below.

Photograph 3 - View of footway provision on Scholes Road

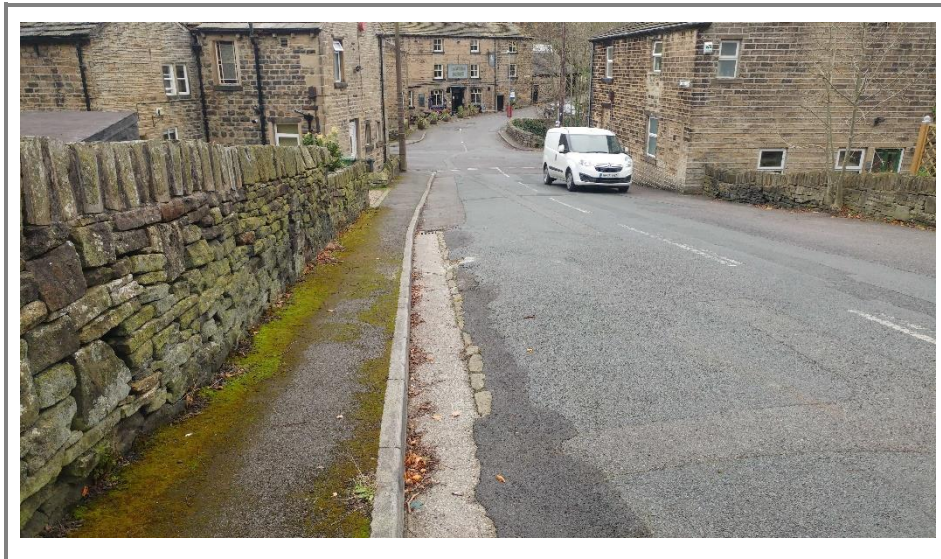
As stated earlier there are no bus stops on the A616 south of its junction with Bank Street but there is a footway along its western (Jackson Bridge) side. This can be reached by the existing footway provision along East Street which starts on its south side and then after a short distance one on the north side is provided. After the terrace of houses on the south side the footway in front stops with the northern footway continuing up to the bend in the road. Dropped kerbs are provided for each footway. There is a public footpath (HOL / 203 / 10) from the north side of East Street linking up to the A616 near to the public house.

Photograph 4 - View of southern footway on East Street looking towards Hepworth Road junction.

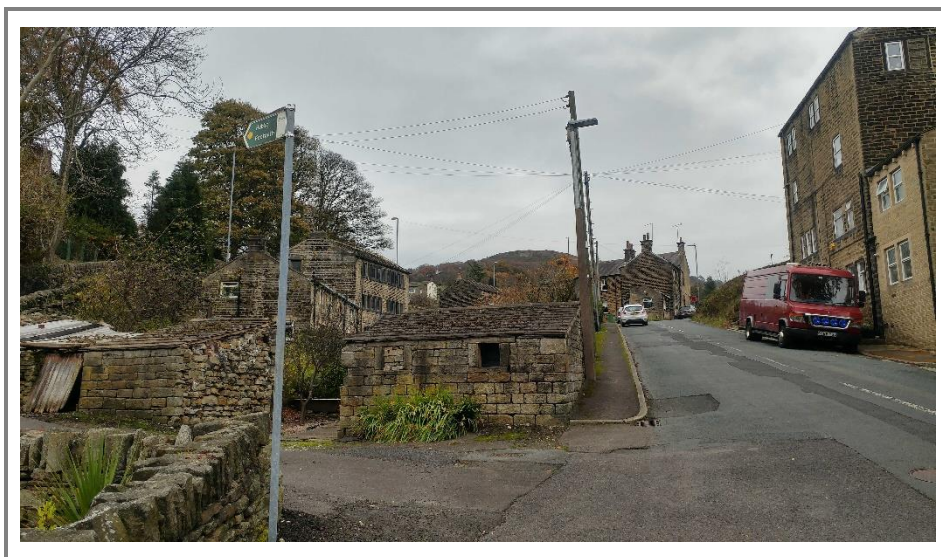
Traffic volumes on East Street are very low (around 20 vehicles per hour so significantly less than 100 vehicles per hour as quoted in Manual for Streets) so some shared use of the carriageway does not appear to cause any difficulties or issues.

Photograph 5 - View of northern footway, start of PROW and southern footway (behind van). Shared section starts beyond white cars.

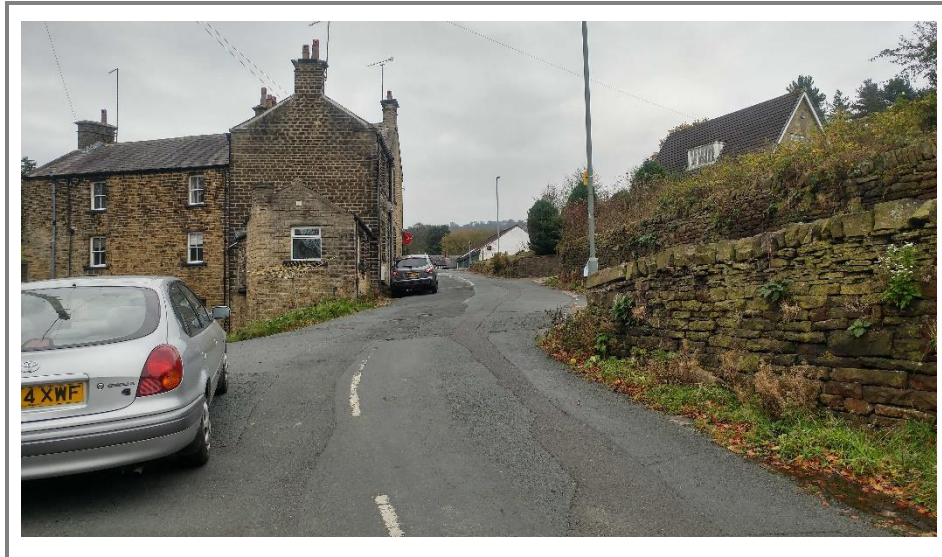
Photograph 7 - View of shared section of East Street uphill of footway provision.

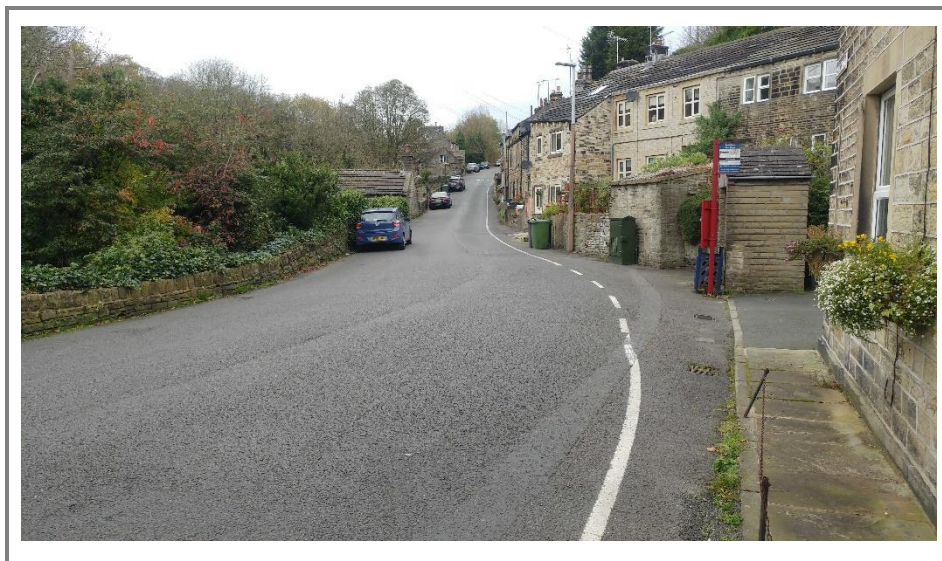
Aside from a short length between East Street and the bus stop / shelter there are no other footways along Bank Street. There is, however, an edge of carriageway line along the eastern side which is offset by between 1.0 – 1.5m from the adjacent boundaries to provide space for pedestrians to walk along.

Photograph 8 - View of Bank Street.
