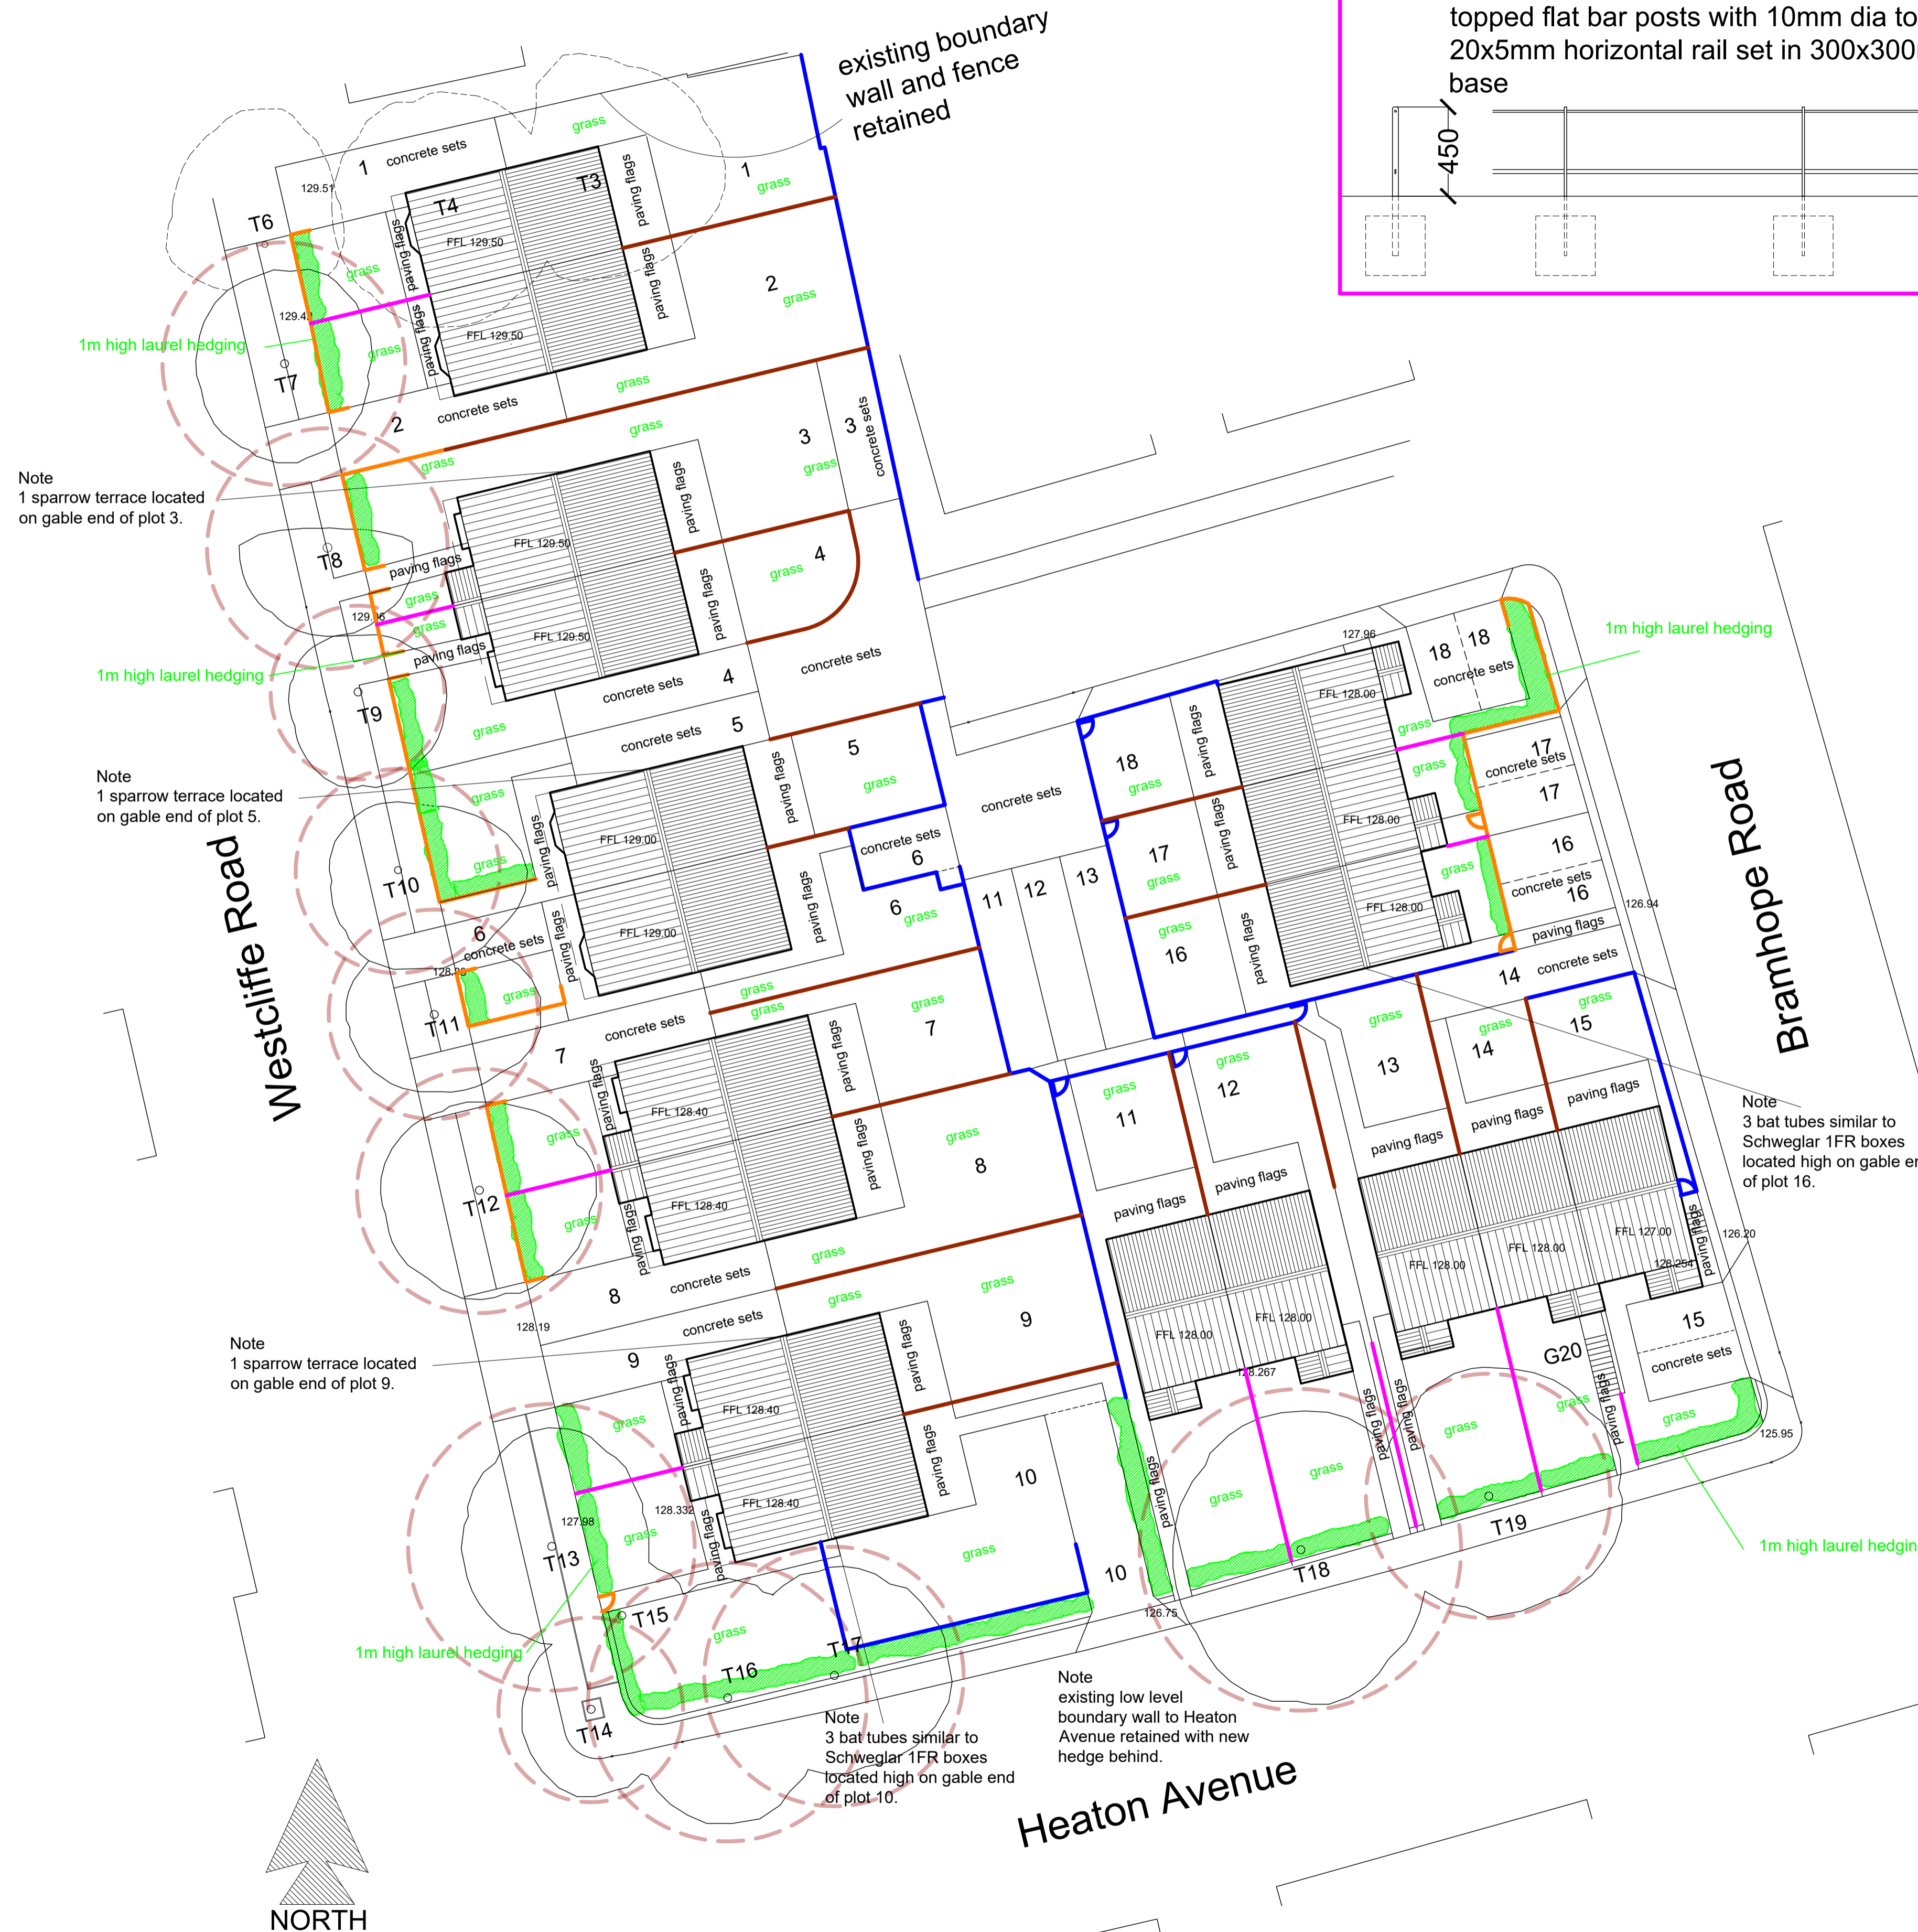
Note  
1 sparrow terrace located on gable end of plot 3.

Note  
1 sparrow terrace located on gable end of plot 5.

Note  
1 sparrow terrace located on gable end of plot 9.

Note  
3 bat tubes similar to Schweglar 1FR boxes located high on gable end of plot 10.

Note  
existing low level boundary wall to Heaton Avenue retained with new hedge behind.

Note  
3 bat tubes similar to Schweglar 1FR boxes located high on gable end of plot 16.
