1 - Building 1 _ West Elevation (Elevation 1) _ Works to Existing
1 : 100

2 - Building 1 _ West Elevation (Elevation 1) _ As Proposed
1 : 100

Client: Job No:
Trinity One LLP 16,047
Project:
Trinity One, Huddersfield
Title:
Building 1 - East (Front) Elevation
Proposals
Date: Scale:
Jul 18 1 : 100QA1
Drawing No: Drawn By: Checked by:
20-120 JNS RG Revision:
A

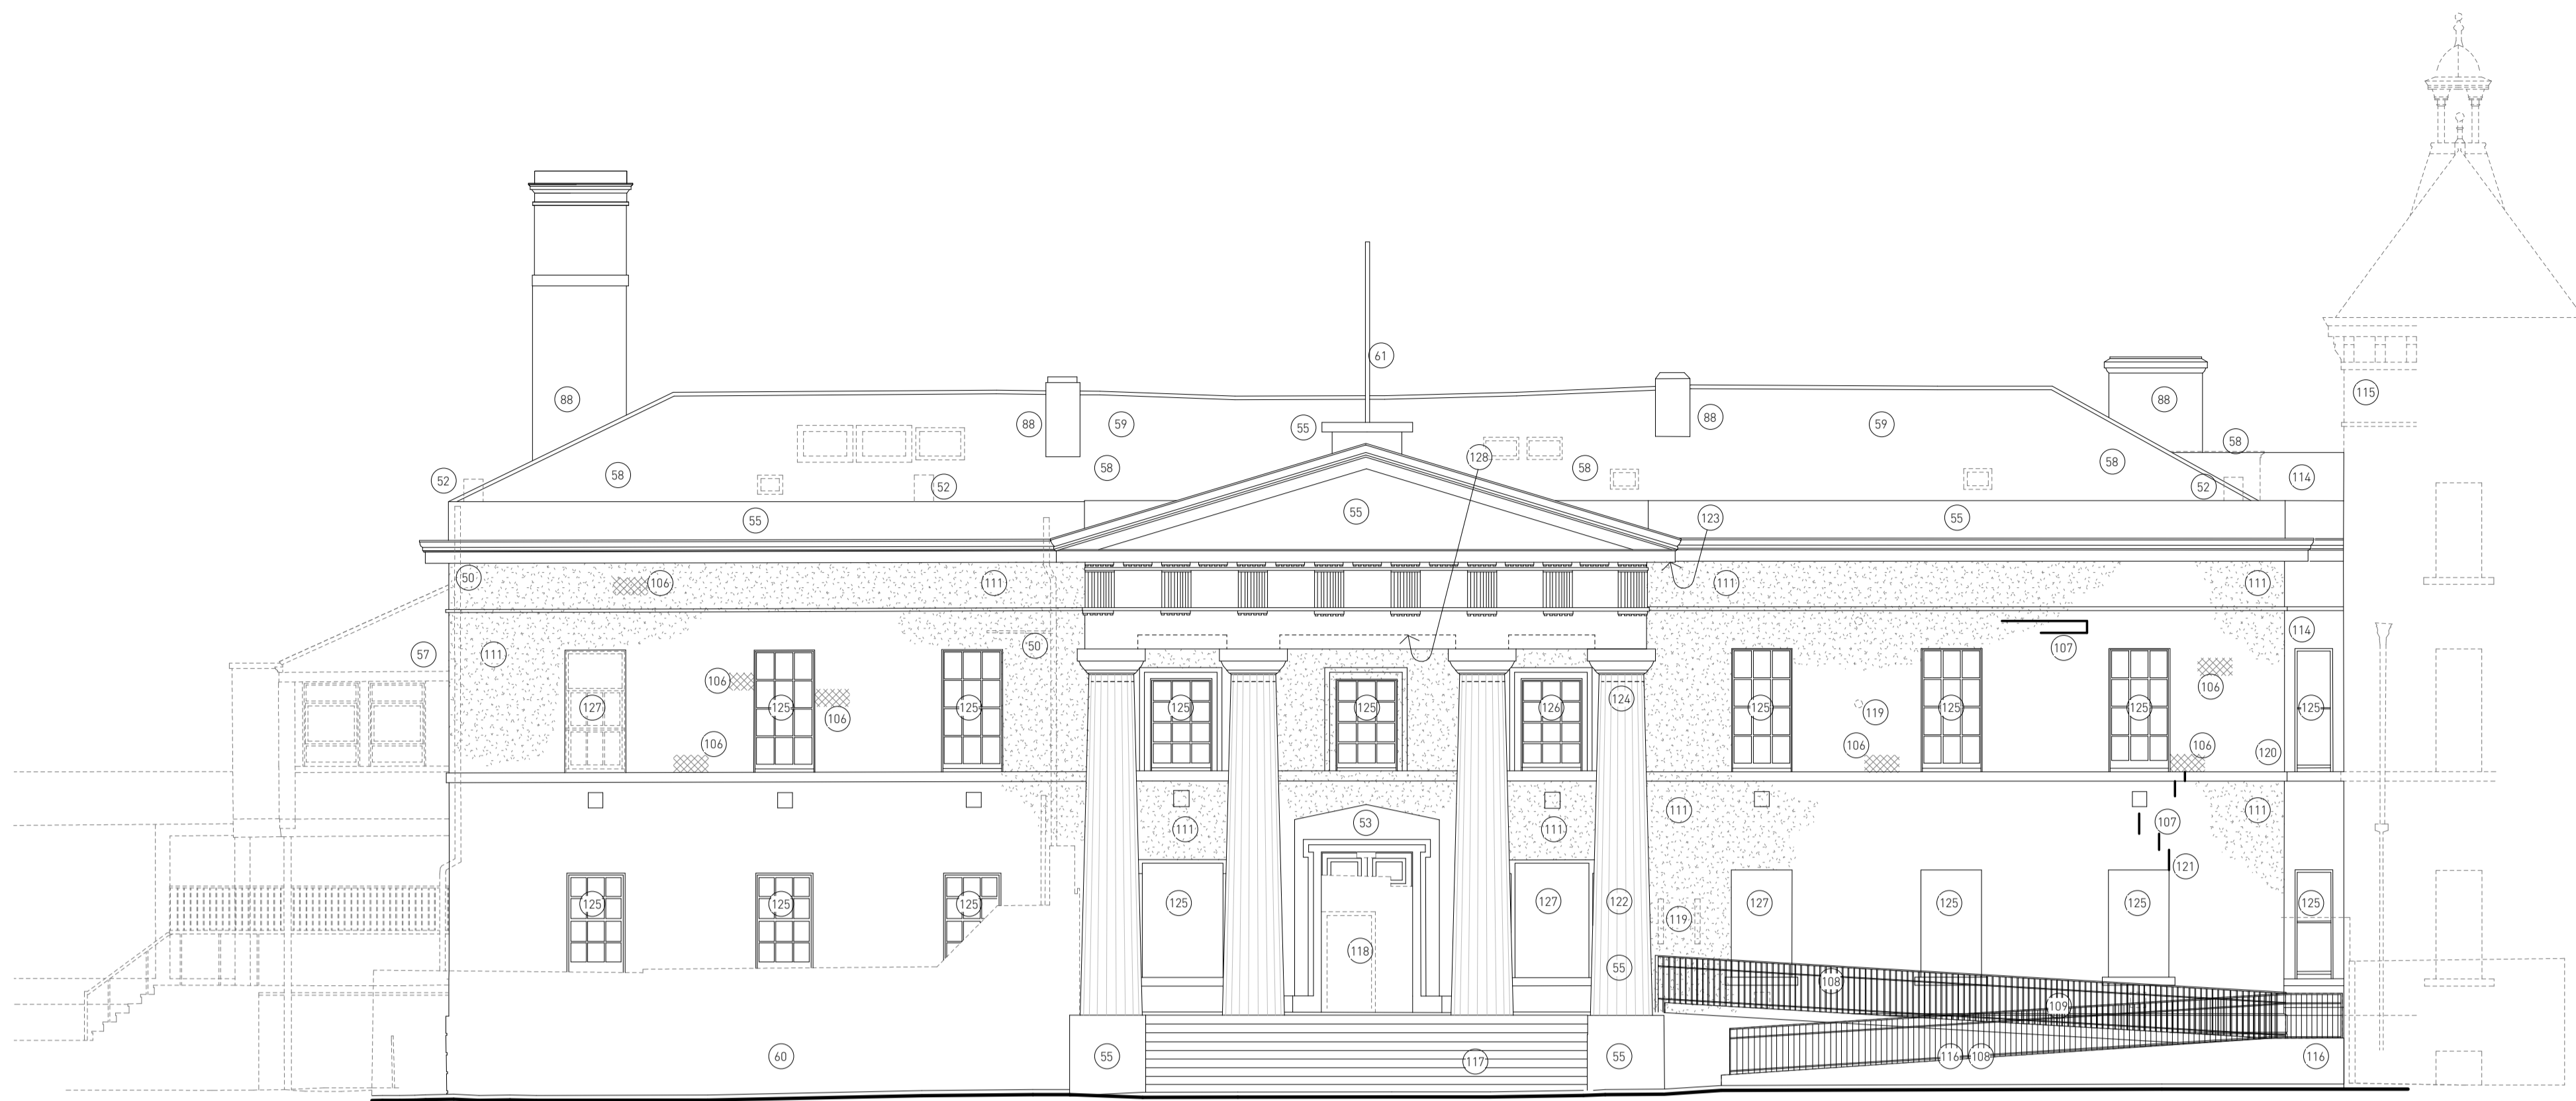
- 50 Existing external pipework / downpipes / soilpipes, including associated bracketry, to be removed and masonry background to be made good with indent repairs.

- 52 Existing flood-lights to be removed and masonry made good.
- 53 Existing electric lantern on cast-iron bracket over principal entrance (not shown on survey) to be refurbished and relamped.

- 55 Existing ashlar masonry to be cleaned (North, East and South Elevations). Cleaning method statement to be submitted to Conservation Officer prior to works commencing. Final scope of cleaning to be agreed, but to include chimney stacks, flagpole base, parapet above cornice, pediment, cornice, columns, daises (all faces and top) and steps.

- 57 Existing lean-to construction, including supporting structure, to be removed: All building elements upto the notional facade line of the 1831 building to be removed. Once removed, the newly exposed facade of the original 1831 to be surveyed and in conjunction with the Conservation Officer, agreement to be reached on what elements to remain, how remaining elements are to be cleaned / repaired, and what elements are to be removed / replaced.

- 58 Existing dormer windows and rooflights to be removed as part of re-roofing works.
- 59 Existing slate roof with lead rolled ridges, lead rolled hips and lead lined valleys: to be re-roofed with as much existing slate being re-used as practicable and reclaimed slate from other buildings demolished on the site used to replace damaged slates; all leadwork to soakers, flashings, gutters, hips and ridges to be replaced with new in accordance with the Lead Manual; patination oil to all areas of lead other than gutters.

- 60 Existing glazed roof over former lightwell (concealed behind hoarding at time of survey): to be removed back to 1831 facade and facade to be made good.

- 61 Existing Flagpole: condition to be reviewed once accessible and proposed works to be agreed with Conservation Officer.
- 71 Existing metal vents: to be cleaned and painted - colour to be confirmed with Conservation Officer.

- 86 Conservation style roof-light flush with existing slate roof; ppc grey metal frames to outside.
- 88 Existing stone chimney stack to be retained, cleaned, re-painted and re-capped as necessary. All lead flashings and soakers to be renewed in accordance with the Lead Manual; patination oil to all lead flashings and soakers.

- 90 Proposed roof safety line: stainless steel cable on stainless steel pedestals.
- 97 Existing link building wall ends to be exposed by demolition of adjacent building: ends of wall to be neatly re-built in salvaged coursing stone c/w lime-based mortar, to express removal of building and exposure of previously concealed construction. Exact alignment of ends of cornice and string courses to be assessed once construction exposed.

- 106 (cross-hatched) Existing face of ashlar stone spalling: loose material to be removed back to sound face and reviewed.
- 107 (heavy lines) Masonry joints opening-up. To be pointed up with lime-based mortar to an agreed sample.

- 108 Existing modern access ramp to be retained and made good to offer level access at front of building. All masonry and metal balustrades to be cleaned and fully refurbished. (For proposed Access Strategy, refer to Enjoy Design drg. ref. 00 004).

- 109 Existing modern railings to be retained and refurbished or replaced to match existing.
- 111 (dotted hatch) Existing masonry exhibiting discolouration and salt contamination due to water ingress - de-scaling to be undertaken to agreed method.

- 114 Existing link building to be retained.
- 115 Existing adjacent building to be removed. Materials to be salvaged for use in repair of retained elements, recreation of lost elements and construction of proposed elements.

- 116 Existing facade to basement level remains, albeit concealed behind access ramp at time of survey.
- 117 Vegetation to be removed from existing steps.

- 118 Existing principal entrance doors and frame to be refurbished. Ironmongery to be reviewed once security guarding removed.
- 119 Existing brackets to be removed: indent repairs to ashlar stone.

- 120 Existing TV aerial and telegraph line bracketry to be removed (not shown on survey). Indent repairs to ashlar.
- 121 Cracked ashlar lintol to be replaced.

- 122 Cracking to all four fluted columns to be investigated - may be due to expansion of corroded iron elements.
- 123 Historic repairs to decorative masonry to soffit of entablature to be investigated further once access available.

- 124 Open bed joint beneath capital to each (all four) column to be investigated once access available.
- 125 Existing Window in reasonably good order. To be refurbished re-using existing glass. Frames and sashes to be painted, colour ref. tbc.

- 126 Existing Window present but requiring some elements of renewal to glazing / sashes. All new glass to be clear. Frames and sashes to be painted, colour ref. tbc.

- 127 Original Window missing or beyond repair. To be replaced with new counter-weighted hardwood, single-glazed sash window to closely match existing. Frames and sashes to be painted, colour tbc. If existing glazing bar profiles allow, a slim double-glazed unit may be proposed, subject to sample review.

- 128 Existing coffered soffit to portico to be further investigated for loose / spalling masonry. Cleaning to be considered in conjunction with Conservation Officer.

- 129 Proposed standing-seam patinated zinc cladding / roofing, subject to presentation of samples.

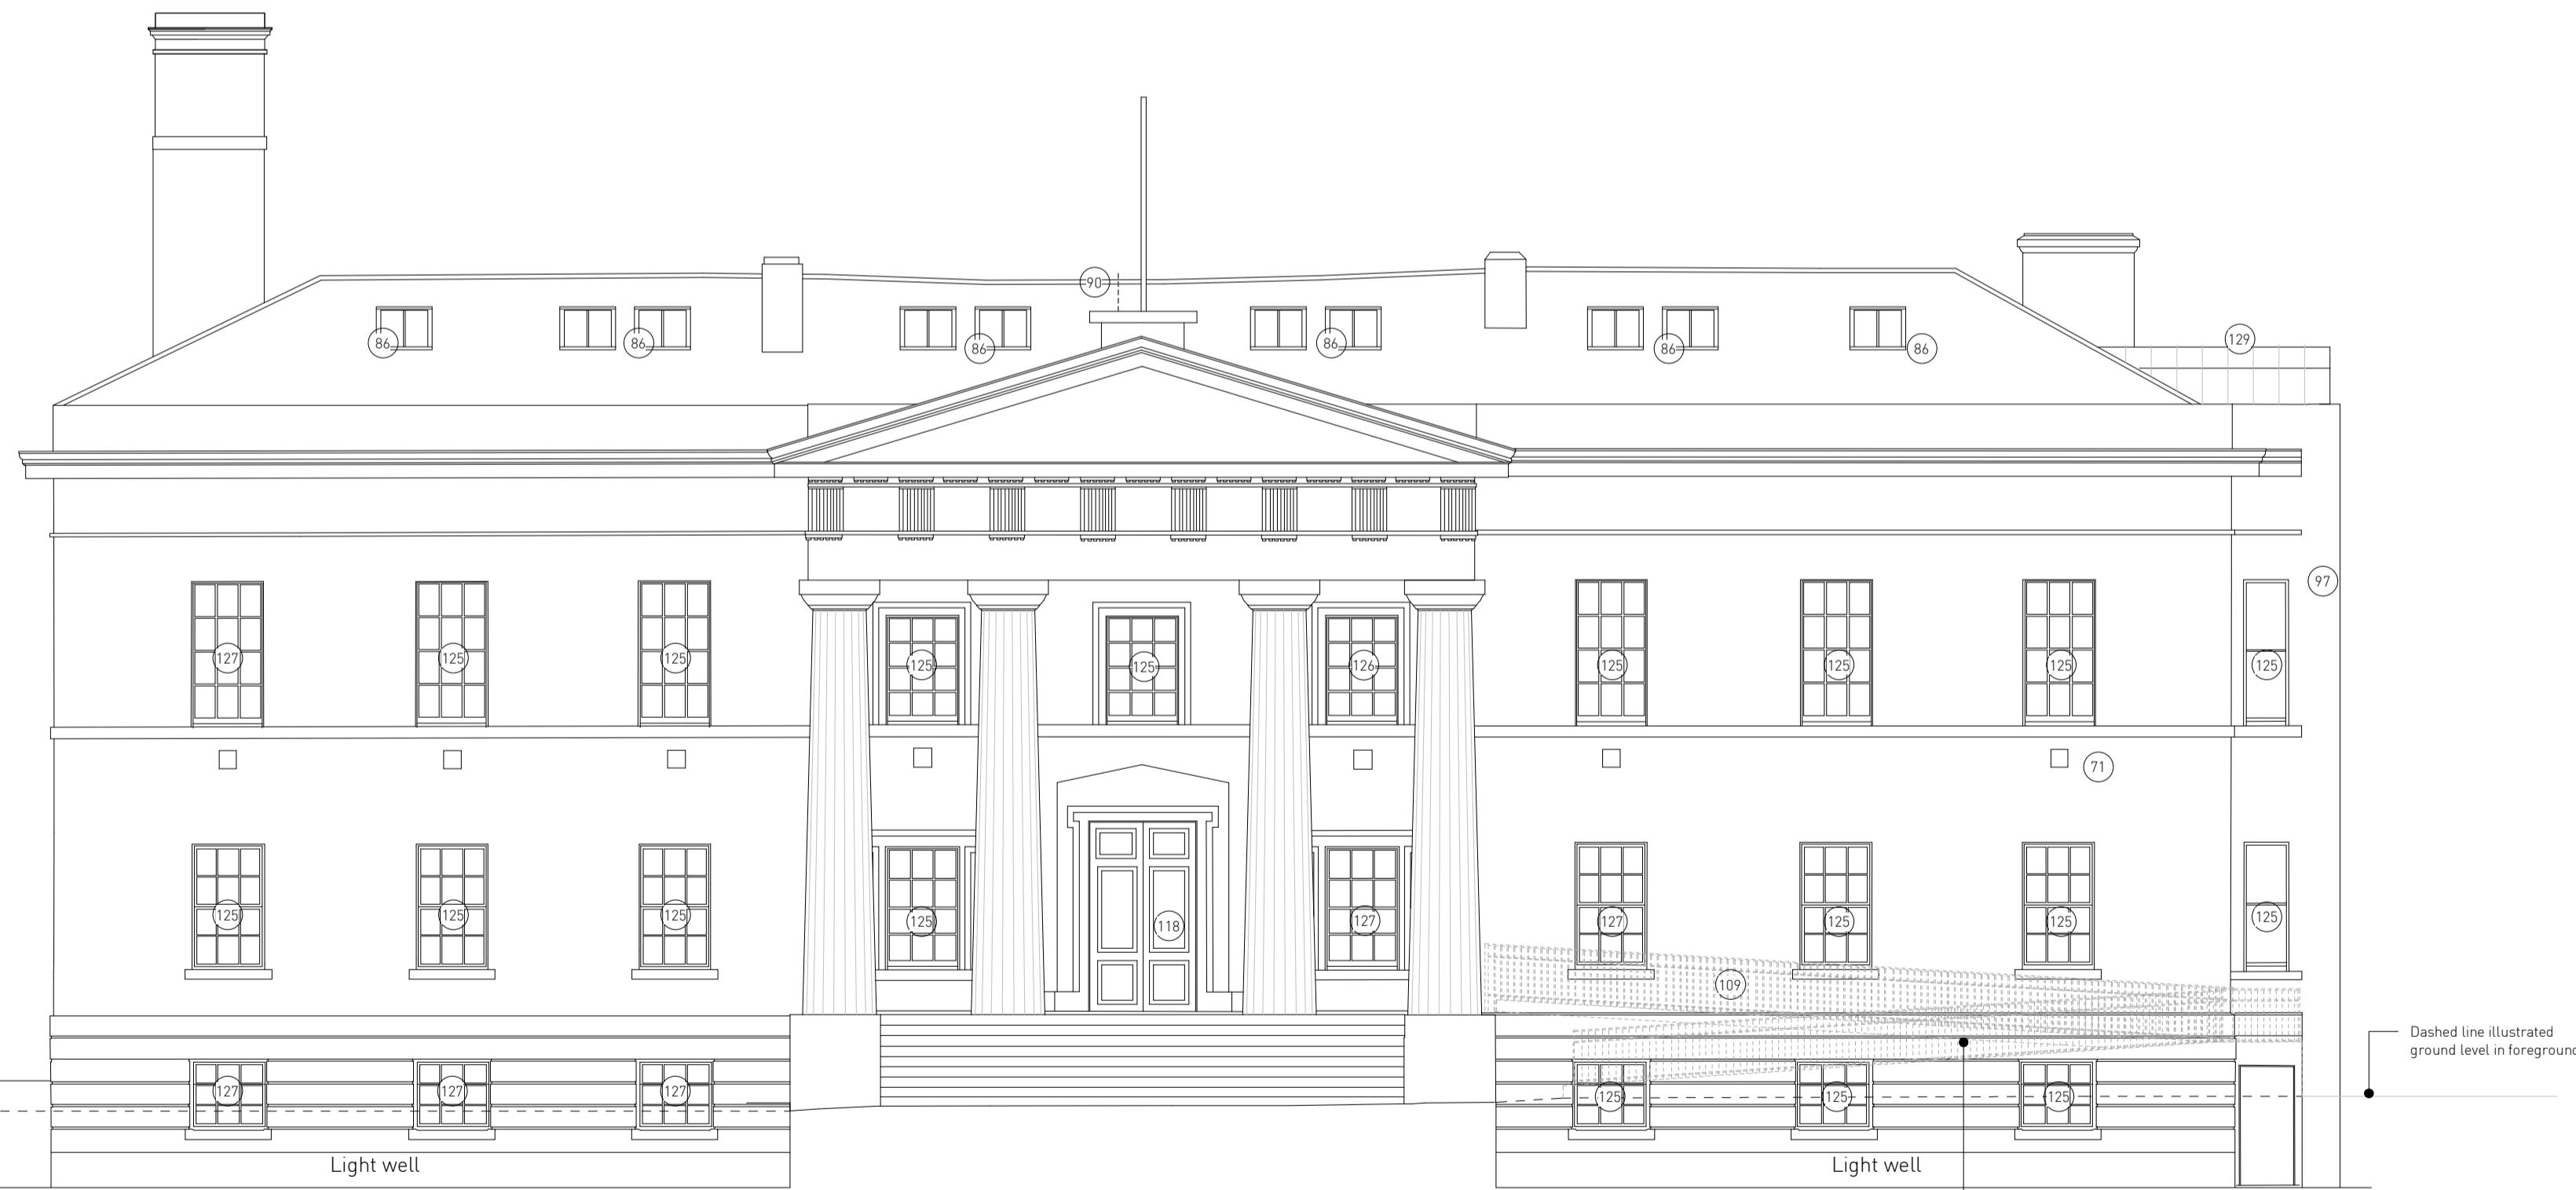
Existing access ramp to be retained to offer level access
NB: Ramp omitted from view for clarity and to illustrate intent for basement windows
