## **Providence Baptist Chapel , Slaithwaite**

**Building Recording** - outlining "historic features that will be removed during the restoration"

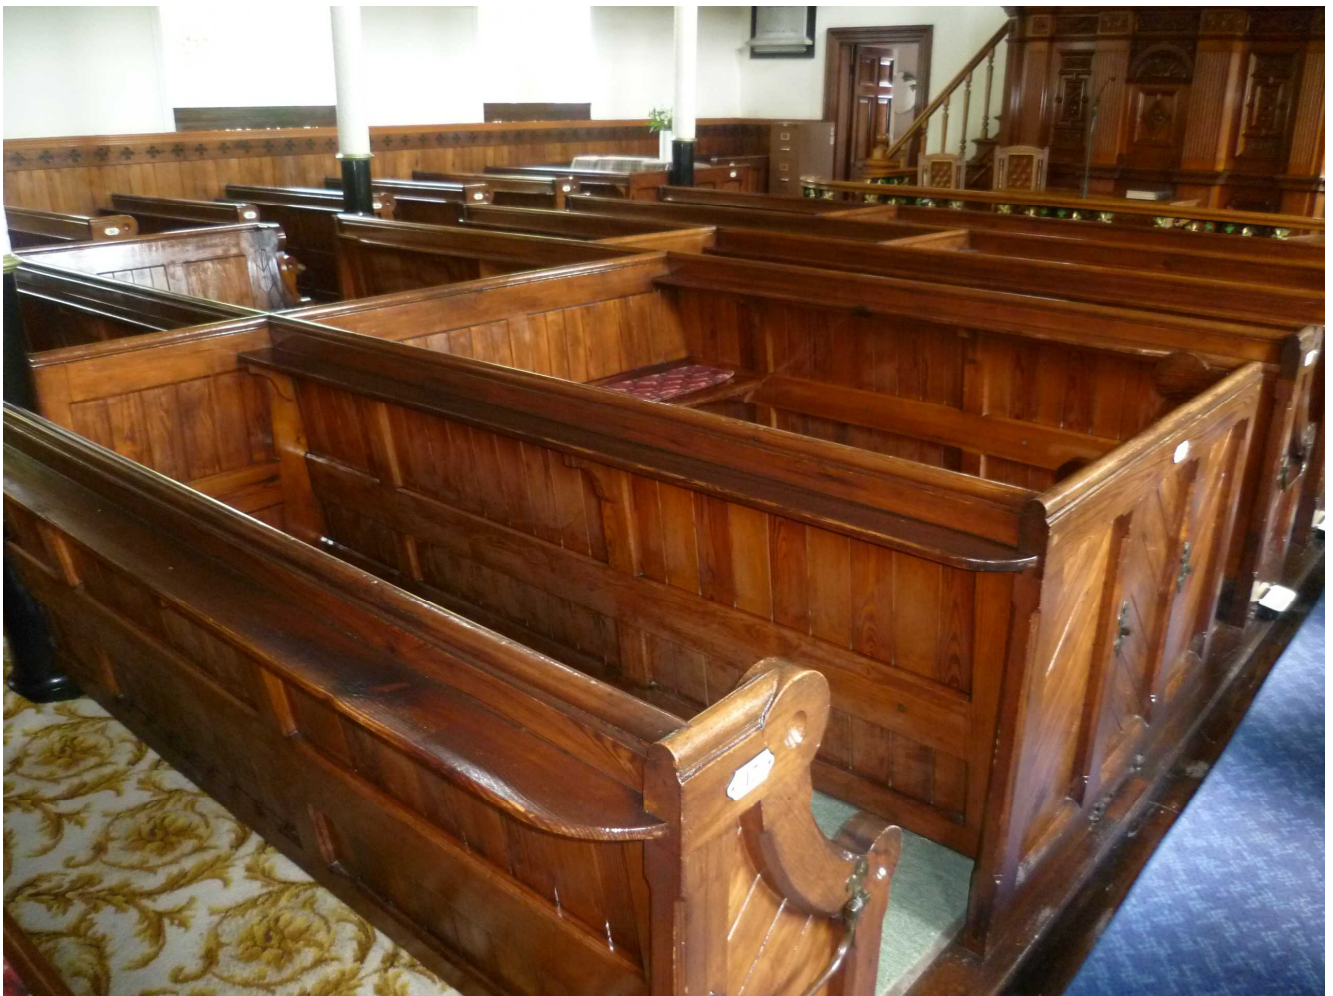
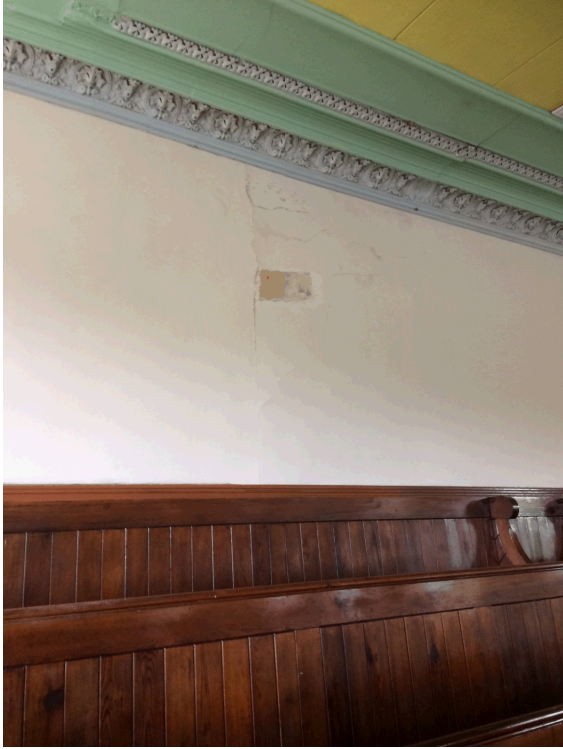
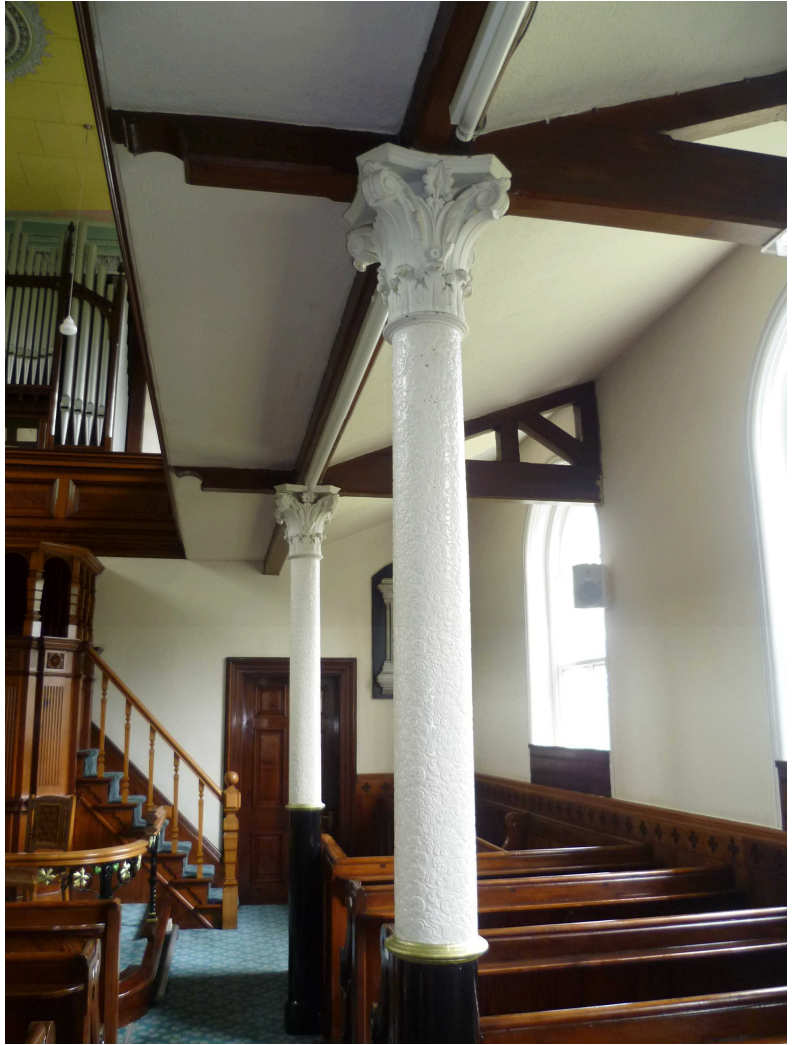
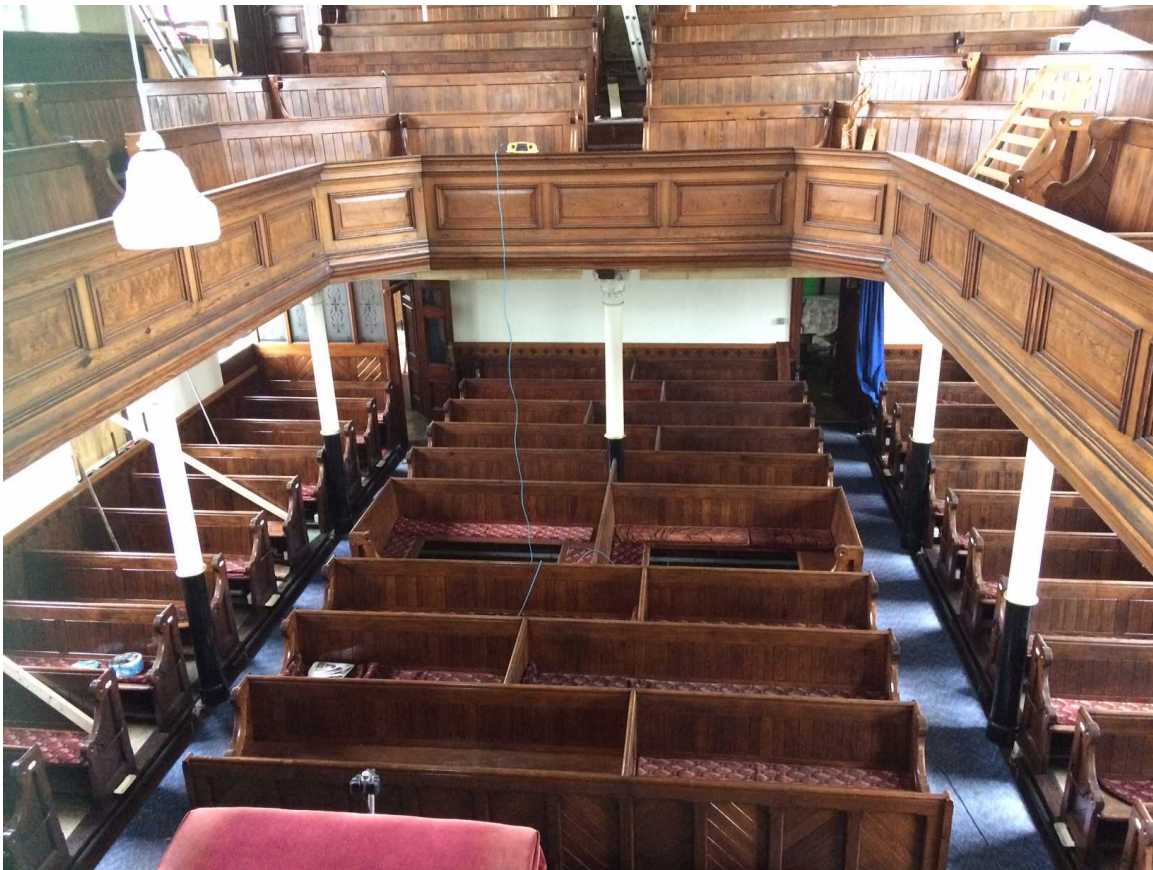
### **1. The Pews**

The pews all constructed in pitch pine and many still retain their umbrella stands.

Many of the Pews are numbered .

The Pews appear to be circa 1880 which suggests that the original early Chapel fittings were removed and lost at the time of the extension and the later expansion works.

Pews in the central chapel space will be removed with as many as possible relocated along the length of the sides.

Pews to the west end of the chapel will be retained and two thirds of pews in the gallery space will also be left in tact.

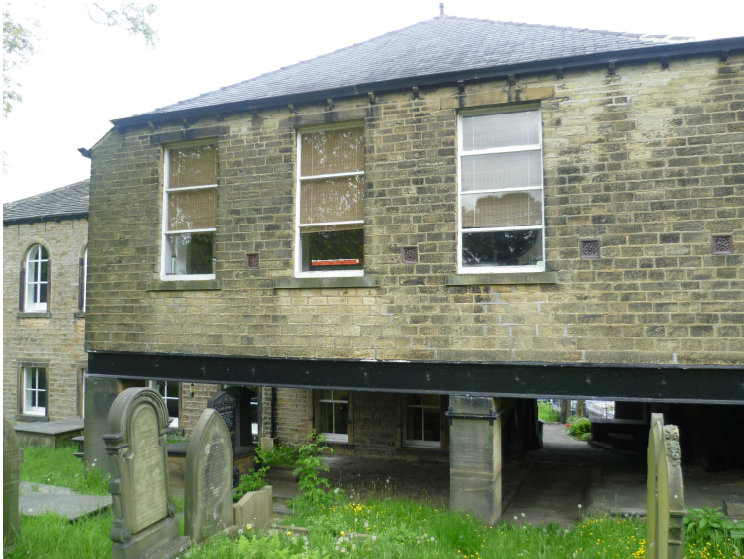
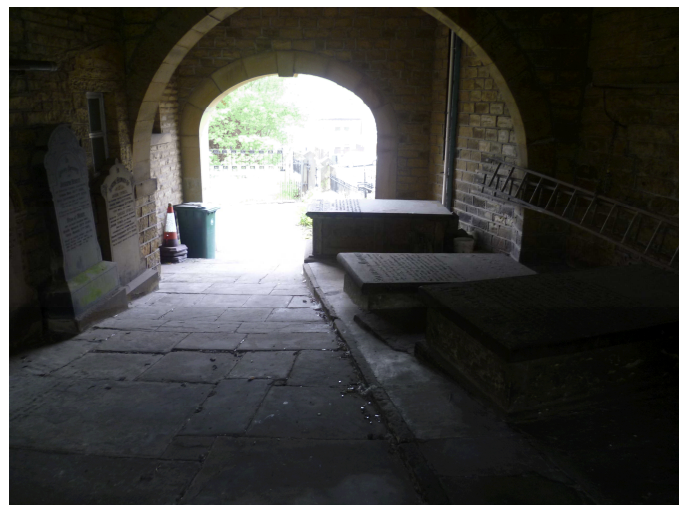
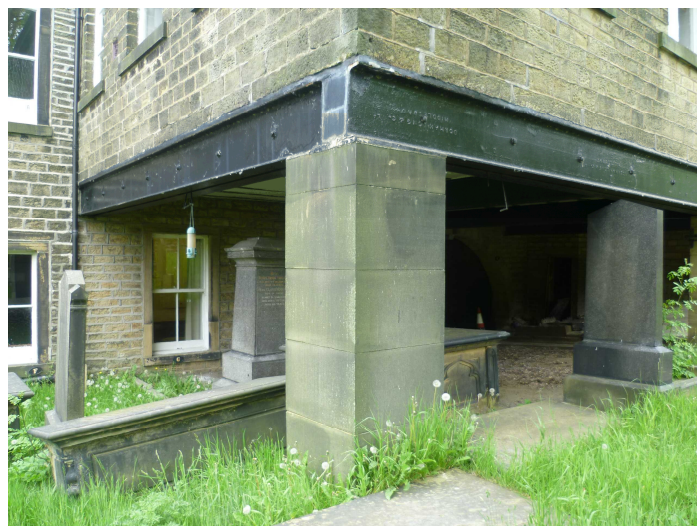
The Glazing to the front arch and rear .

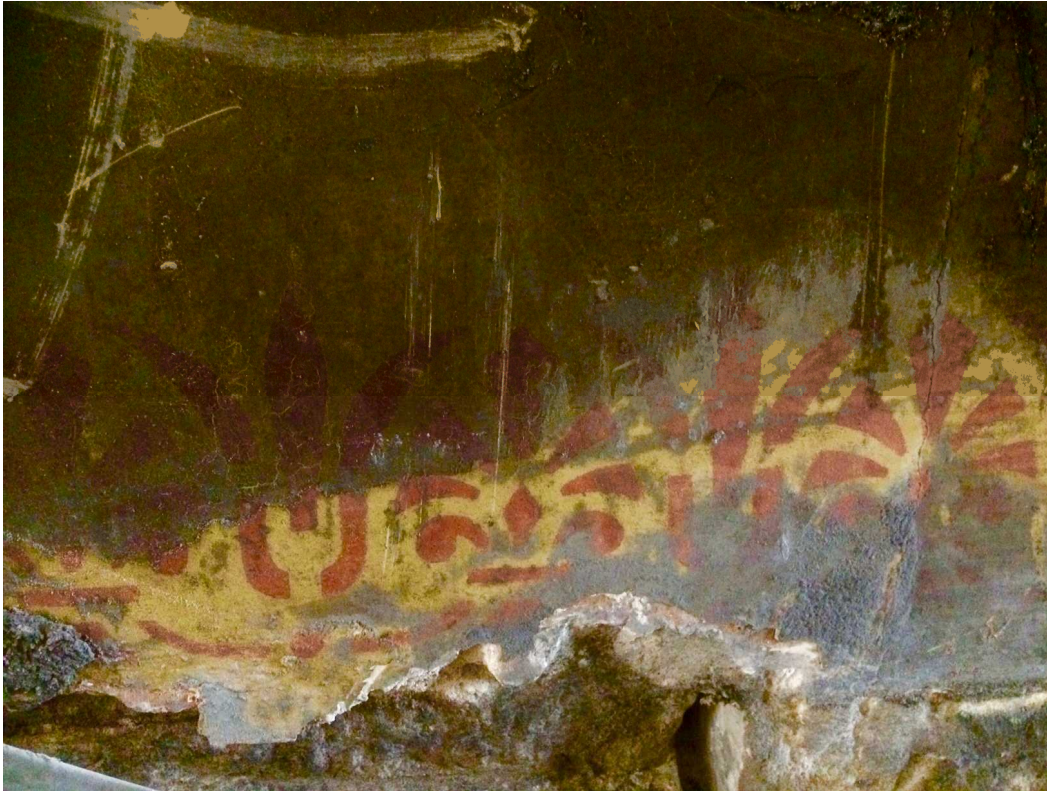
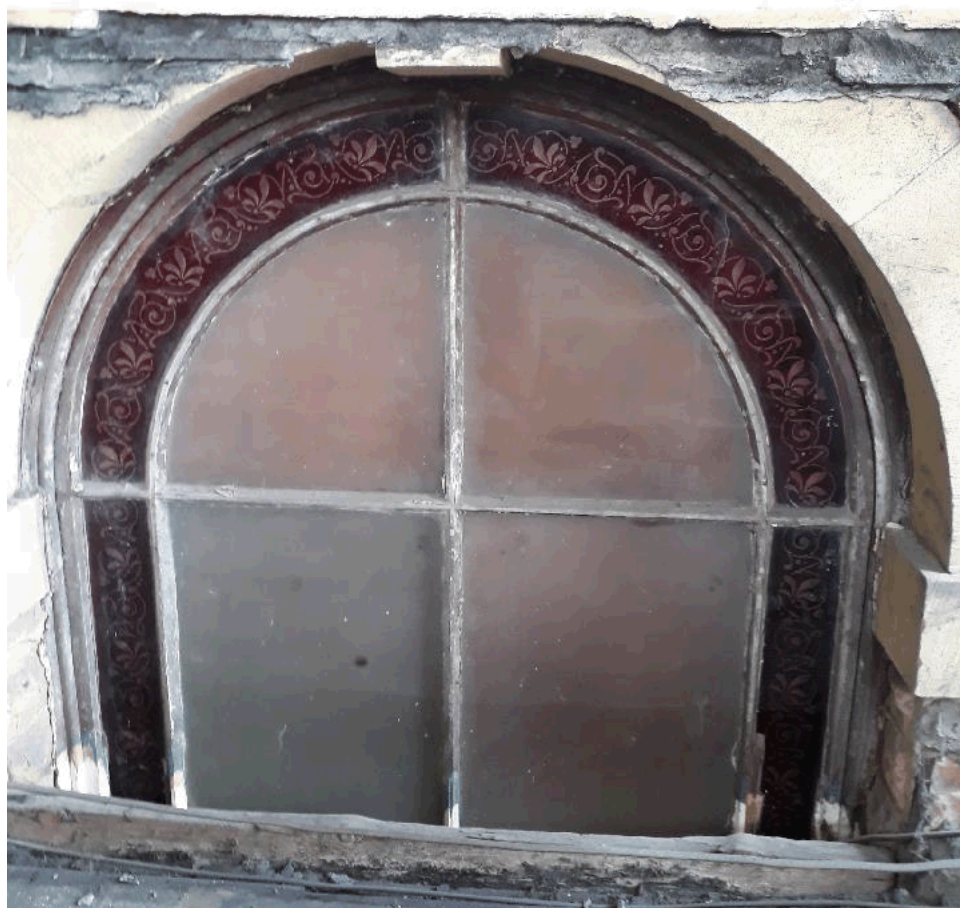
## 5. Other features

In the course of treating dry rot, two features were discovered:

A stencil on what would have originally been the outside east wall of the chapel , pre extension and the top of the window on the east wall:
