SPEN VIEW - DBWS BURY MOOR 06/06/2019.

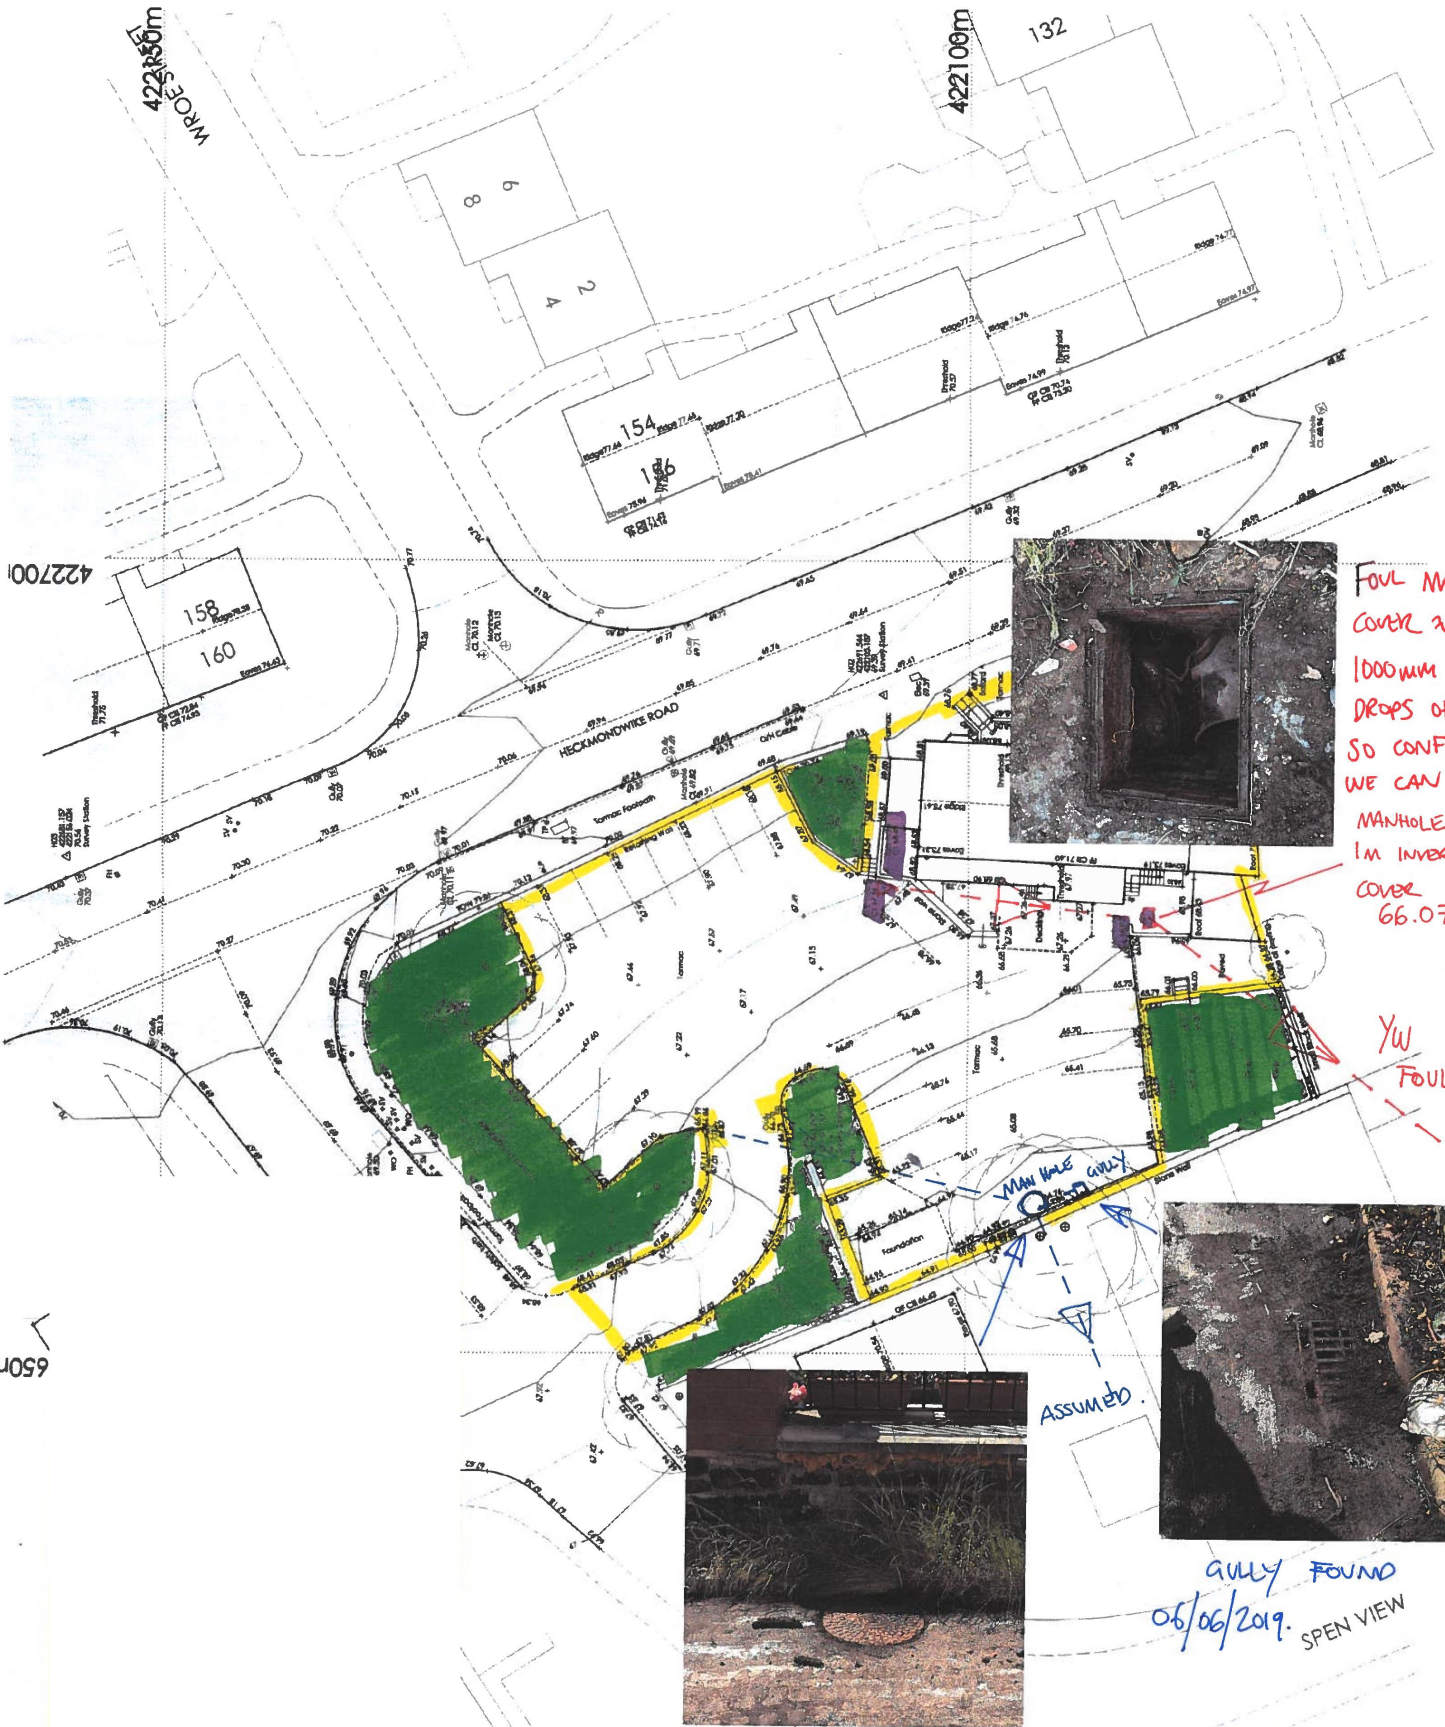
FOUL MANHOLE
COVER \approx 66.07
1000MM INVERT
DROPS OFF DEEP
SO CONFIDENT
WE CAN CONNECT
MANHOLE
1M INVERT.
COVER
66.07.

YW
FOUL.

MANHOLE GULLY

ASSUMED

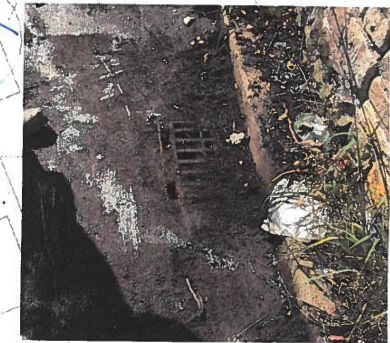
GULLY FOUND
06/06/2019.
SPEN VIEW
