# Interchange 26

## Mine Entry Investigation and Preliminary Treatment Strategy

Curtins Ref: 065646-CUR-00-XX-RP-GE-005

Site Address: Former North Bierley WWTW, Cliff Hollins Lane, Bradford, BD4 6RQ

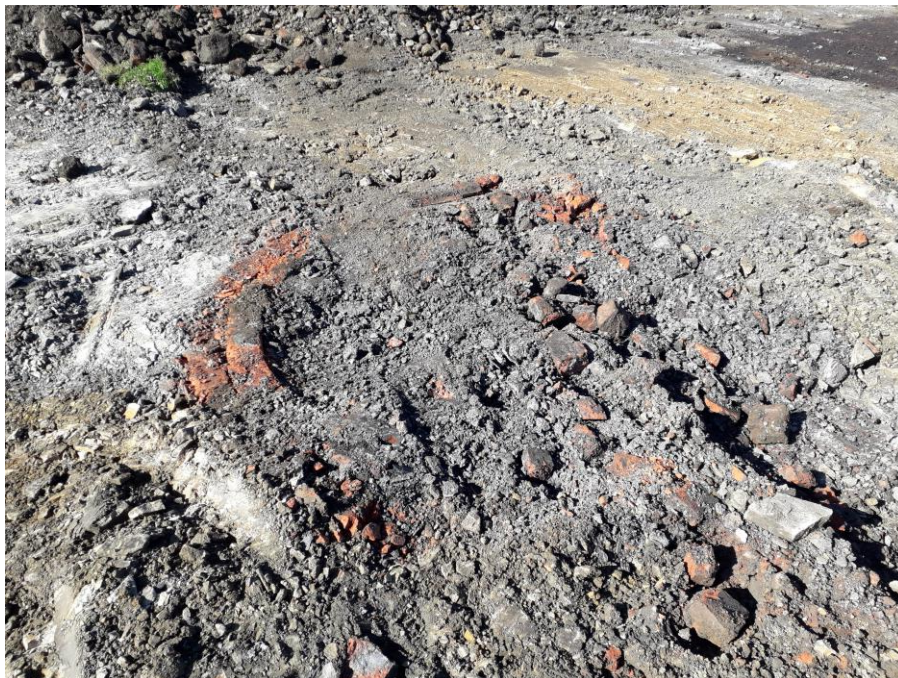
**Figure 3.1.1;** Mine Entry 417427-015, Bateman Shaft

The mine entry was recorded to be 2.2 m in diameter, with a double skinned brick lining. The mine entry was backfilled visually at surface with a black cohesive soil containing mudstone, sandstone and coal.

The mine entry was recorded at coordinates SE17906, 27378. The Coal Authority report that the mine shaft is present at SE17903, 27378 which is within the tolerance of the GPS used on site.

The southern mine entry recorded as 417427-015 the Bateman shaft was investigated initially.

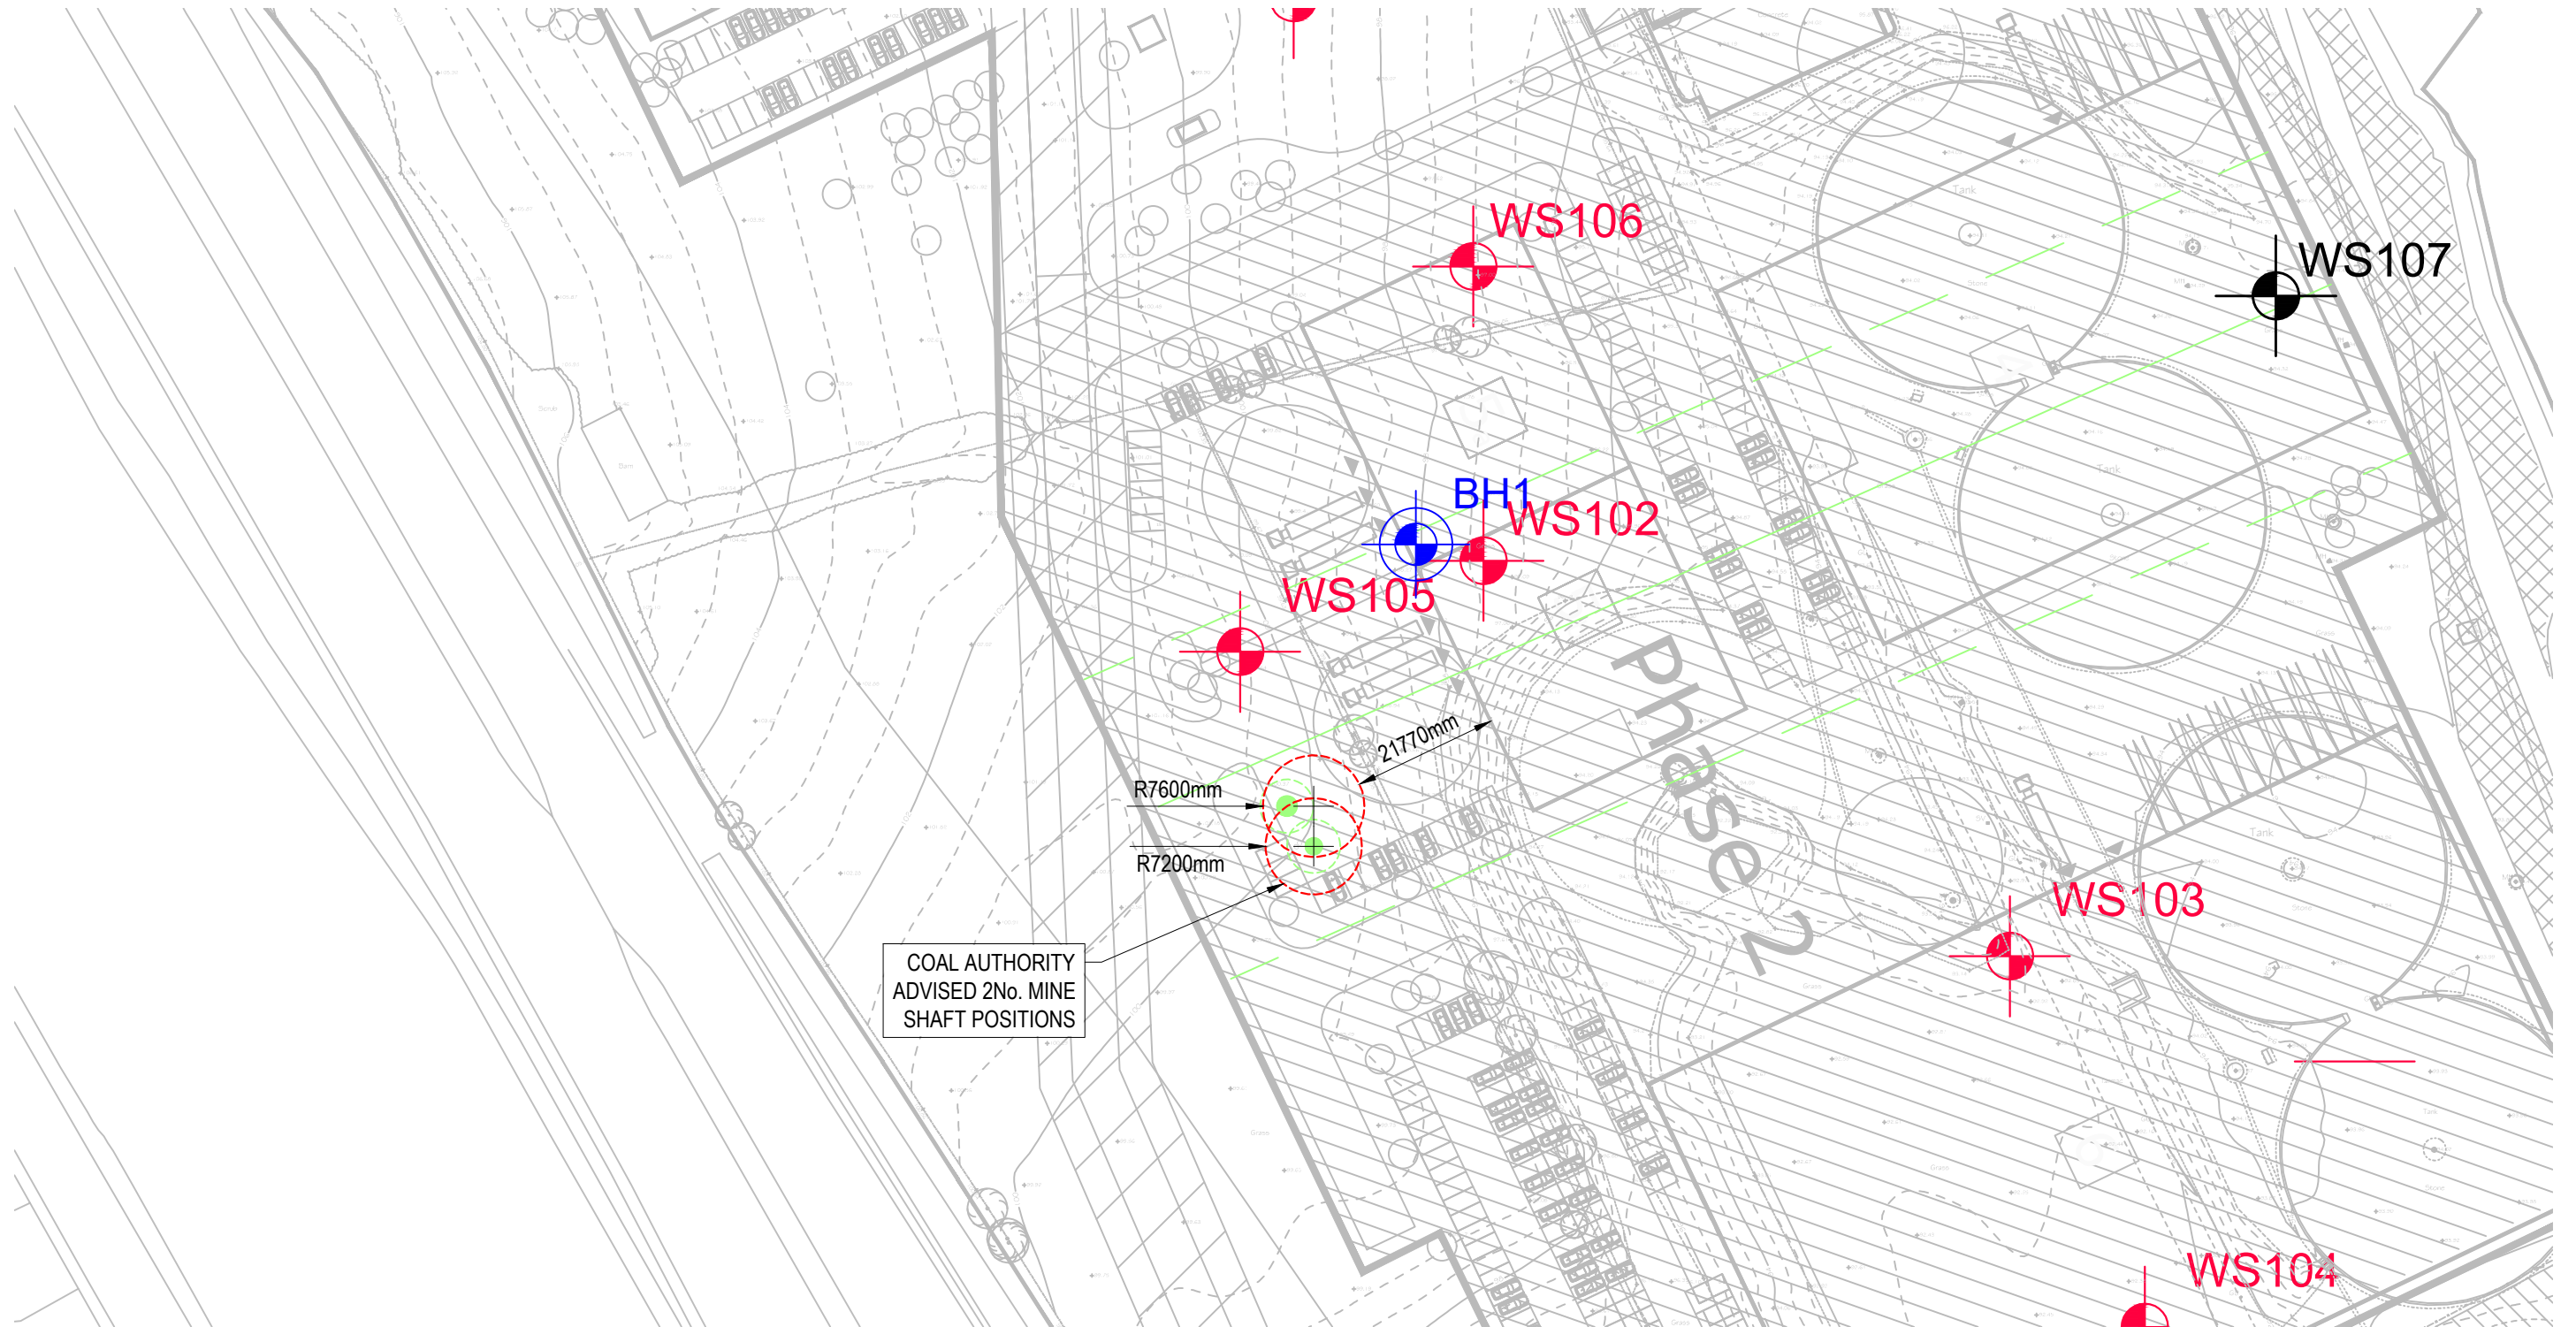
Dashed green line indicates 8m departure zone from shafts, dashed red line indicated 14.8m collapse zone from shafts
