# Sevenairs Consulting Ltd

**New Mill Road, Holmfirth, West Yorkshire**

**Road Safety Audit Stage 1**

New Mill Road, Holmfirth, West Yorkshire - Road Safety Audit Stage 1 – Revision 2

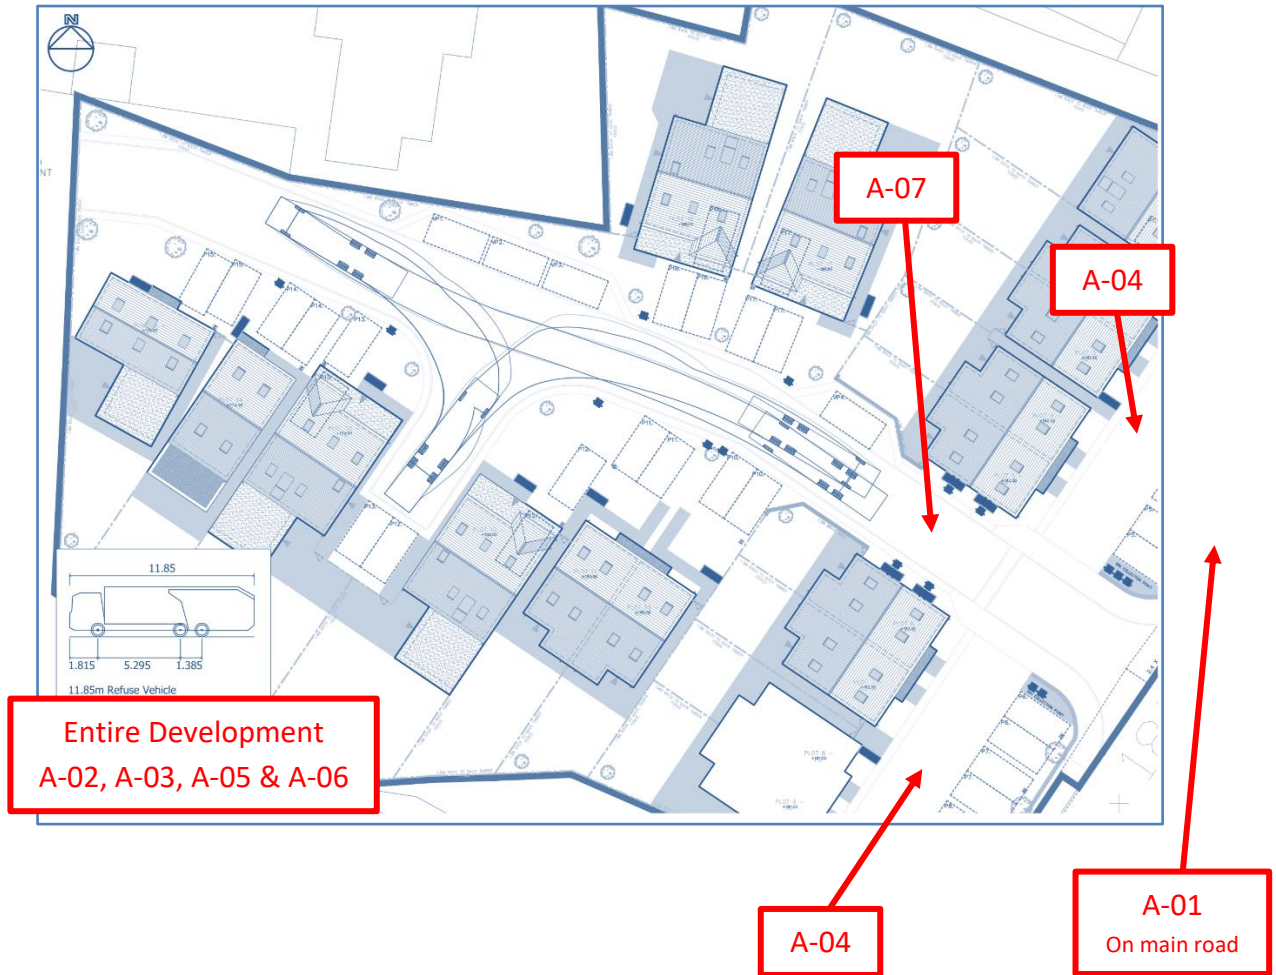
# Problem Location Plan

**Summary:** Visibility – Poor junction visibility may increase the risk of junction related collisions.

There is an existing bus stop to the northern side of the proposed access, the shelter provided is a cantilever type with minimal obstruction to the junction visibility splay. However, there is a concern that when pedestrians are waiting for a bus service, there may be a risk of obstruction by waiting pedestrians, this may increase the risk of junction related collisions.

**Summary:** Drainage – Poor drainage may increase the risk of skid and loss of control type collisions.

No details have been provided of the surface water drainage in terms of crossfall and gully locations. Poor surface water drainage may lead to ponding water and detritus in the carriageway, this may increase the risk of skidding and loss of control type collisions for motorised and non-motorised users, especially in wintery conditions due to freezing.

**Summary:** Skidding Resistance – Insufficient construction details may compromise road safety in terms of skidding resistance.

No details have been provided of the polished stone values (PSV) of the bituminous materials, especially with consideration of the anticipated estate road gradient. In addition, there are likely to be inspection chamber covers on gradients and near junctions. Inappropriate carriageway construction with low PSV values or covers with a low PSV may increase the risk of overshoot, rear shunt or pedestrian accidents, and may also increase the risk of skid/loss of control type collisions for powered two-wheel users.

**Summary:** Parking Layout – Poor provision for parking may increase the risk of collisions involving reversing vehicles.

Some of the parking places indicated on the drawing, would require a significant distance of reversing in order to either access or leave the parking space. This may increase the risk of NMUs being struck by a reversing vehicle, especially in the parking cul-de-sac areas where children are most likely to be playing.

**Summary:** Pedestrians – Lack of segregation between NMUs and vehicles may increase the risk of collisions involving NMUs, especially young children playing.

NMUs appear to be accommodated within a shared use area for all users, this creates an ambiguity of priority for users, in that vehicles entering the shared use area may not expect to encounter NMUs, in particular children playing in what they may perceive as a safe area. This may increase the risk of collisions on the share area between pedestrians and moving vehicles.

**Summary:** Lighting – Poor road illumination may increase the risk of collisions during the hours of darkness.

The drawings supplied do not indicate any road illumination provision. Poor levels of road surface and user illumination may increase the risk of collisions during the hours of darkness.

**Summary:** Gradients – Poor gradient interface design may increase the risk of junction related collisions due to failed hill starts

The drawings supplied do not indicate any gradients on the design. The nature of the site suggests that gradients inside the site may exceed 4%, as such, there may be a risk that vehicles setting off from the side road are at risk from hill start type stalls. DMRB CD123 gives recommendations in terms of a “level” of no more than 4% in advance of the interface with the major road, although given the use will not be typically by large goods vehicles the recommended distance of 15m may over generous in this location. Lack of a “level” approach to the major road may increase the risk of junction related collisions due to failed hill starts.

It is recommended that the bus stop and waiting area for pedestrians is relocated to a point outside of the junction visibility splay. This may require the bus stop to be inset into the site at the back of the footway.

It is recommended that a positive means of surface water drainage is provided for all public areas of the estate infrastructure.

It is recommended that a minimum 55 PSV is provided and that inspection chamber covers provide a similar level of skidding resistance to the surrounding carriageway surface.

It is recommended that a swept path analysis is undertaken of the parking spaces to inform the next stage of design.

It is recommended that a pair of “share space” signs to TSRGD 2016 Diag. 886 are placed at the entrance to the development. It is also recommended that where no other hard paved area is provided, a hard-paved verge strip of at least 600mm is provided either side of the access to give a safety margin for pedestrians to side step any approaching vehicle on the access.

It is recommended that carriageway surface illumination is provided.

It is recommended that a “level” area is provided on the approach to the major road in the spirit of the requirements of CD123.
