**Accent Housing Ltd**

**Plane Street  
Huddersfield**

**Stage 1 Road Safety Audit**

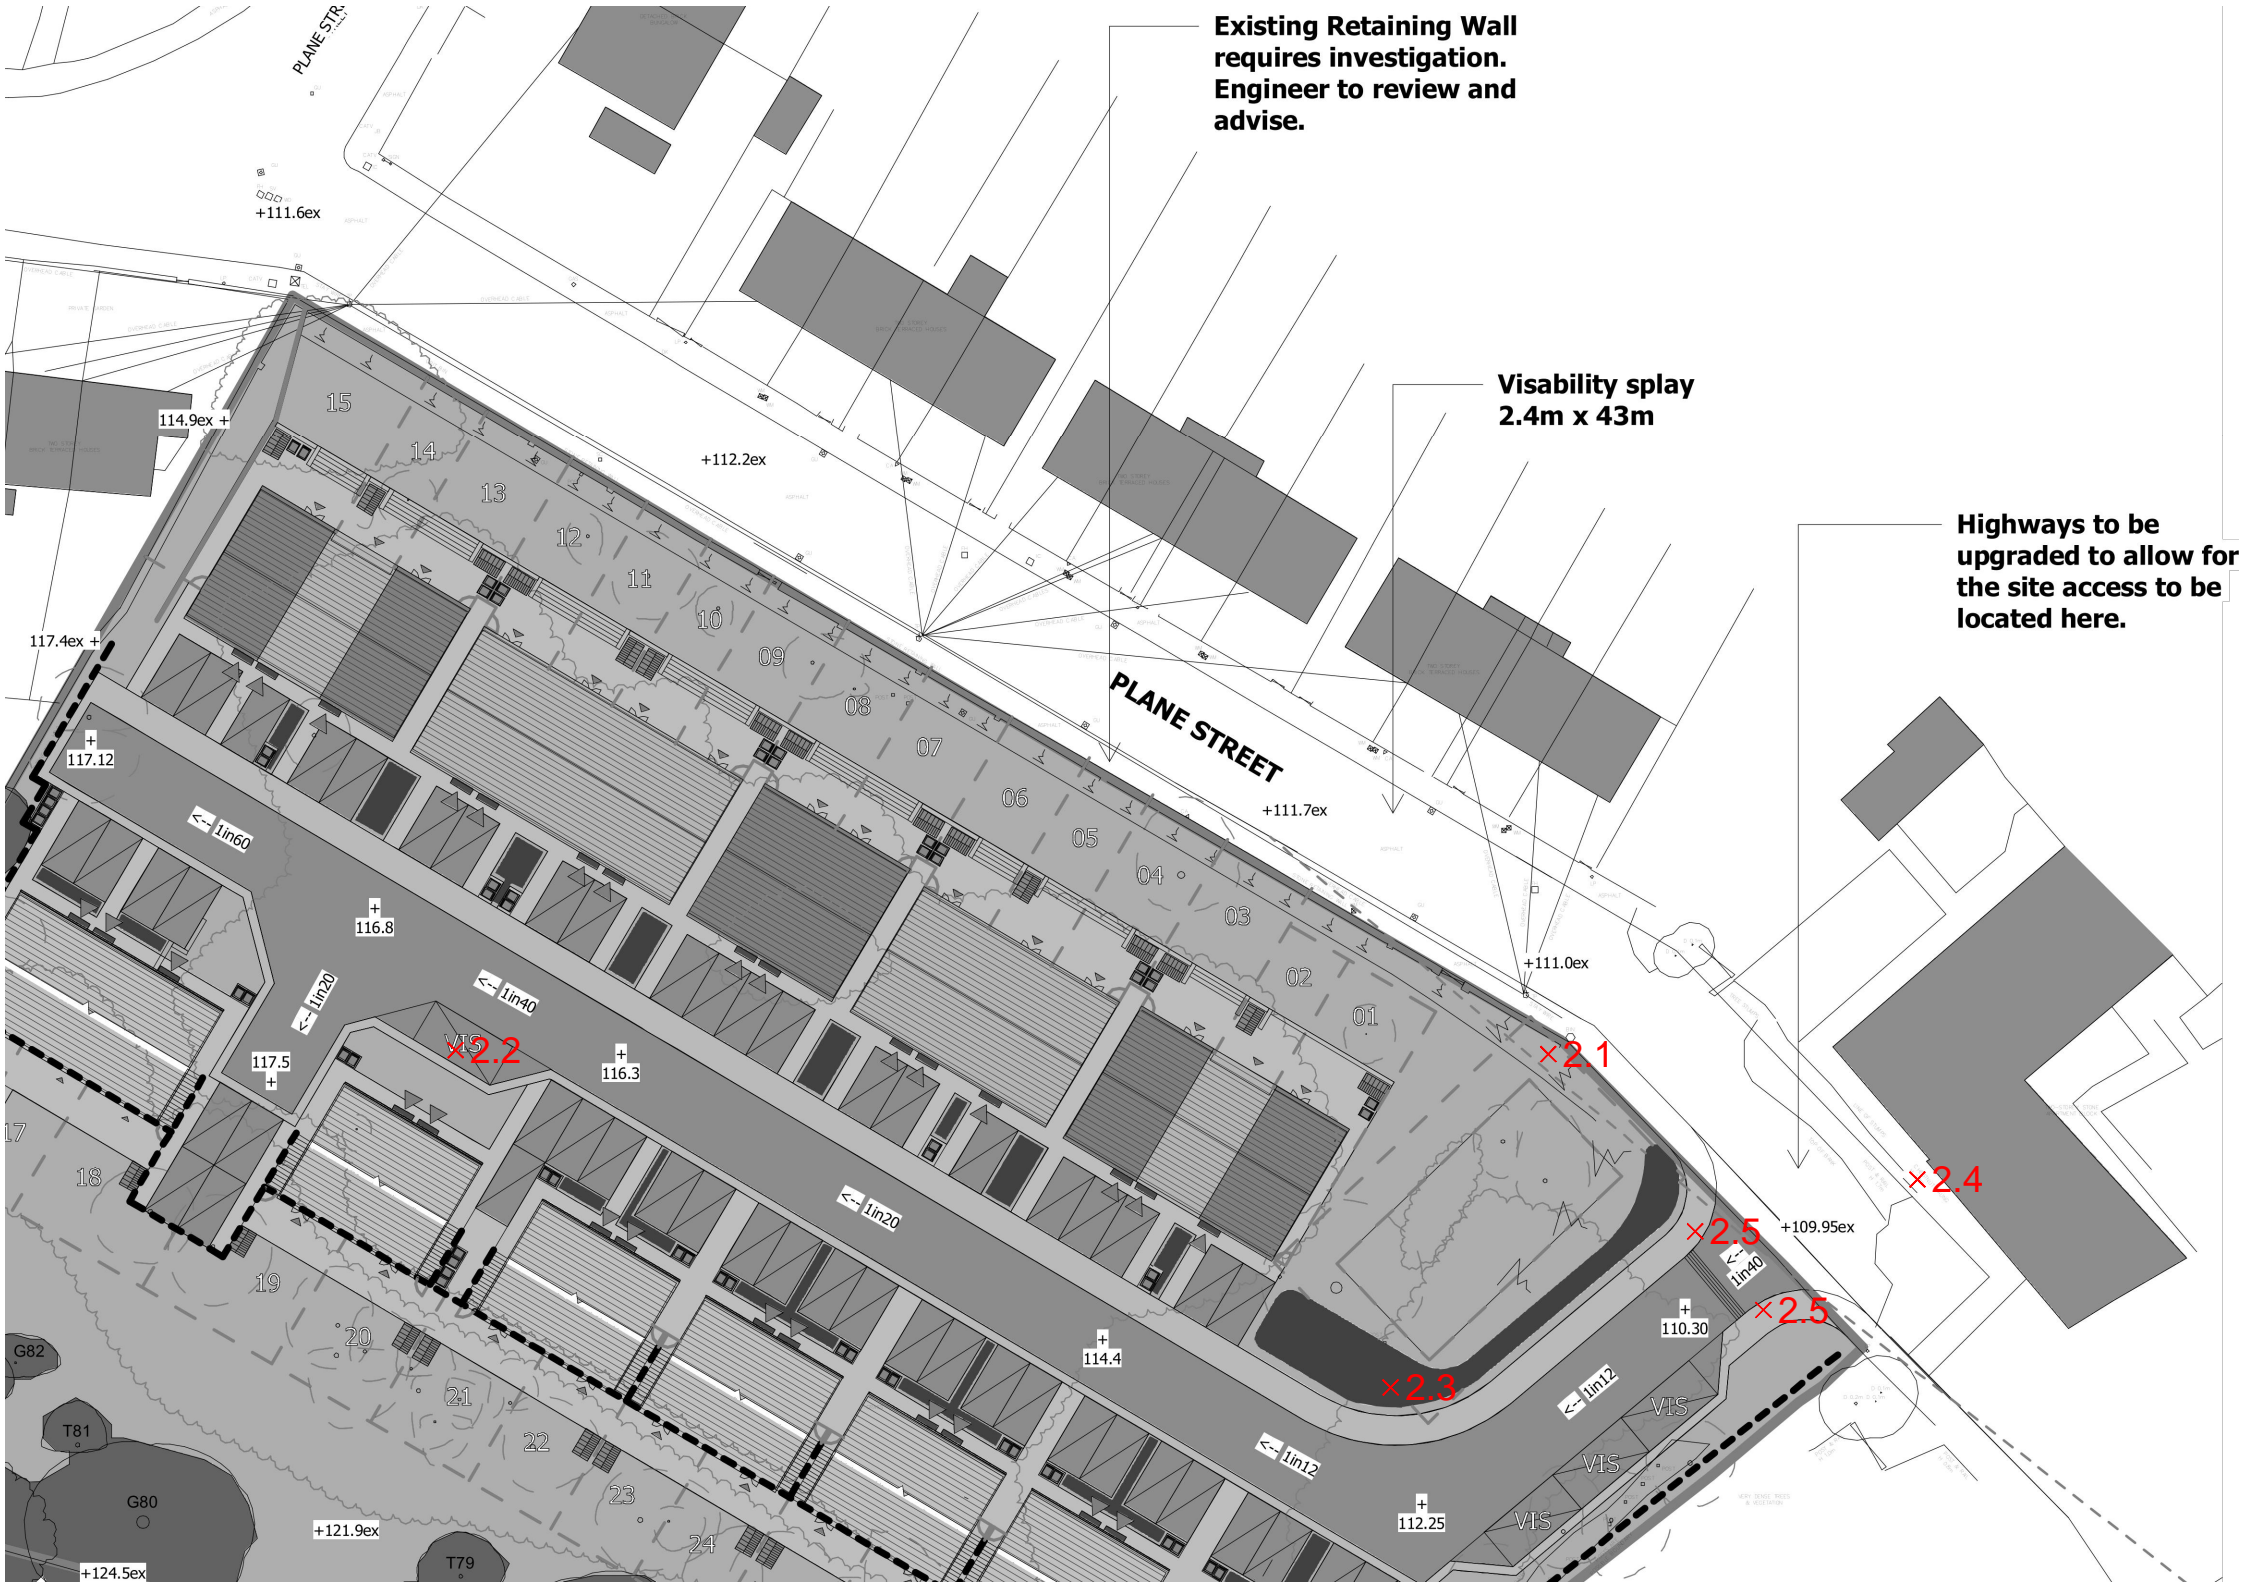
***APPENDIX A***  
***Marked up plan***

**Existing Retaining Wall  
requires investigation.  
Engineer to review and  
advise.**

**Visibility splay  
2.4m x 43m**

**Highways to be  
upgraded to allow for  
the site access to be  
located here.**
