# DESIGN AND ACCESS STATEMENT

## + HERITAGE IMPACT ASSESSMENT

| application | Retrospective Application for Property Refurbishment and Rebuilding of Single Storey Rear Extension at 49 Butterley Lane, New Mill, Holmfirth, HD9 7EZ |
| job number | 20/583 |

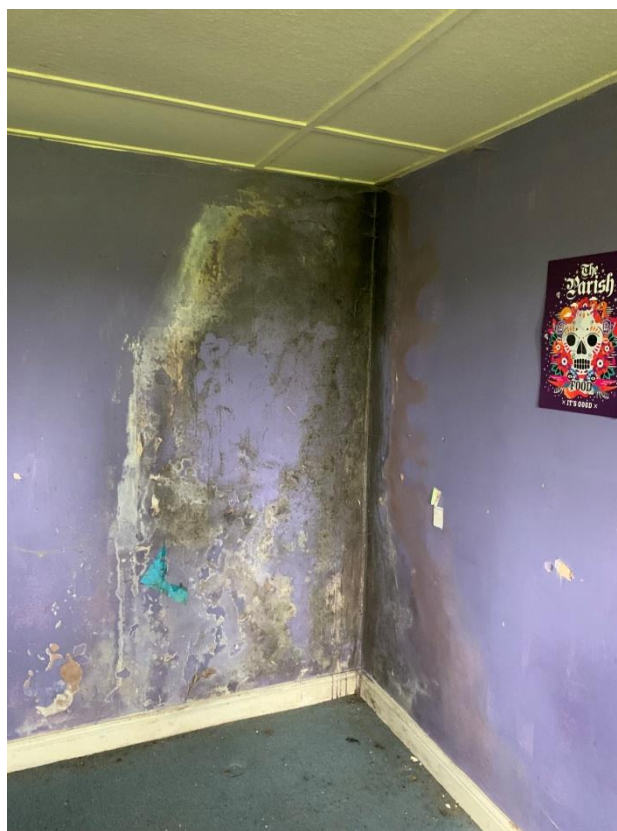
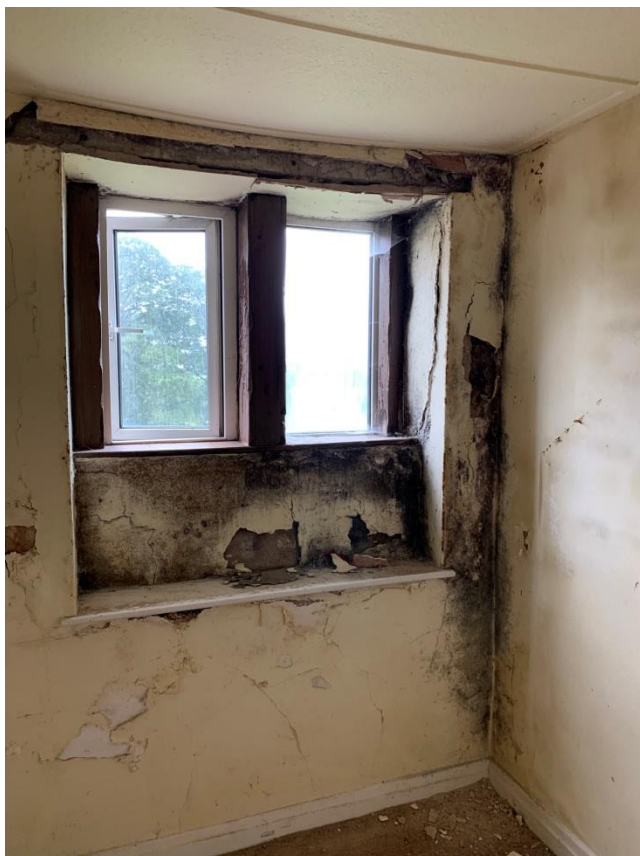
Water ingress causing internal mould growth leading to potential respiratory issues for occupants

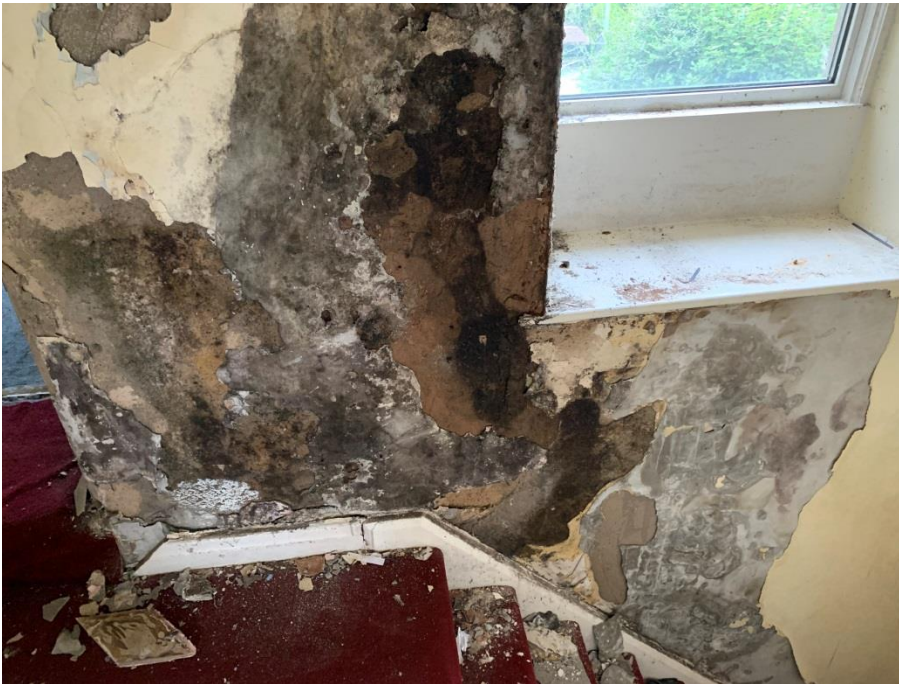
Damp ingress around first floor window surround causing damage to the internal décor and surfaces (plasterboard)

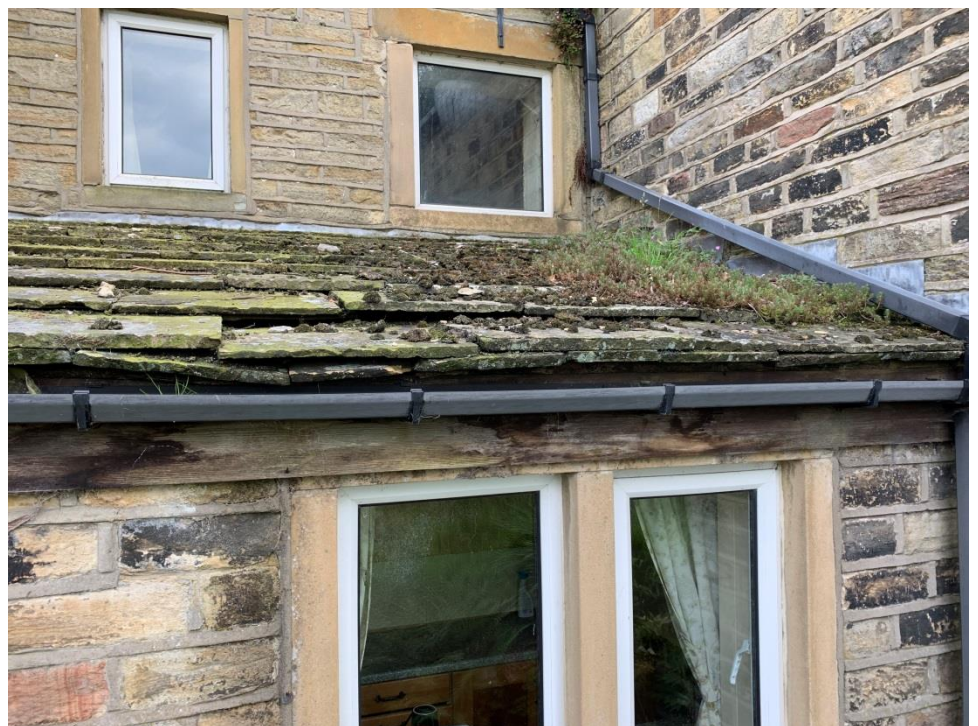
Unsafe fire within existing dining room posing risk to life with Carbon monoxide exposure.

Rear lean to roof failure with rotten roof timbers not adequately supporting stone slate roof covering.

The rear lean to, considered to be a previous extension, required reroofing due to an extensive and longstanding leak. Upon opening up the roof it became apparent that the roof structure had suffered due to the timespan of the leak. Many roof timbers were rotten and required replacement, the wall plate was rotten and required replacement which resulted in the whole roof structure having to come off and be reformed/replaced. It then transpired that the cavity walls were uninsulated with mortar snots bridging the cavity potentially contributing to the internal dampness, so the decision was made to fully take down the extension and rebuild it using the same stone for the outerleaf. The extension has been rebuilt in the same location, albeit with slightly more projection (yet still not set back from the two storey rear element). The pitch of the lean to roof has been retained and continued over the slight additional projection of 800mm. This results in a slightly lower eaves level. The extension is very similar in size and appearance to the previous dilapidated lean to.
