# Proposed Housing Development Northorpe Lane, Mirfield

## Road Safety Audit: Stage 1

| Report Reference: | MAL/NLMRSA1Rev0 |

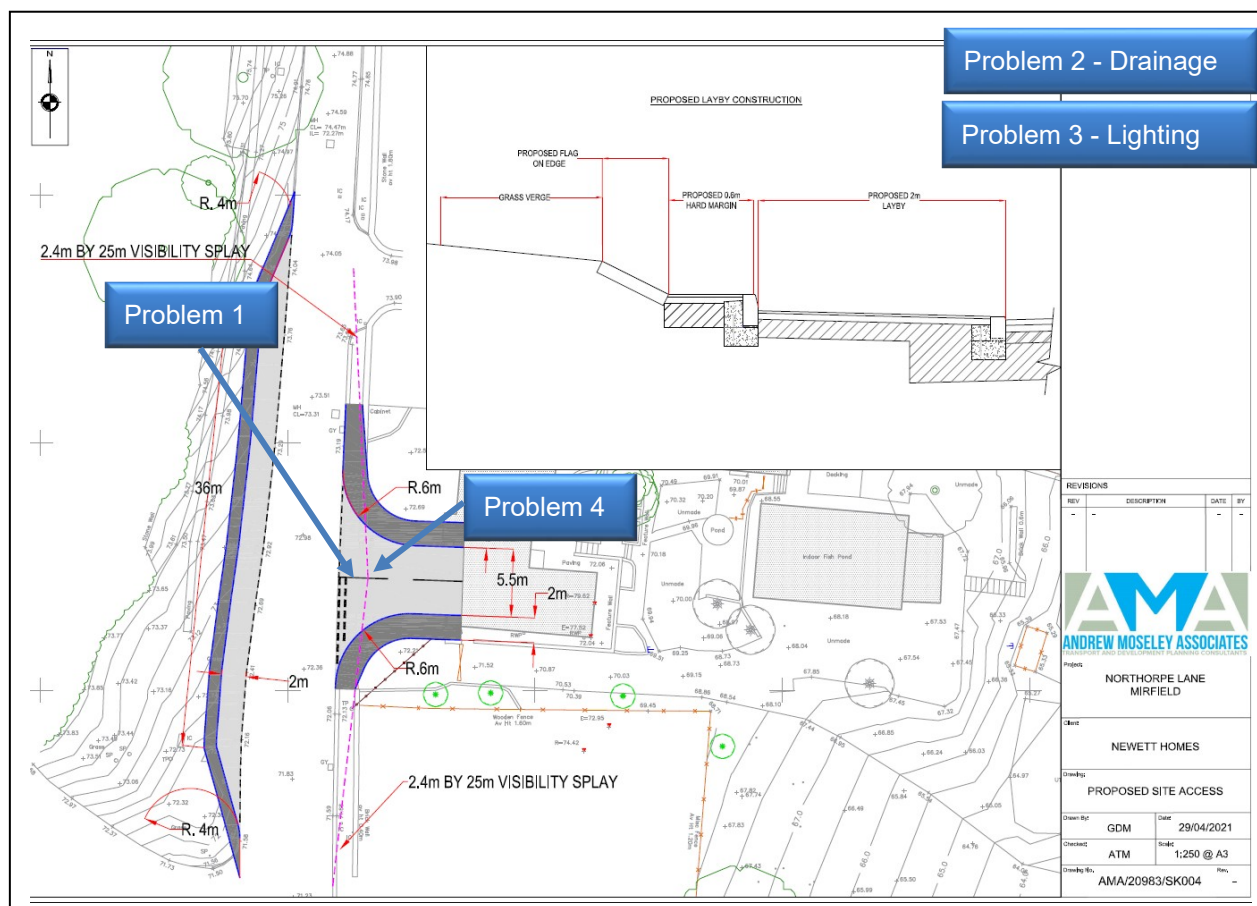
## Appendix 2 – Problem Location Plan

This section details the findings of this Stage 1 Road Safety Audit. All locations of identified problems are illustrated on the plan included at **Appendix 2**.
