**Haigh Huddleston & Associates**

Our Ref: E19/7366/MD/007A

**Further Site Investigation for Site at Station Road, Skelmanthorpe**

SITE INVESTIGATION PLAN

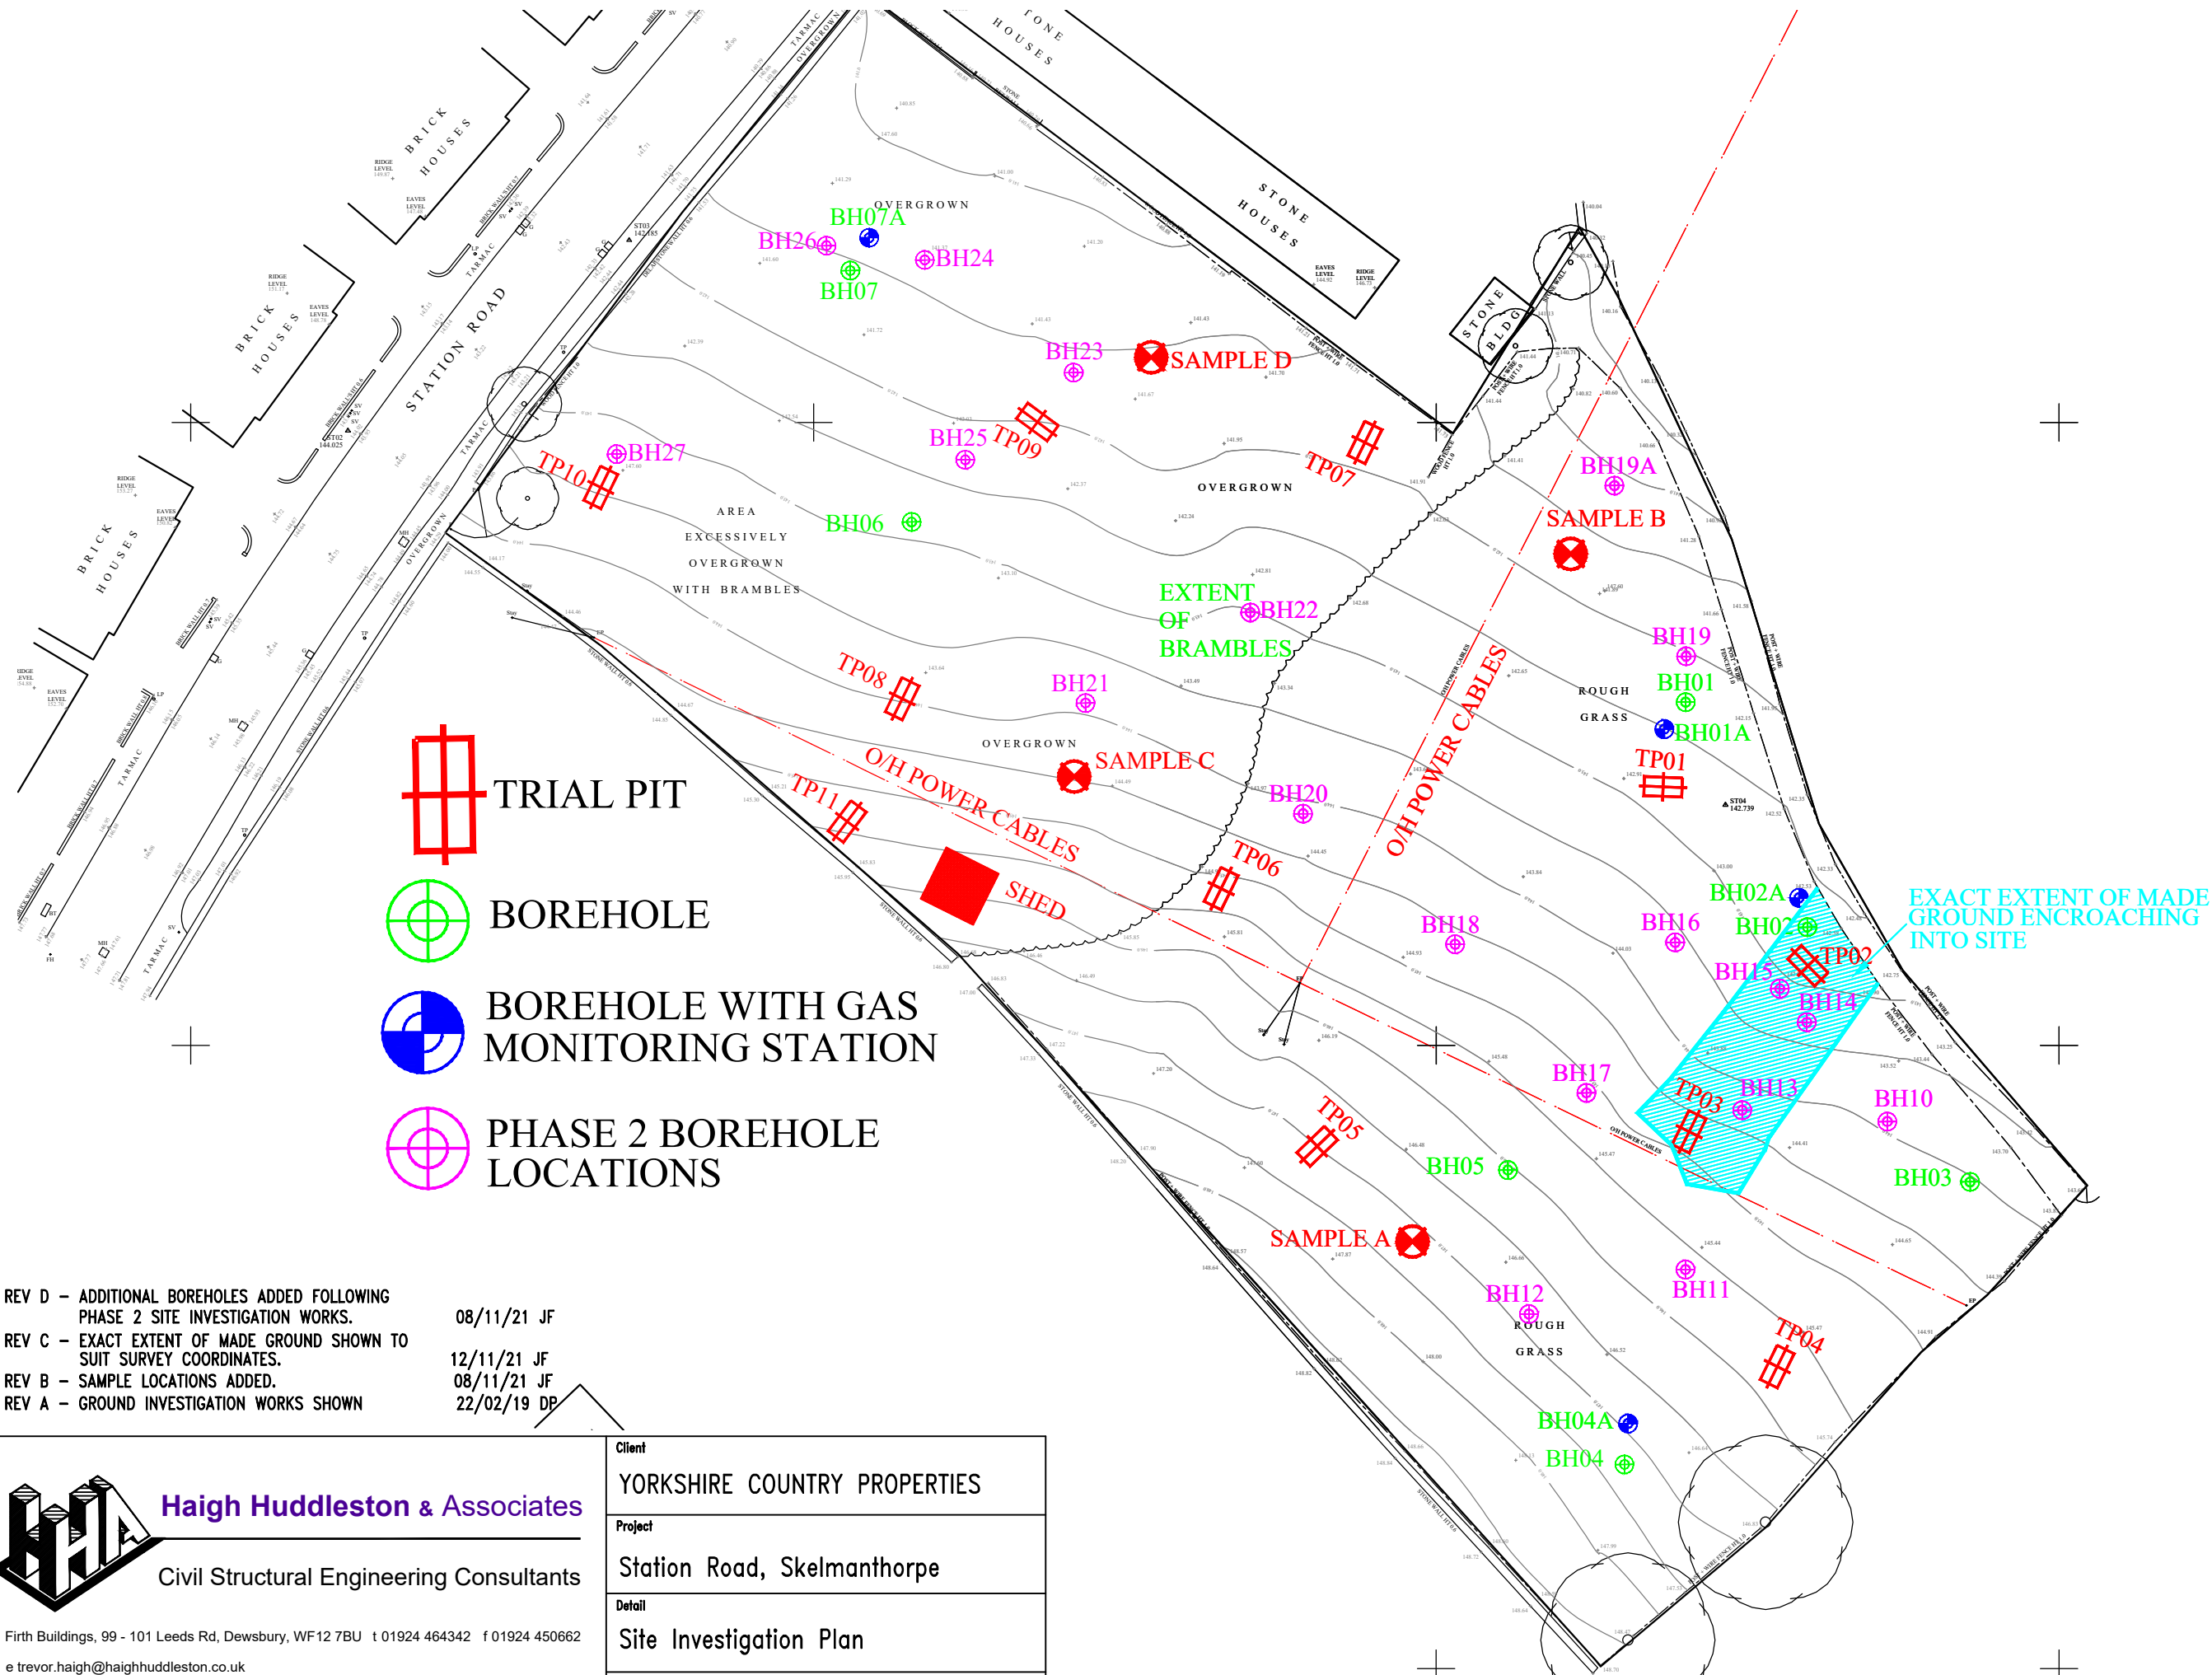
| Dwg No. | E18/7366/03D |

- 1.1 The additional fieldwork comprised of a trial trench and site scrape undertaken with an 8 tonne 360 tracked excavator. In addition to this, a total of nineteen rotary boreholes were sunk. The location of the trial pits and boreholes are indicated on Drawing E21/7786/03/01D.

- 2.1.3 Except BH13-BH15, the boreholes generally proved 0.2m of topsoil overlying 1.3-2.5m of clay with a mudstone bedrock encountered at 2.3-2.7m below existing ground levels.

- 2.1.4 BH10, BH11 and BH16-BH18 proved a single 0.9-1.0m thick coal seam at depths of 7.8-11.3m below existing ground levels.
- 2.1.5 BH12 and BH19-BH27 proved two coal seams within the mudstone strata.

- 2.1.6 BH13-BH15 were undertaken in the assumed former opencast mine and proved 4.7-7.9m of made ground, dipping towards the north eastern boundary, underlain by mudstone. In BH13 an intact 1m thick coal seam was encountered at 8.8-9.8m below existing ground levels.

- 2.2.1 During the initial site investigation works, BH02 proved an 8.1m depth of made ground. It was therefore surmised that the historical opencast coal mining recorded to the north east of the site had encroached onto the development.
- 2.2.2 A site scrape was undertaken in the vicinity of BH02 and proved an approximately 9m wide strip of re-engineered ground extending from the north eastern boundary into the development. The depth of re-engineered ground got shallower as it extended into the site and boreholes undertaken proved the coal here had been unworked.
- 2.2.3 This feature has been surveyed to enable an accurate plan of the made ground area to be overlaid on the planning layout to determine how it will affect the proposed development.

- 2.2.4 The investigation works indicate that this is not an extension of the opencast mineworks into the site, however, it is suspected of being a ramped access to the base of the opencast mineworkings. No other evidence of historical mineworking was proved during the site scrape.
- 2.2.5 The extent of the re-engineered ground associated with the ramp excavation is shown on drawing E18/7366/18D to the rear of this report.

3.1.3 In addition to this, due to the incursion of the area of made ground into the footprint of Plot 26 and associated double garage, piled foundations are recommended for these two properties. The piles should be pre-drilled to ensure they are not founded on the shallow coal seams encountered beneath the site and socketed a minimum of 1m into suitable natural mudstone bedrock.

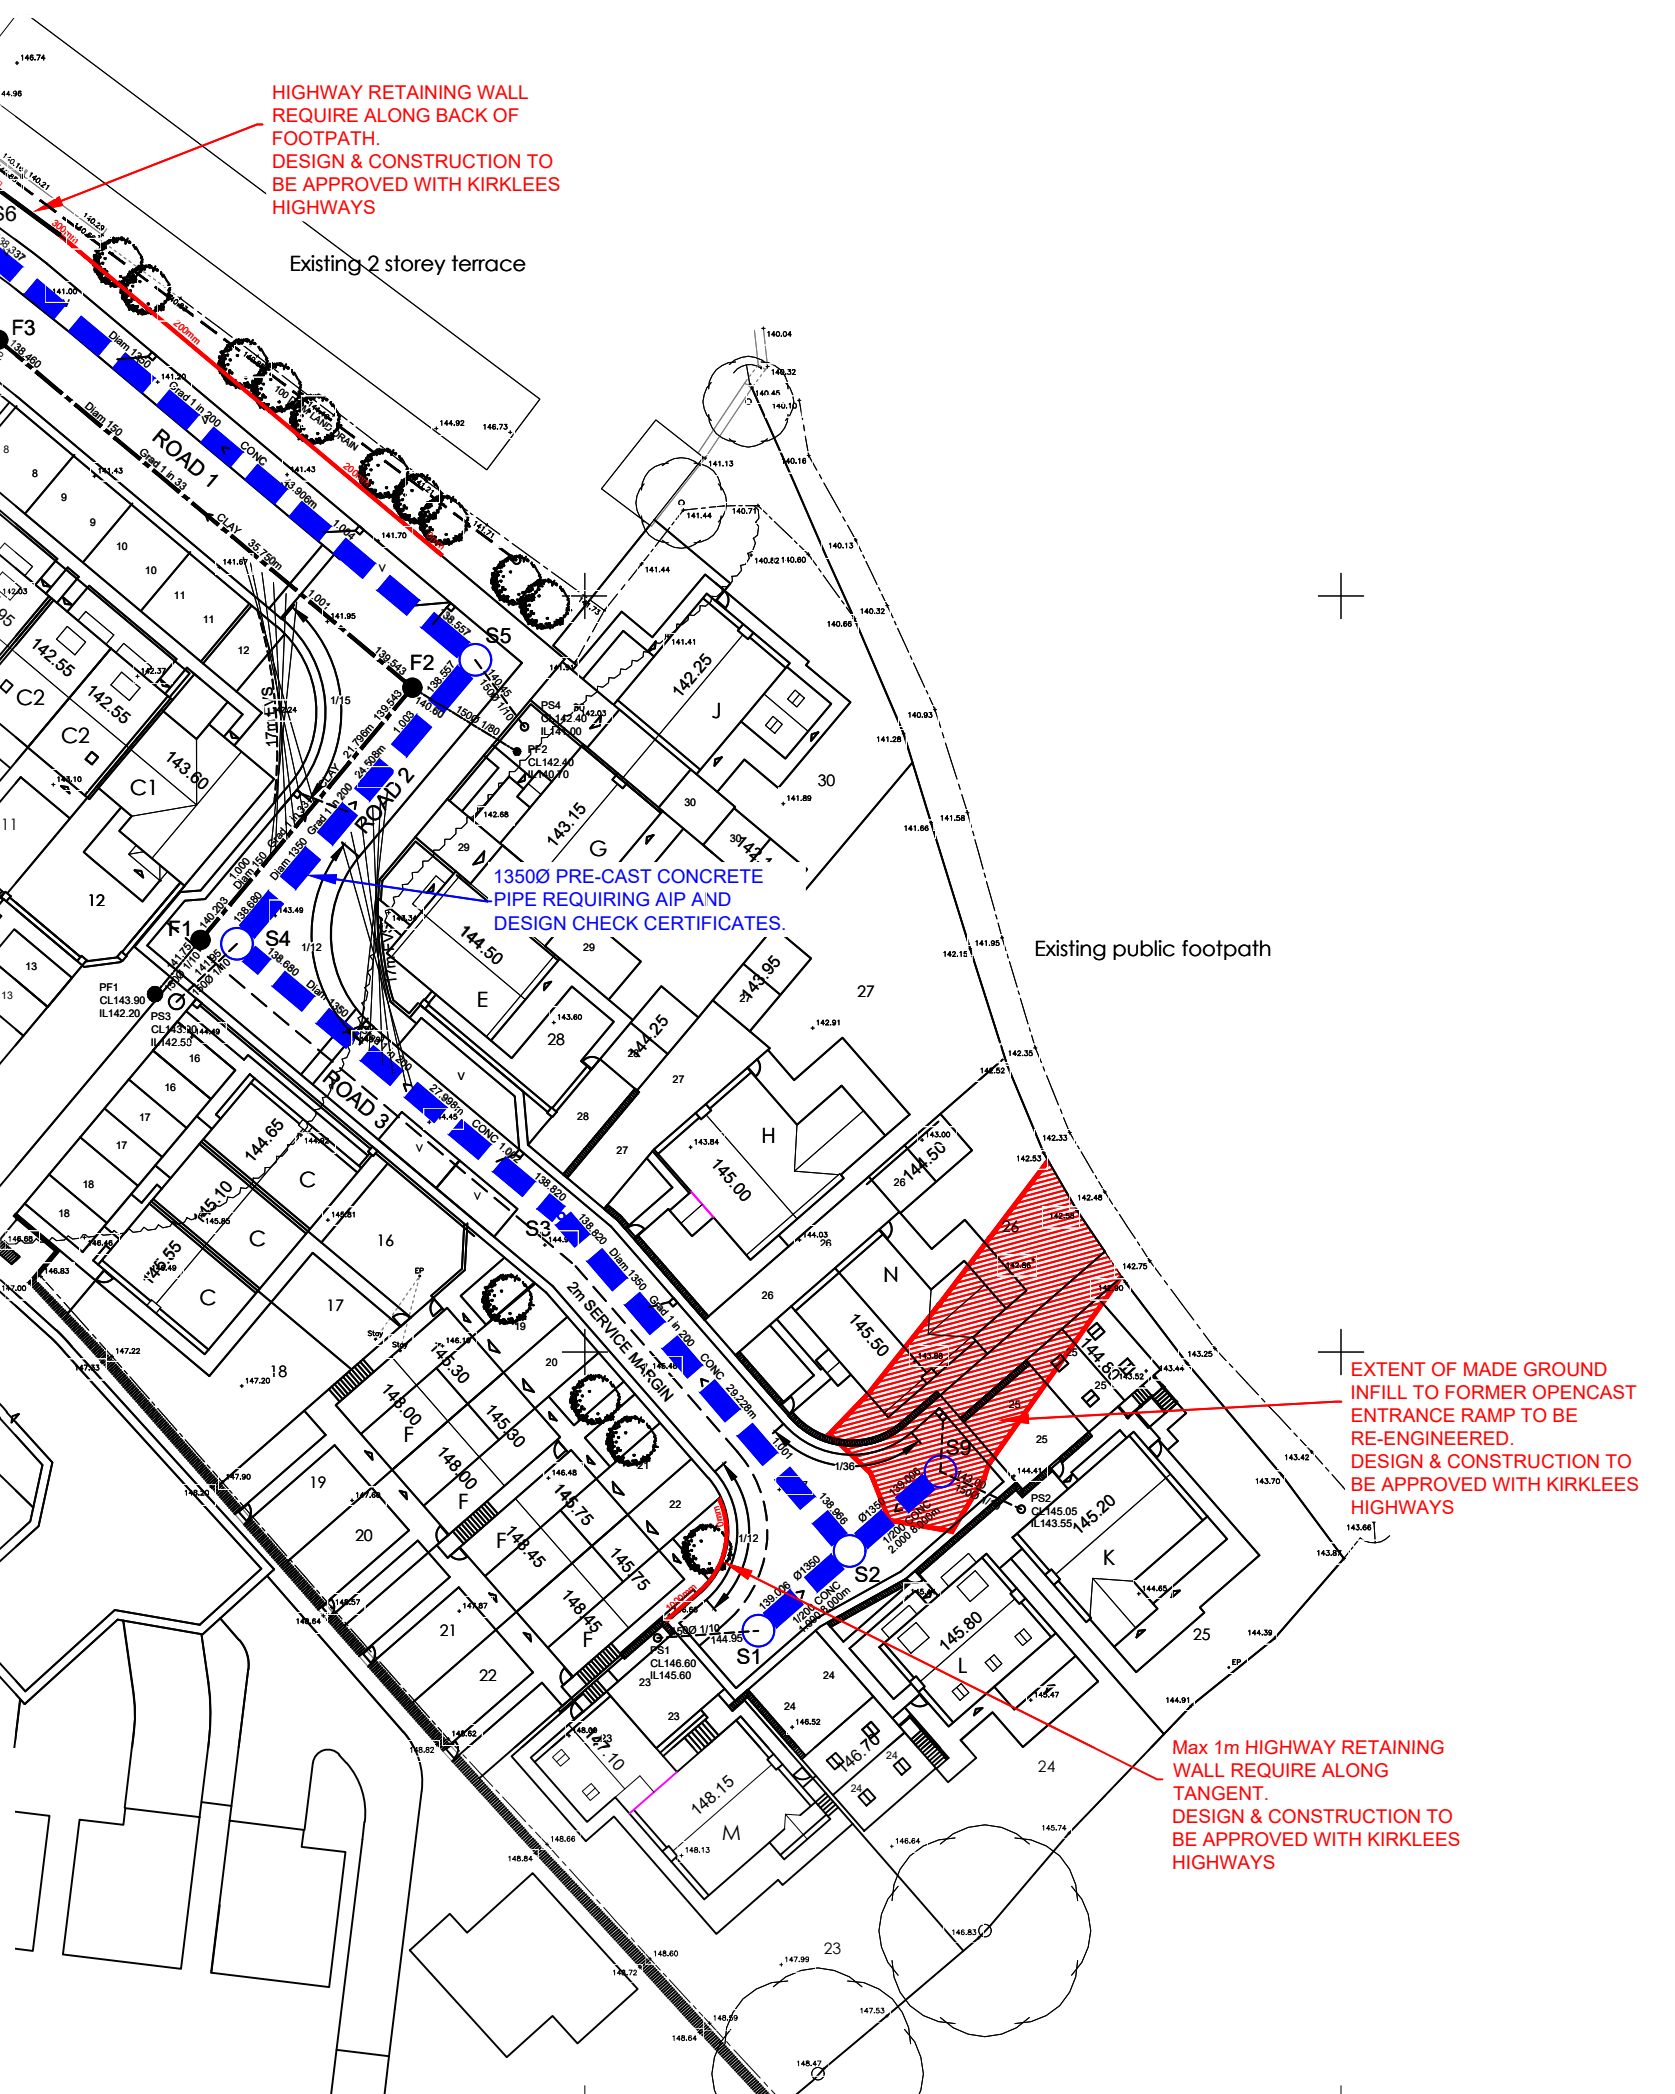
| 1:500@A3 | MD | | Dec'21 | E19/7366/044 | |

3.2.2 However, the entrance ramp to the former opencast mine encroaches beneath the footprint of the adoptable highway and remedial works will be required to provide a suitable formation layer to the proposed adoptable highway.

- The proposed back of footpath levels at the site entrance are elevated above existing ground levels on the northern boundary by approximately 200mm. The northern boundary is formed by a single skin brick wall retaining the site approximately 700mm above the land to the north of the site. It is proposed to deepen the mass concrete footings to the proposed barrier wall at the back of the footpath to prevent additional loading from the proposed highway onto the existing boundary retaining wall.

- A 1000mm highway retaining wall is required adjacent Plot 22 due to the steep nature of the exist ground levels. A mass concrete burr wall is to be constructed beneath the proposed hard margin onto the underlying natural clays.

- Due to the low allowable surface water discharge from site, in conjunction with the lack of available space to provide attenuation outside the adoptable highway, it is proposed to use 1350mm diameter concrete pipes beneath the carriageway. These are to be put forward for adoption under a Section 104 Agreement with Yorkshire Water with AIPs and Design Check Certificates to be submitted to Kirklees Council.

3.2.6 The location of the features mentioned in paragraphs 3.2.2 and 3.2.4 are indicated on drawing E19/7366/044 attached to the rear of this report.
