# Remediation Strategy

## Land at Westgate, Cleckheaton For Strata Homes Ltd

Report no: 3043/4B

Date: November 2021

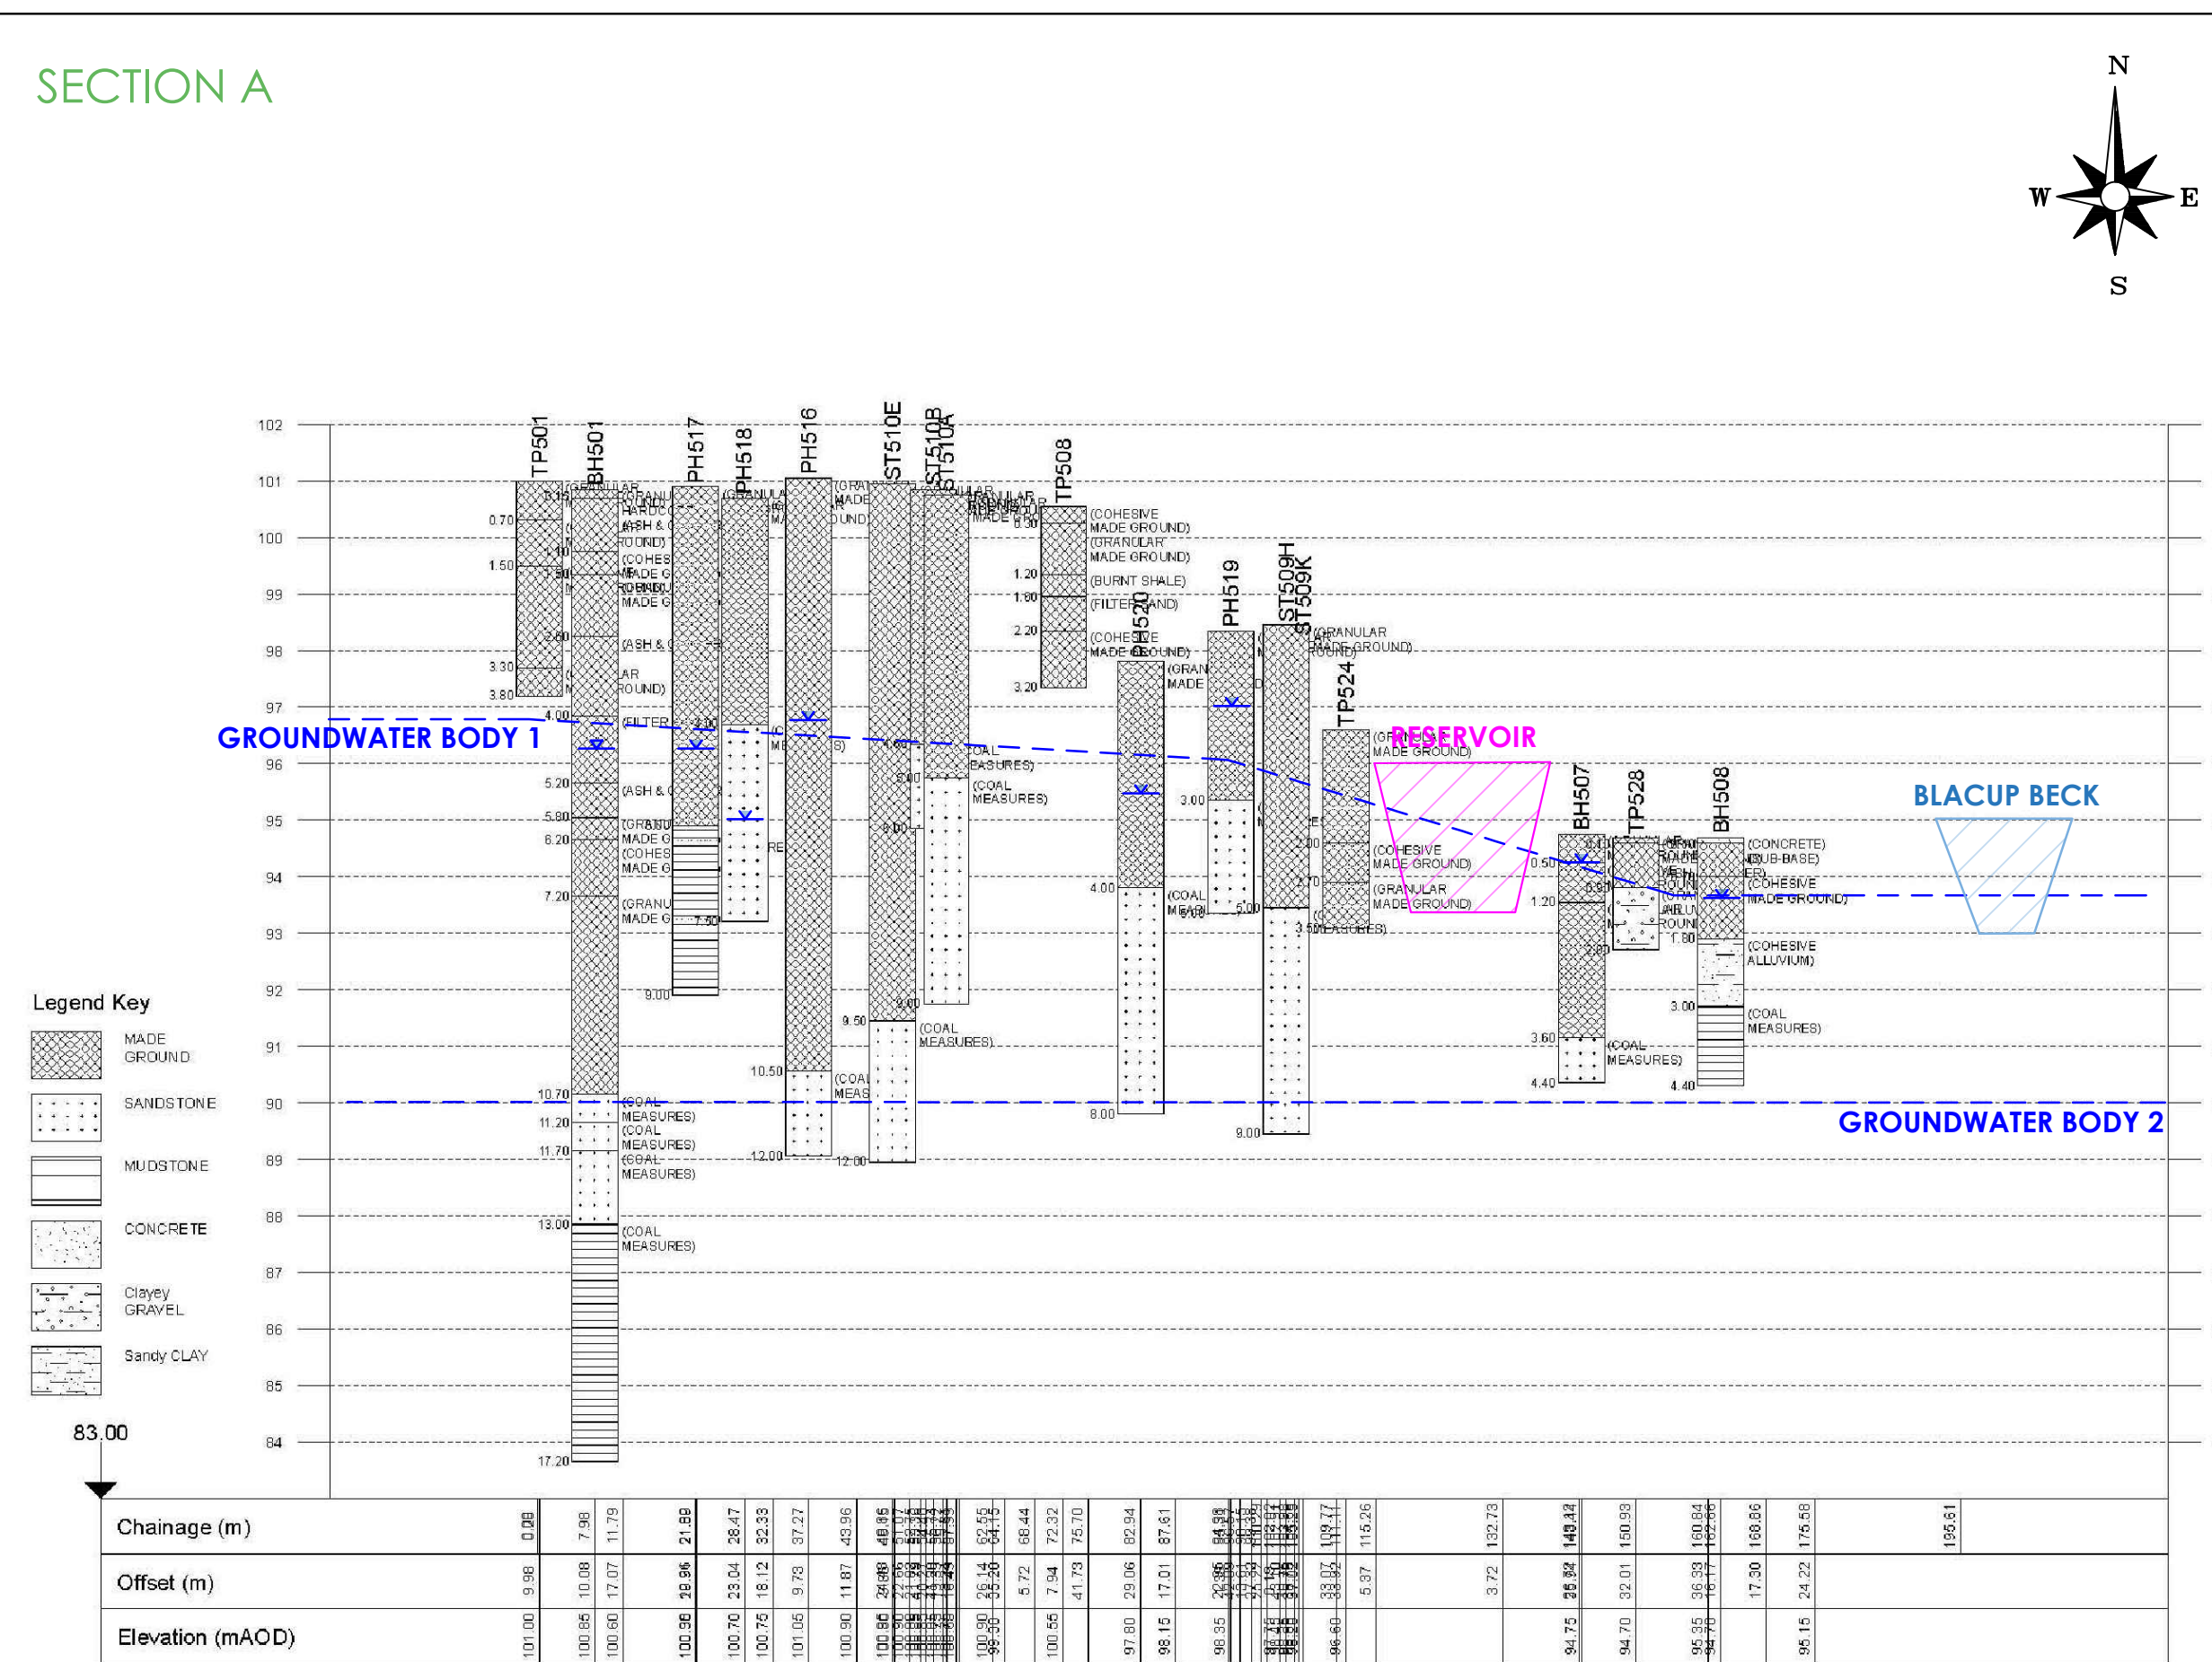
## SECTION A

- NOTES
- LINE OF CROSS SECTION
  - APPROXIMATE SITE BOUNDARY
  - GROUNDWATER LEVEL FROM MONITORING WELL DIPS
  - GROUNDWATER LEVEL
  - BACKFILLED RESERVOIR
  - SURFACE WATERCOURSE

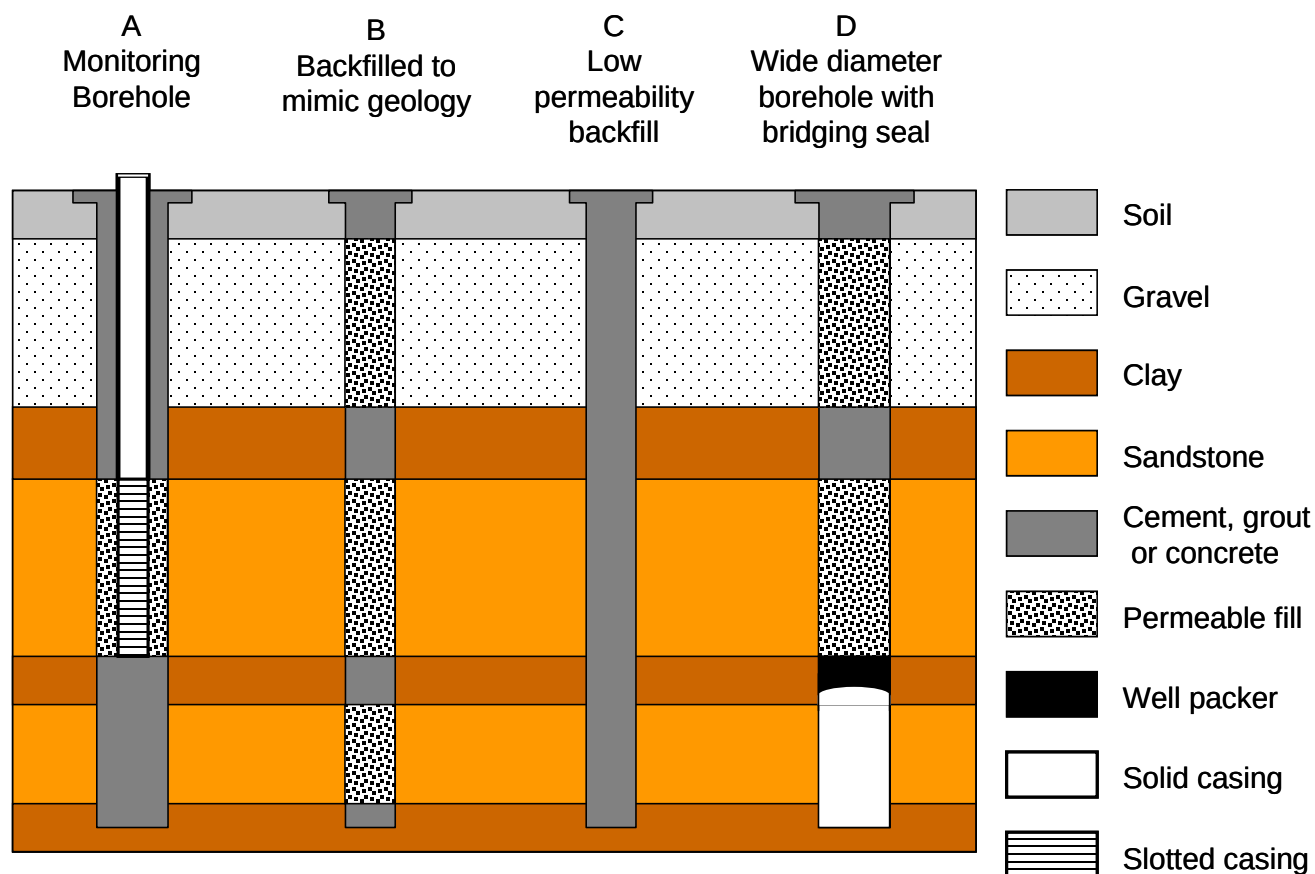
**Figure 1: Schematic options (B–D) for decommissioning wells and boreholes**

Each situation is different in terms of its location, geological setting, borehole construction, dimensions, hazards and, very importantly, intended site afteruse. Therefore the most appropriate abandonment procedure will vary from site to site. It is strongly recommended that you engage the services of a proficient well contractor with a good knowledge of the local geology and well abandonment procedures. For large boreholes and wells you may need to seek engineering advice. **(Note that structural aspects are outside the scope of this guidance.)**

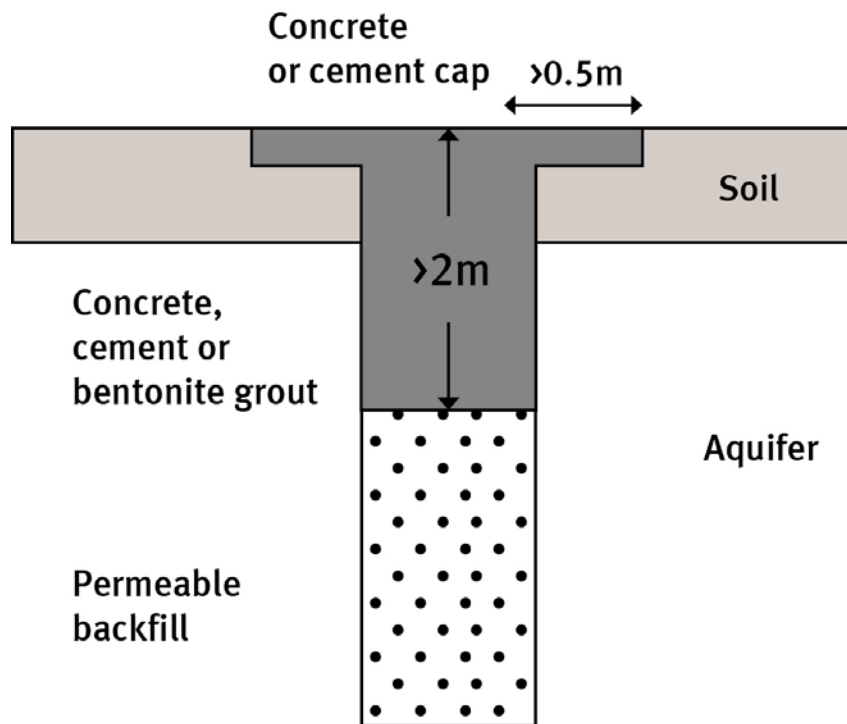
**Figure 2: Schematic diagram for borehole seal and cap**

The backfilled borehole/well should be completed with an impermeable plug and cap to prevent entry of potentially contaminated surface run-off or other liquids. The top two metres should be filled with cement, concrete or bentonite grout. A concrete cap of suitable strength, with a diameter at least one metre greater than the width of the backfilled borehole (see Fig. 2), should then be installed. The exact finished depth of this cap will depend on the setting and planned afteruse of the site. It should be at least 2 metres below plough depth in agricultural areas and at least 1 metre below formation level for sites proposed for redevelopment. Never build structures directly onto well caps or linings.
