**PHASE II / GROUND INVESTIGATION  
AND UPDATED RISK ASSESSMENT  
REPORT**

**LAND ADJACENT TO NO. 7, TOWN  
GATE, SCHOLLS**

**MR D. BLACKBURN**

Report Reference: GES 2371-22 PII

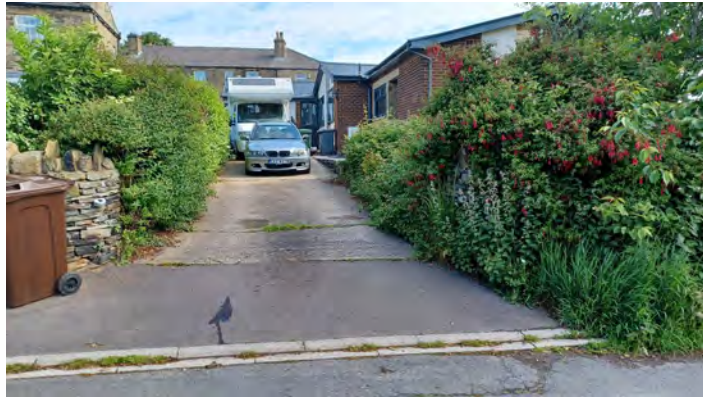
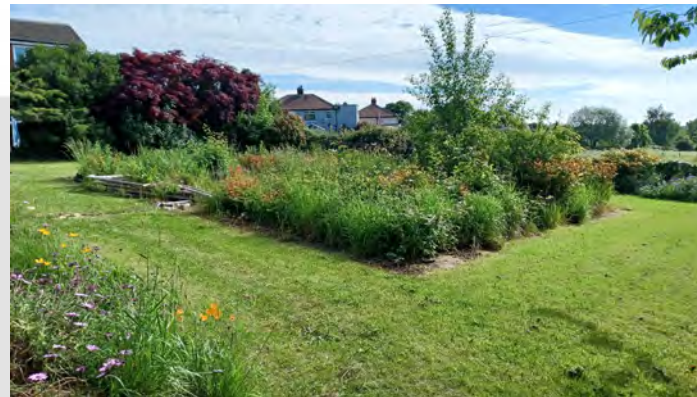
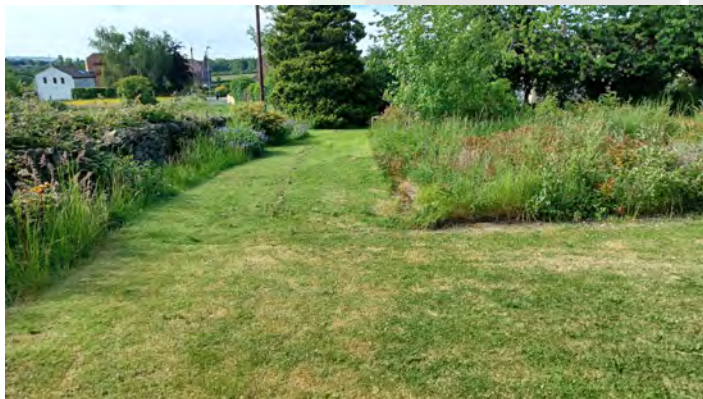
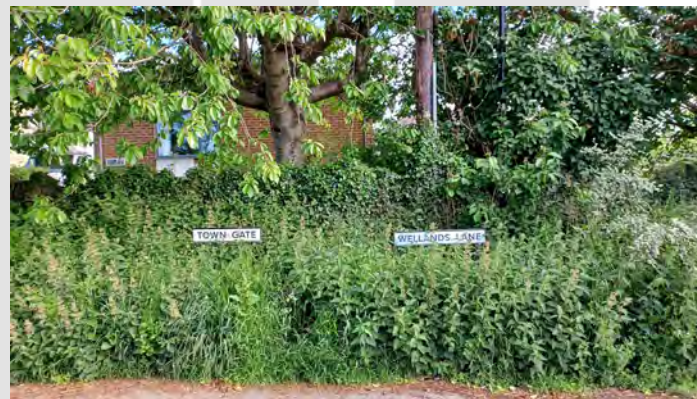
- A. Facing north, view of site access.
- B. Facing northeast, view of central site area.
- C. Facing south, view of eastern site boundary.
- D. Facing north, view of southern site boundary from Town Gate.
