MARSH DESIGN LIMITED

18 April 2023
Our Ref: MDL – 8338

Structural Appraisal of 2No. Barn Buildings for a Proposed Residential Development at Moss Edge Farm, Holmbridge

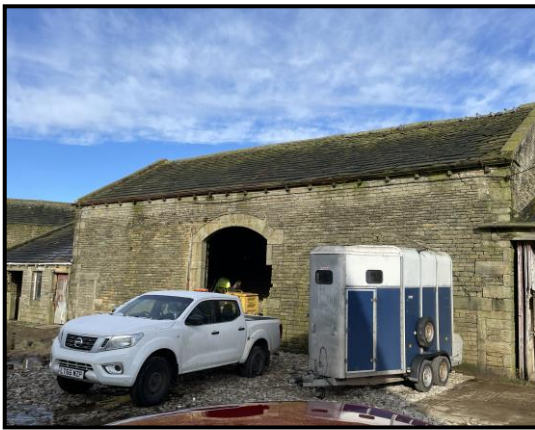
Front Elevation

Minor lateral movement was noted to the top of the front elevation of the North Barn, however we do not consider this to be a major structural concern.

The stone arch and feature quoins are well aligned with no structural movement noted.

Minor undulations to the ridge line of the North barn were noted and simple realignment of the ridge will be required during the proposed redevelopment when the roof structures of the barns are redressed.

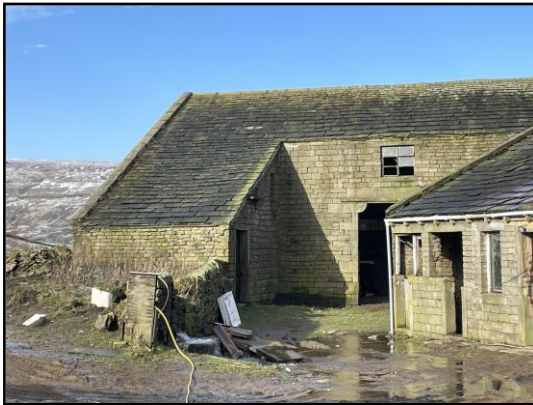
Front Elevation

A fracture was noted to the stone lintel over the entrance to the West Barn. This can either be replaced or repaired with steel dowels resin fixed into the lintel.
