## Remediation Strategy

Taylor Hall Lane

Mirfield

**Report A4245/24/RMS**

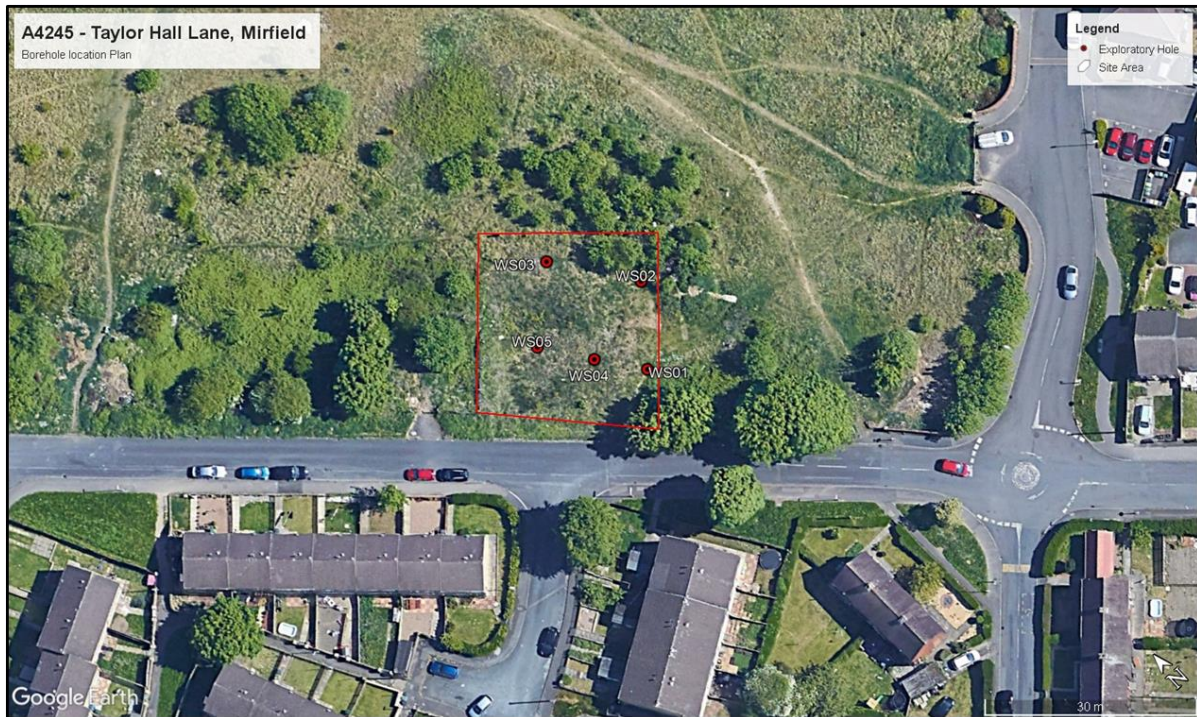
**Figure 3: Exploratory Hole Location Plan**

- Five window sample boreholes (WS101 - WS105 inclusive) to depths of between 3.00 and 6.00m bgl.

- 50mm diameter standpipes were installed in all the window sample boreholes at depths between 3.00m - 6.00m below ground level.

An exploratory hole location plan is presented as Figure 3, below.
