**ARBORICULTURAL REPORT  
AND  
ARBORICULTURAL IMPACT ASSESSMENT  
to BS 5837:2012  
at  
53 Hall Lee Fold  
Lindley  
Huddersfield  
West Yorkshire  
HD3 3NX**

**JCA Ref:**  
21465/AJB

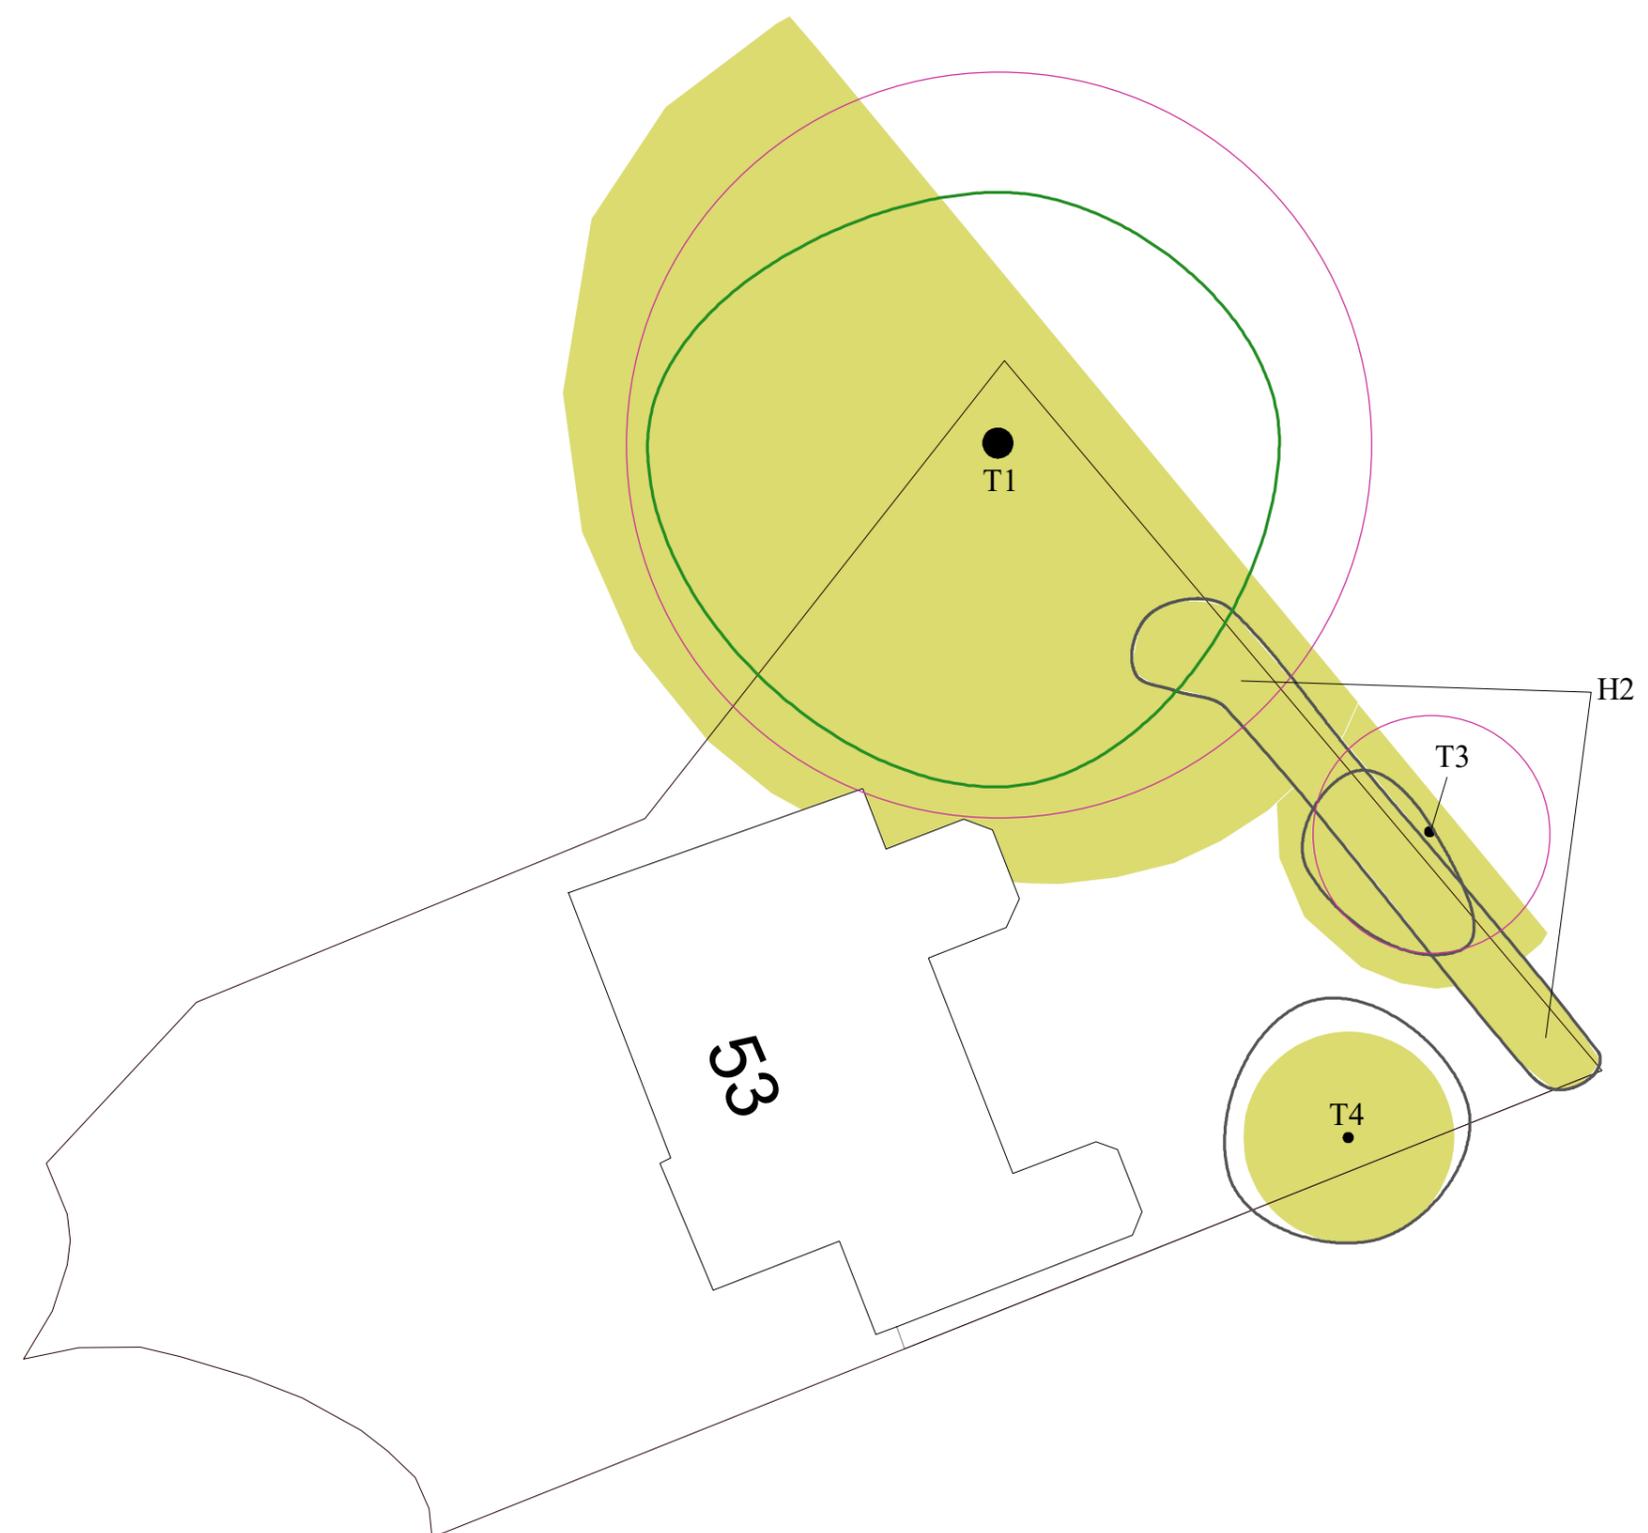
**Appendix 5:  
Tree Constraints Plan**

**Root Protection Area: RPA**

THE ROOT PROTECTION AREA SHOULD IDEALLY REMAIN UNDISTURBED IF THE TREE IS TO BE RETAINED.

THE DEVELOPMENT PROPOSALS SHOULD THEREFORE BE DESIGNED TO AVOID THE RPA OF ANY TREE WHICH IS TO BE RETAINED.

IF IT IS NECESSARY FOR THE DEVELOPMENT TO ENCROACH INTO THE RPA OF A TREE WHICH IS TO BE RETAINED THEN SPECIALIST CONSTRUCTION TECHNIQUES AND MATERIALS MUST BE CONSIDERED.

- 1.2.1 For this purpose, a site plan has been provided by our client's architect which forms the basis for the Tree Constraints Plan at **Appendix 5**. Tree positions were not marked on the site plan and have therefore been plotted by the surveyor on site.
- 1.2.2 Whilst not as accurate as a topographical survey, our drawing is considered to provide a fair representation of the positions of the trees surveyed. Tree positions should, however, be considered indicative on the Tree Constraints Plan.

- 3.1.1 In total, 4 items of vegetation were surveyed, three individual trees and a hedge. Of these, one tree (T1) was considered to fall into retention category 'A' and two trees and one hedge (H2, T3 and T4) were considered to fall into retention category (C).

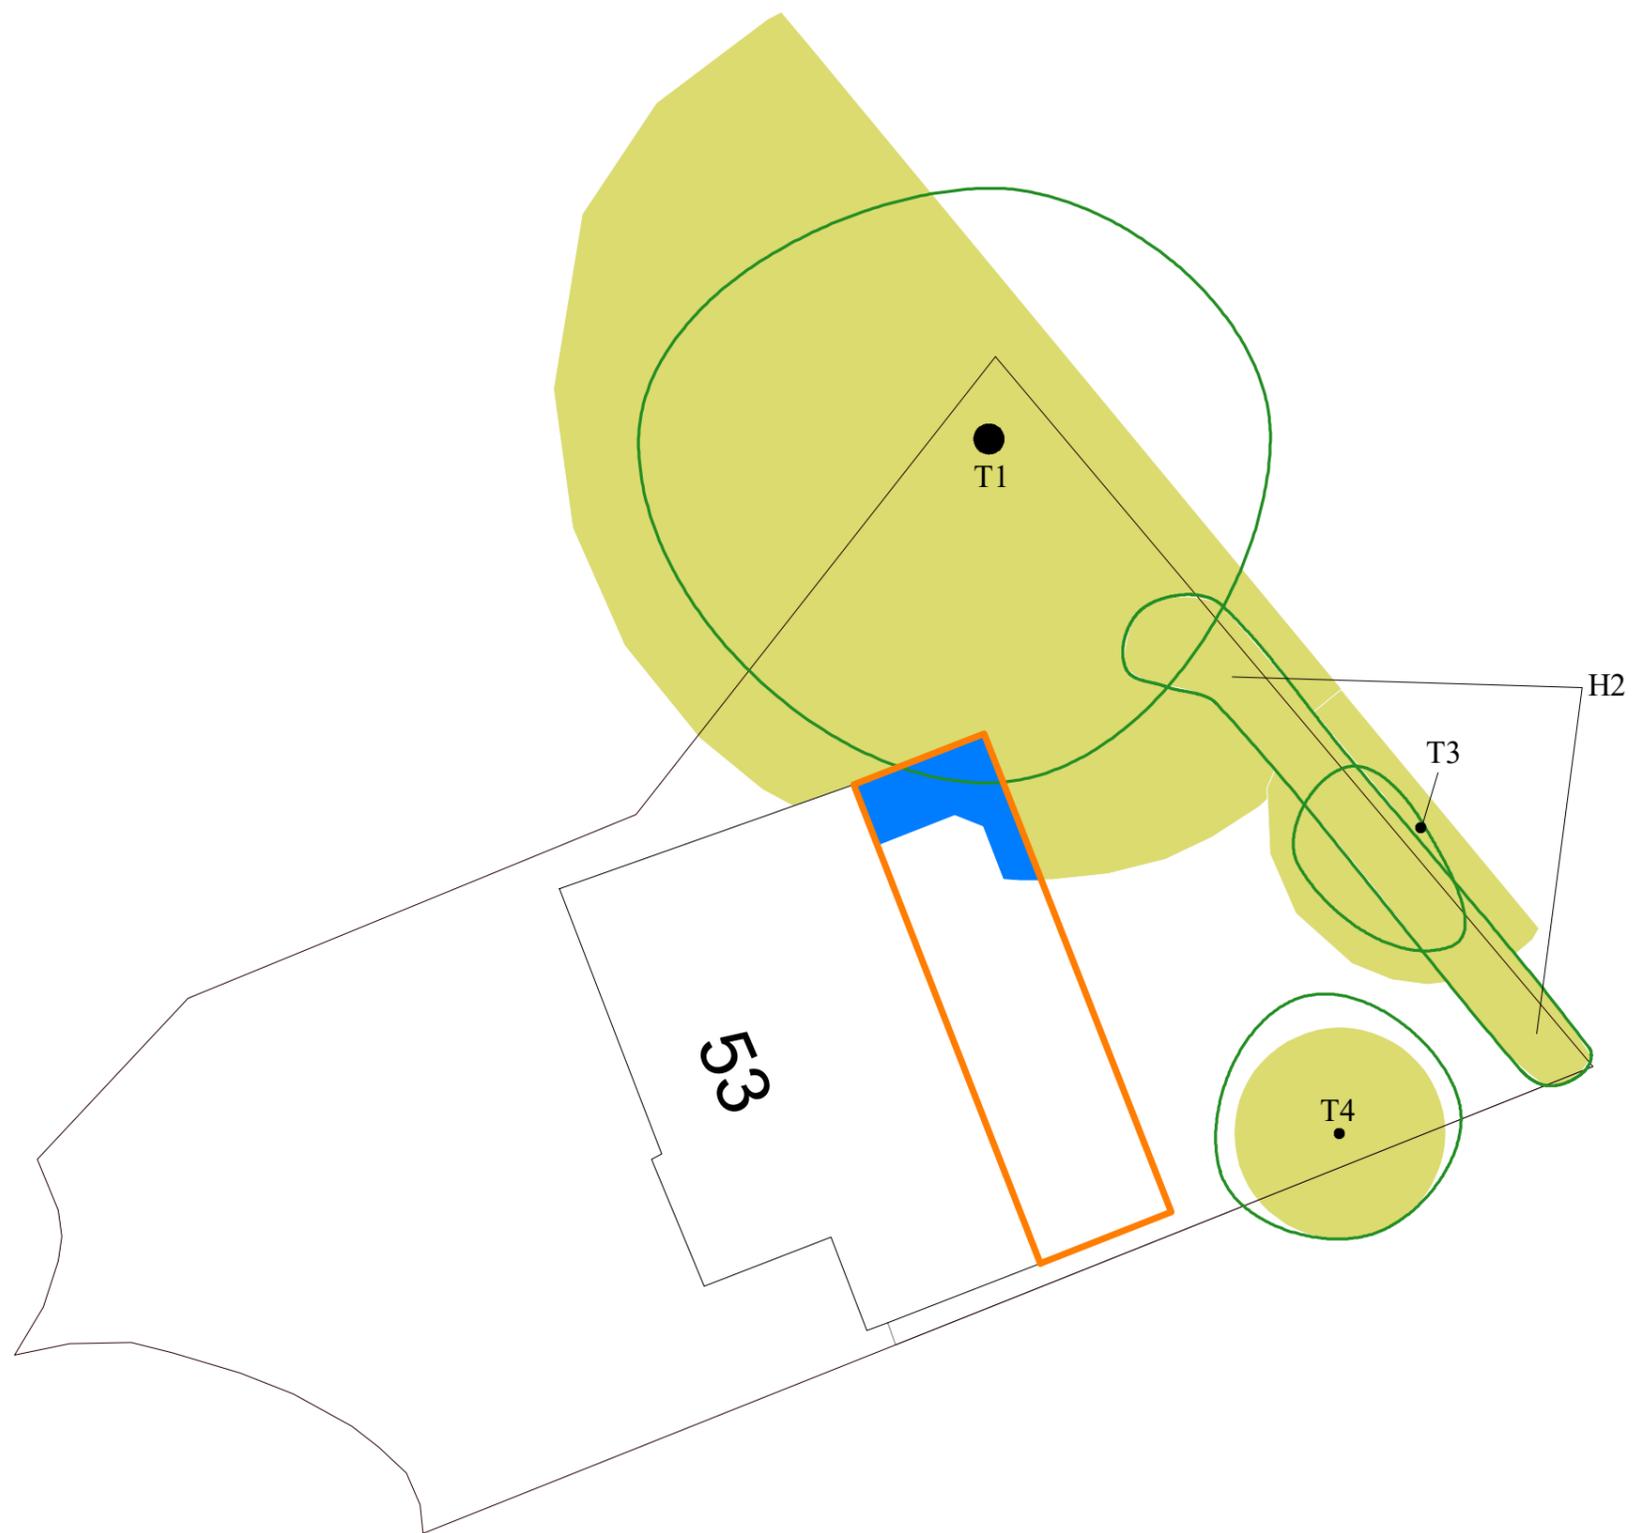
### Appendix 6: Arboricultural Implications Plan

TREE TO BE RETAINED
	TREE TO BE REMOVED
	STEM OF TREE TO BE RETAINED
	STEM OF TREE TO BE REMOVED
	ROOT PROTECTION AREA
	ROOT PROTECTION AREA ENCROACHED BY THE PROPOSED EXTENSION WHERE ROOT PRUNING MUST BE UNDERTAKEN UNDER ARBORICULTURAL SUPERVISION
	PROPOSED EXTENSION

- 4.3.1 The footprint of the proposed extension passes within the RPA of **T1** (as shown in [blue](#) on the Arboricultural Implications Plan at **Appendix 6**). Where the encroachment occurs, root pruning will be carried out, under the supervision of an appointed arboriculturist.
- 4.3.2 Root pruning will accommodate the proposed extension whilst preventing any ‘ripping’ damage, a problem commonly associated with mechanical excavations.

- 4.5.4.1 The footprint of proposed extension incurs the RPA of **T1** in the area shown in blue shade on the plan at **Appendix 6**. In this case, because of the minimal nature of the incursion, it is considered appropriate to undertake root pruning. This will allow for the construction of the building, without causing ‘ripping’ damage to the roots, a problem commonly associated with mechanical excavation, whilst also preventing the need for specialist foundation designs.
- 4.5.4.2 Advice should always be sought from a suitably qualified Structural Engineer. The water demand of trees can be an important consideration when determining the appropriate foundation design. Due of this, water demands for the trees identified on this site are included in **Appendix 1**, in accordance with **NHBC chapter 4.2**, for the use of the appointed structural expert.

- 5.4 The arboricultural implications of the development have been considered and discussed in **Section 4**.
- 5.5 **T1** requires root pruning under arboricultural supervision in order to facilitate the proposed development, as discussed in **Section 4** and detailed on the Arboricultural Implications Plan at **Appendix 6**.
